City of Rancho Palos Verdes
Rancho Palos Verdes ADA Assessment
Facility Report with Photos

Facility ID: # 11 - Point Vicente Fishing Access

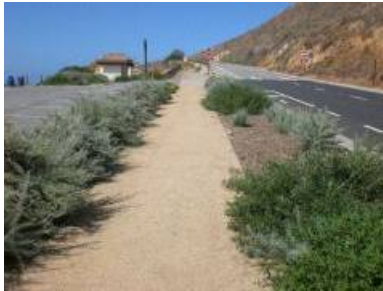
Keynote 1

Field Condition	
03A.07A - Cross Slope (PAR) - Cross slope of the pedestrian access route exceeds 1:50.	1991 ADAAG 4.3.7
Existing Condition: 3.7% to 6.3% CS.	2004 ADAAG 403.3
	2007 CBC 1133B.7.1.3
	Other 2005 PROWAG-R301.4.1

Classification	
DOJ Location Type:	1
Use:	PV
Severity:	C
Level of Difficulty	Moderate to High

Corrective Action
015A - Decomposed Granite Pathway - New decomposed granite pathway. The walkway slope shall not exceed 5% along the POT and cross slope shall not exceed 2%.
Additional Comments:

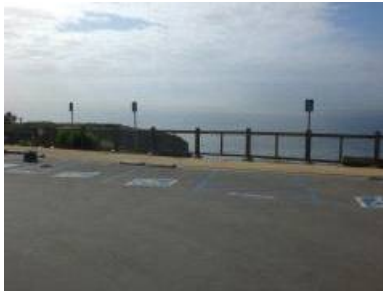
Keynote 5

Field Condition	
01.13 - Level Surface - The accessible parking spaces and access aisles are not level (slope is greater than 2%).	1991 ADAAG 4.6.3
Existing Condition: 2.6% to 3.5% CS & 3.0% to 5.2% RS.	2004 ADAAG 502.4; advisory 502.4
	2007 CBC 1129B.3 items 3 & 4
	Other

Classification	
DOJ Location Type:	1
Use:	PV
Severity:	C
Level of Difficulty	Moderate to High

Corrective Action	
194 - Asphalt Paved Parking Stall and Access Aisle - Remove non-compliant pavement and replace with new asphalt paving. The parking space and access aisle slope shall not exceed 2% in any direction.	
Additional Comments:

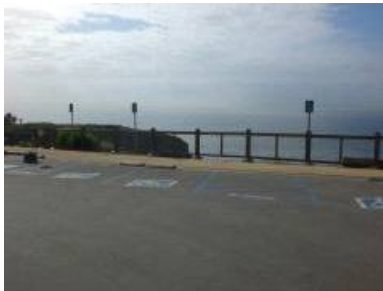
Keynote 6

Field Condition	
01.15B - Parking Space Sign - Accessible parking space has no reflectorized sign visible from the stall, showing an ISA in white on a blue background.	1991 ADAAG 4.6.4
Existing Condition:	2004 ADAAG 502.6
	2007 CBC 1129B.4
	Other

Classification	
DOJ Location Type:	1
Use:	PV
Severity:	C
Level of Difficulty	Low to Moderate

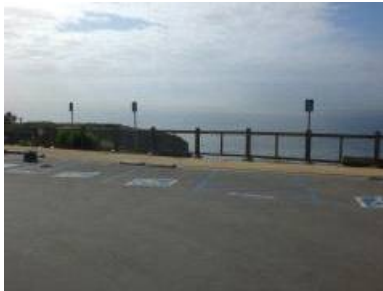
Keynote 7

Field Condition	
01.15C - Minimum Fine Sign - Accessible parking space has no sign stating "Minimum Fine \$250" below the ISA.	1991 ADAAG -
Existing Condition:	2004 ADAAG -
	2007 CBC 1129B.4
	Other

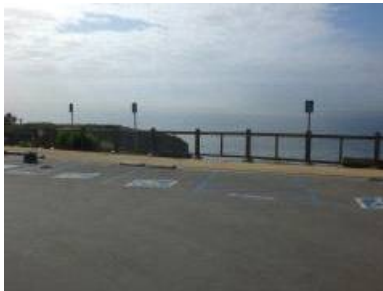
Keynote 8

Field Condition	
01.17 - Van Accessible Sign - Van accessible space has no sign stating "Van Accessible" below the ISA.	1991 ADAAG 4.6.4
Existing Condition:	2004 ADAAG 502.6
	2007 CBC 1129B.4
	Other

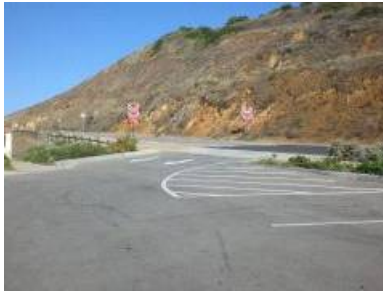
Keynote 9

Field Condition	
01.19B - Tow-away Sign - A California tow-away sign is not posted in a conspicuous place at each entrance to off-street parking lot, or immediately adjacent to and visible from each accessible stall.	1991 ADAAG -
Existing Condition:	2004 ADAAG -
	2007 CBC 1129B.4
	Other

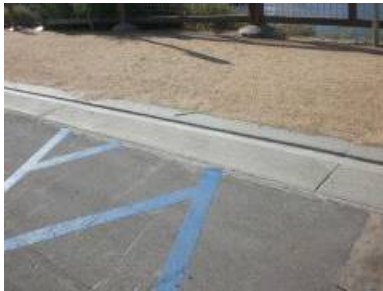
Keynote 10

Field Condition	
01.23 - Other - Parking - See Additional Comments	1991 ADAAG -
Existing Condition: 1" level change at concrete curb.	2004 ADAAG -
	2007 CBC -
	Other

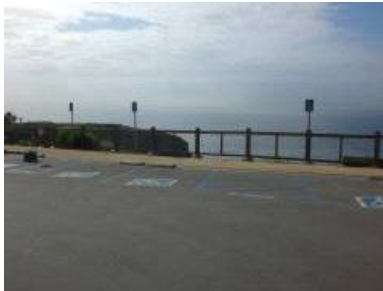
Keynote 11

Field Condition	
01.23 - Other - Parking - See Additional Comments	1991 ADAAG -
Existing Condition: No detectable warning provided.	2004 ADAAG -
	2007 CBC -
	Other

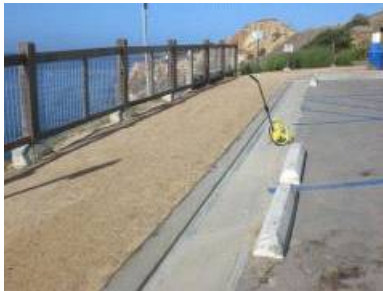
Keynote 12

Field Condition	
30.06E - Outdoor Recreation Access Route (ORAR) Segment - Cross Slope - Cross slope of the access route segment exceeds 3.33%. Exception: Cross slopes of 5% maximum are permitted to ensure proper drainage.	1991 ADAAG -
Existing Condition: 2.65 to 11.1% slope.	2004 ADAAG -
	2007 CBC -
	Other 1999 ADAAG-16.3.7.1

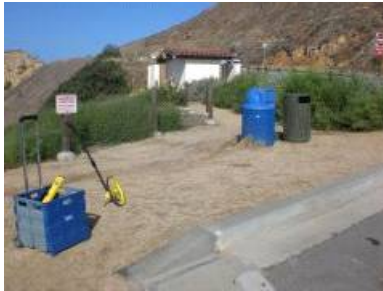
Keynote 13

Field Condition	03B.20 - Directions to Accessible Entrance - Where not all entrances are accessible, directional signage has not been provided indicating the accessible route to an accessible entrance.	1991 ADAAG 4.1.2(7); 4.1.3(8)(d)
	Existing Condition:	2004 ADAAG 216.6; Advisory 216.6; 703.5
		2007 CBC 1117B.5.8.1.2
		Other -

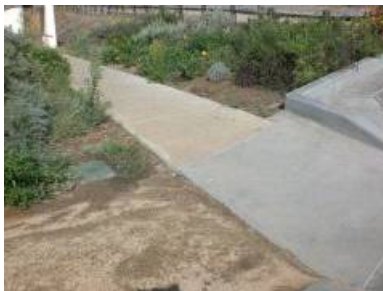
Keynote 14

Field Condition	03B.14 - Changes in Level (Curb Ramps, Ramps, or Elevators) - Curb ramps, ramps, or elevators are not compliant.	1991 ADAAG 4.7.1; 4.8.1
	Existing Condition:	2004 ADAAG 405; 406
		2007 CBC -
		Other -

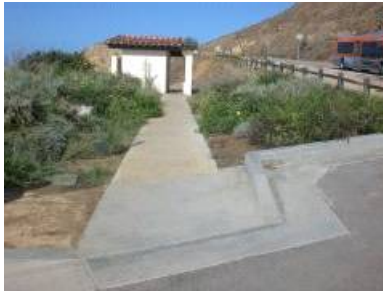
Keynote 15

Field Condition	
03B.01 - On-site Accessible Route of Travel - There is no accessible route within the property line of the site linking an accessible building entrance with site arrival points serving the following, if provided: public transportation stops, accessible parking, passenger loading zones, and public sidewalks.	1991 ADAAG 4.1.2(1)
Existing Condition: No POT from PROW to restrooms.	2004 ADAAG 202.2.1; Advisory 206.2.1
	2007 CBC 1114B.1.2; 1127B.1
	Other -

Classification	
DOJ Location Type:	1
Use:	PV
Severity:	C
Level of Difficulty	High

Corrective Action
006 - Concrete Walk - Remove non-compliant pavement and replace with new concrete (area as shown on the drawings). The walkway slope shall not exceed 5% along the POT and cross slope shall not exceed 2%.
Additional Comments:

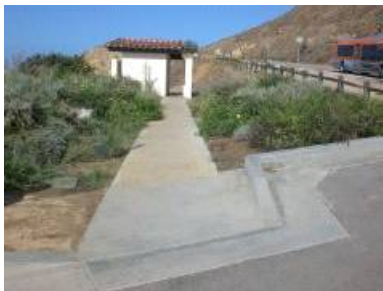
Keynote 16

Field Condition	
03B.09 - Cross Slope - Cross slope of the accessible route of travel exceeds 1:50.	1991 ADAAG 4.3.7
Existing Condition: 3.2% to 4.2% CS.	2004 ADAAG 403.3
	2007 CBC 1133B.7.1.3
	Other -

Classification	
DOJ Location Type:	1
Use:	PV
Severity:	C
Level of Difficulty	High

Corrective Action
006 - Concrete Walk - Remove non-compliant pavement and replace with new concrete (area as shown on the drawings). The walkway slope shall not exceed 5% along the POT and cross slope shall not exceed 2%.
Additional Comments:

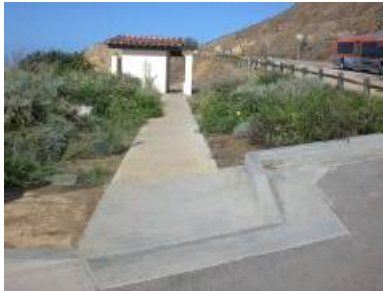
Keynote 17

03B.21 - Hazardous Vehicular Areas - Detectable Warnings - Where a walk crosses or adjoins the vehicular way and the walking surface is not separated by curbs, railings, or other elements between the pedestrian areas and vehicular areas, the boundary between the areas is not defined by a continuous detectable warning at least 36" wide complying with CBC 1121B.3.1 item 8(a). (i.e., the warning surface shall contrast visually with adjoining surfaces, either light on dark or dark on light, and shall differ from adjoining walking surfaces in resiliency or sound on cane contact. Color: yellow conforming to Federal Color No. 33538, Table IV/ Standard No. 595B. Where the color value contrast between the yellow warning and the main walking surface is less than 70 percent, a 1" wide black strip shall separate the yellow warning from the main walking surface.)

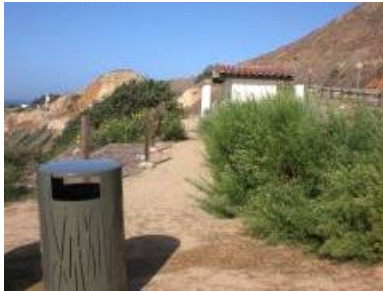
Keynote 18

Field Condition	
30.05 - Accessible Route - Width - Accessible route of travel is less than 48" wide (note: 48" wide requirement does not apply to doorways or gates).	1991 ADAAG 4.3.3
Existing Condition: 30" to 3' due to shrubs.	2004 ADAAG 403.5.1
	2007 CBC 1133B.7.1
	Other -

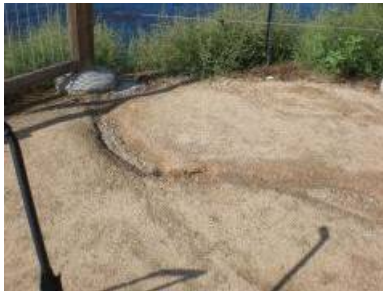
Keynote 19

Field Condition	
30.08 - Maintenance of Accessible Trail - Title II Entity - Accessible trail is not in operable working condition. (28 CFR 35.133)	1991 ADAAG -
Existing Condition: Water erosion.	2004 ADAAG -
	2007 CBC 1101B.3
	Other 28 CFR 35.133

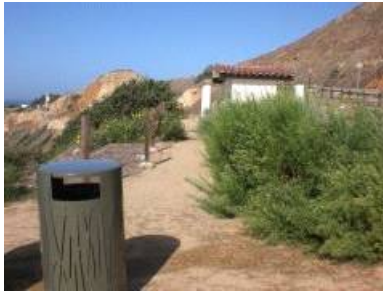
Keynote 20

Existing Condition: 2.4% to 7.2% at various locations.

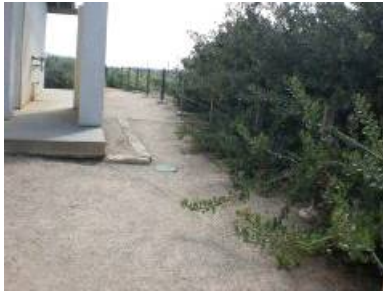
Keynote 22

Field Condition	
30.05 - Accessible Route - Width - Accessible route of travel is less than 48" wide (note: 48" wide requirement does not apply to doorways or gates).	1991 ADAAG 4.3.3
Existing Condition: 24" wide due to shrubs.	2004 ADAAG 403.5.1
	2007 CBC 1133B.7.1
	Other -

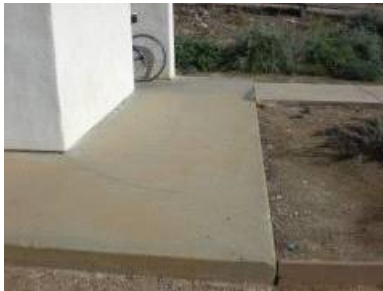
Keynote 23

Field Condition	
03B.09 - Cross Slope - Cross slope of the accessible route of travel exceeds 1:50.	1991 ADAAG 4.3.7
Existing Condition: 2.9% to 4.4% CS.	2004 ADAAG 403.3
	2007 CBC 1133B.7.1.3
	Other -

Corrective Action
006 - Concrete Walk - Remove non-compliant pavement and replace with new concrete (area as shown on the drawings). The walkway slope shall not exceed 5% along the POT and cross slope shall not exceed 2%.
Additional Comments:

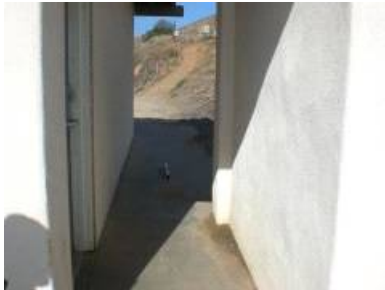
Keynote 24

Field Condition	
03B.04 - Width - Accessible route of travel is less than 48" wide (note: 48" wide requirement does not apply to doorways or gates).	1991 ADAAG 4.3.3
Existing Condition: 36" to 40" at wall.	2004 ADAAG 403.5.1
	2007 CBC 1133B.7.1
	Other -

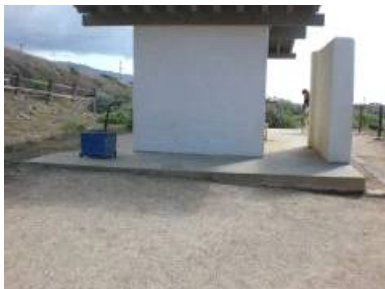
Keynote 25

Field Condition	
03B.13 - > 1/2" Changes in Level - Curb ramps, ramps, or elevators are not used for changes in level greater than 1/2 inch. (Lifts may only be used in certain limited situations.)	1991 ADAAG 4.5.2
Existing Condition: 3" to 10" level change.	2004 ADAAG 303.4
	2007 CBC 1124B.2
	Other -

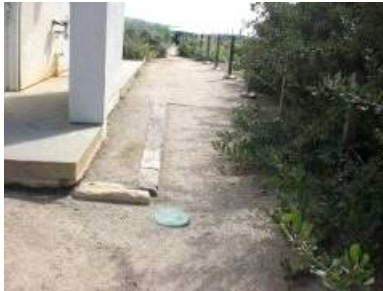
Keynote 26

Field Condition	03B.17 - > 4" Abrupt Change in Level - Site includes abrupt changes in level adjacent to pedestrian areas exceeding 4" vertical (exceptions: (1) between a walk or sidewalk and an adjacent street or driveway, or (2) where a 6" high warning curb or guardrail is provided to warn of a potential drop off).	1991 ADAAG -
Existing Condition:		2004 ADAAG -
		2007 CBC 1133B.8.1
		Other -

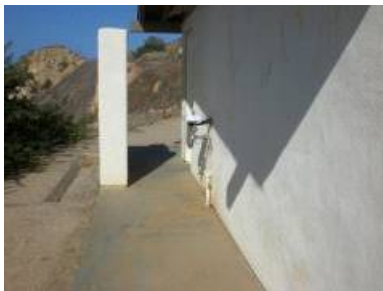
Keynote 27

Field Condition	03B.04 - Width - Accessible route of travel is less than 48" wide (note: 48" wide requirement does not apply to doorways or gates).	1991 ADAAG 4.3.3
Existing Condition:	36" to 40" at wall.	2004 ADAAG 403.5.1
		2007 CBC 1133B.7.1
		Other -

Corrective Action	027 - Site Work - Miscellaneous - See Additional Comments
Additional Comments:	Remove wall and repair concrete surface to meet existing with compliant cross slope.

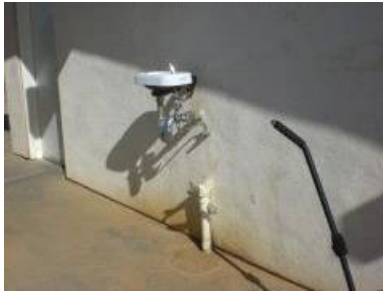
Keynote 28

05.01A - "Hi" Drinking Fountain Requirement - Where there is only one drinking fountain area on a floor (e.g., an area with a drinking fountain or separate drinking fountains), it is accessible to wheelchair users and not to persons who have difficulty bending or stooping (i.e., the required accessibility for persons who have difficulty bending or stooping on each floor has not been provided).

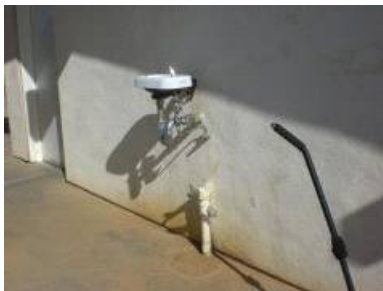
Keynote 29

05.08A - Wall-Mounted Protruding Objects - Wall mounted drinking fountain with leading edges between 27" and 80" from the floor projects more than 4" into the circulation path.

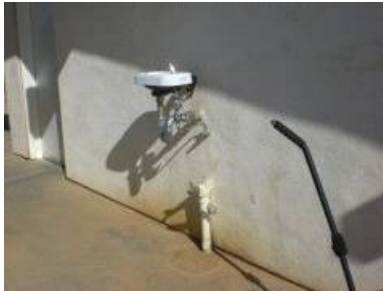
Keynote 30

Field Condition	
05.11 - Water Flow - Round or Oval Bowl - For a fountain with a round or oval bowl, the water flow is not within 3" of the fountain's front edge.	1991 ADAAG 4.15.3
Existing Condition: 4".	2004 ADAAG -
	2007 CBC 1115B.4.6 item 5
	Other -

Classification	
DOJ Location Type:	4
Use:	PV
Severity:	C
Level of Difficulty	High

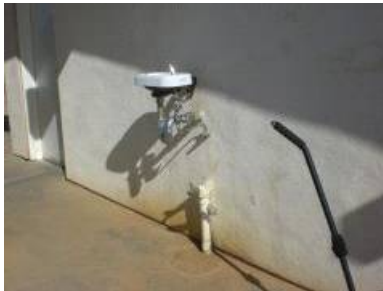
Keynote 31

Field Condition	
05.13 - Operation - The controls are not compliant.(Accessible controls shall be operable with one hand, and without tight grasping, pinching, or twisting of the wrist, and the force to operate the controls shall be no greater than 5 lbs.)	1991 ADAAG 4.27.4
Existing Condition:	2004 ADAAG 602.3; 309.4
	2007 CBC 1115B.4.6 item 4
	Other -

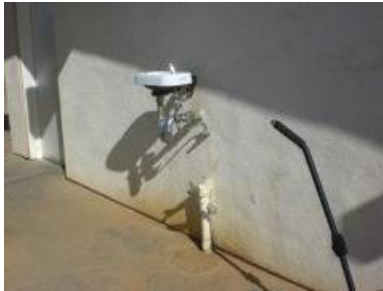
Keynote 32

Field Condition	
05.07 - Clear Floor Space - Drinking fountain does not have a 30" x 48" clear floor space that adjoins or overlaps an accessible route of travel and that allows a forward approach by wheelchair users. (A side approach is not acceptable.)	1991 ADAAG 4.15.5(1); Figs. 27(c) and (d)
Existing Condition: 36" clear to edge of concrete walk.	2004 ADAAG 305.1
	2007 CBC 1115B.4.6 item 2
	Other -

Corrective Action
006 - Concrete Walk - Remove non-compliant pavement and replace with new concrete (area as shown on the drawings). The walkway slope shall not exceed 5% along the POT and cross slope shall not exceed 2%.
Additional Comments:

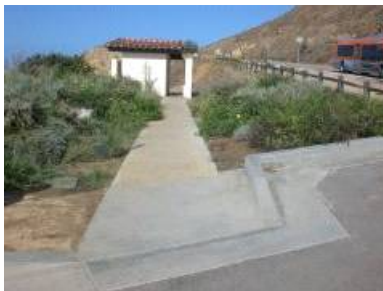
Keynote 33

Field Condition	
16.04 - Accessible Path of Travel - Toilet room is not located on an accessible route of travel.	1991 ADAAG 4.22.1
Existing Condition: No POT to restroom from PROW.	2004 ADAAG 206.2.4; Advisory 206.2.4
	2007 CBC 1115B.1
	Other -

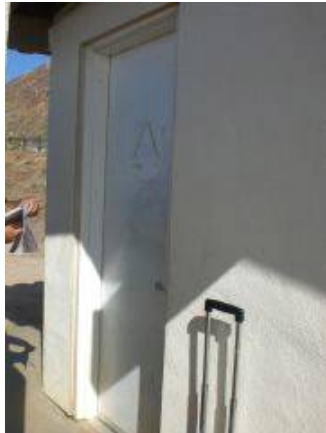
Keynote 34

Field Condition	
16.07 - Clear Door Opening - When the door is open 90 degrees, clear opening width is less than 32" measured between the face of the door and the doorstop on the latch side.	1991 ADAAG 4.13.5
Existing Condition: 29" wide.	2004 ADAAG 404.2.3
	2007 CBC 1133B.1.1.1.1; 1133B.2.2
	Other -

Corrective Action
056 - Widen Door Opening - Remove existing door and replace with new door and door frame. Cut existing wall to widen door opening. Provide new accessible door hardware.
Additional Comments:

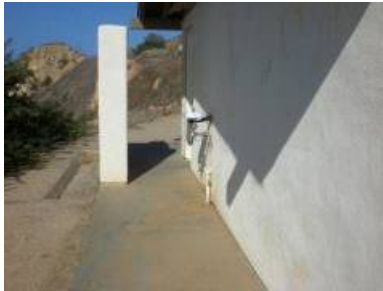
Keynote 35

Existing Condition: 46 1/2" on push side

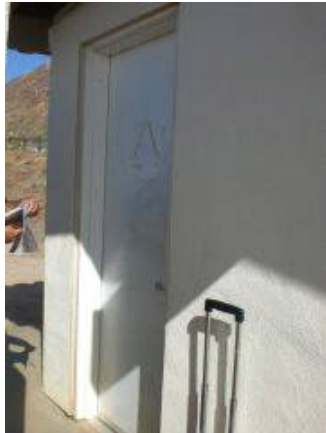
Keynote 36

Field Condition	
16.11A - Door Operating Effort - The force required to operate door exceeds 5 lbs. (Fire doors may have up to 15 lbs to achieve positive latching).	1991 ADAAG 4.13.11
Existing Condition: 12 LBF.	2004 ADAAG 404.2.9
	2007 CBC 1133B.2.5
	Other -

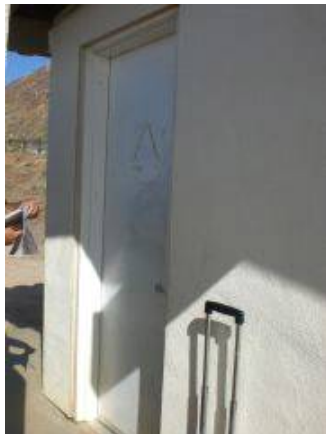
Keynote 37

Field Condition	
16.13B - Women's RR Geometric Symbol Signage - Circle - Doorway leading to a women's toilet room is not identified by a circle, 1/4" thick and 12" in diameter. OR Circle is provided, however it is accompanied by words in raised characters and Braille. (ADA and CBC Standards require a separate sign with raised characters and Braille mounted on the wall adjacent to the latch side of the door.)	1991 ADAAG -
Existing Condition:	2004 ADAAG -
	2007 CBC 1115B.6
	Other -

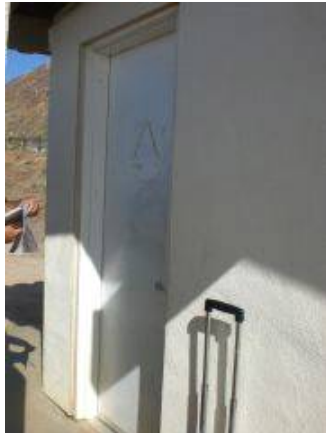
Keynote 38

Field Condition	
16.15A - Providing Room/Space ID Sign - A sign designating the permanent room or space has not been provided.	1991 ADAAG 4.30.1
Existing Condition:	2004 ADAAG 216.2; 703.1; 703.2; 703.5
	2007 CBC 1117B.5.1(1)
	Other -

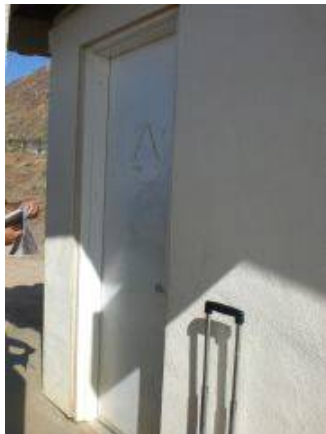
Keynote 39

Field Condition	
16.18A - ISA - Accessible toilet room is not identified by an ISA.	1991 ADAAG 4.1.3(16)(b)
Existing Condition:	2004 ADAAG 216.8
	2007 CBC 1117B.5.1(3)
	Other -

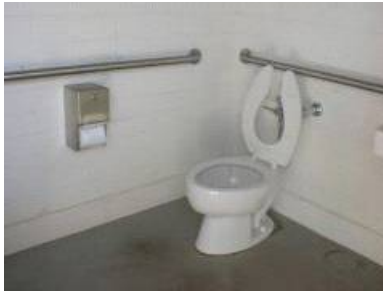
Keynote 40

Field Condition	
16.47A - WC Location from Sidewall - The centerline of the WC is not 18" absolute from a wall or partition.	1991 ADAAG 4.22.4
Existing Condition: 19 1/2".	2004 ADAAG -
	2007 CBC 1115B.4.1(1)
	Other -

Corrective Action
319C - Water Closet - New Location - Replace existing water closet with compliant model in new location.
Additional Comments:

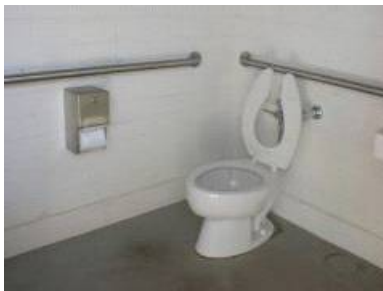
Keynote 41

Field Condition	
16.48 - WC Seat Height - The top of the WC seat is not between 17" and 19" AFF.	1991 ADAAG 4.16.3; Fig. 29(b)
Existing Condition: 16" high.	2004 ADAAG 604.4
	2007 CBC 1115B.4.1(4); Fig. 11B-1A
	Other -

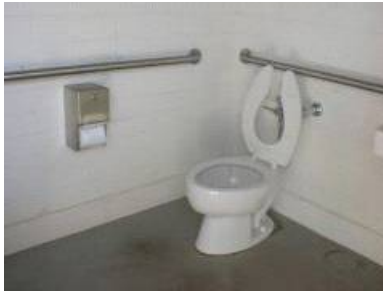
Keynote 42

Field Condition	
16.49B - WC Flush Controls - Location - Flush controls are not located on the wide side of the WC where the clear floor space is provided.	1991 ADAAG 4.16.5
Existing Condition:	2004 ADAAG 604.6; Advisory 604.6
	2007 CBC 1115B.4.1(5); Fig. 11B-1A
	Other -

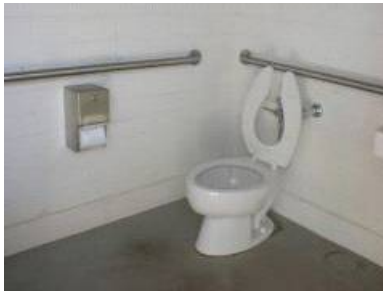
Keynote 43

Field Condition	
16.50_07CBC - TP Dispenser - Location - Location of the toilet paper dispenser is not compliant. (Effective January 1, 2008, CBC Standards require toilet tissue dispensers located on the wall within 12" of the front edge of the toilet seat, mounted below the grab bar, centered at a min. height of 19" AFF, and 36" maximum to the dispenser's far edge from the rear wall; there is no requirement to retroactively alter existing toilet paper dispensers when installed in compliance with CBC Standards in effect at the time of original construction.)	1991 ADAAG 4.16.6; Fig. 29(b)
Existing Condition: 15" from WC.	2004 ADAAG 604.7; Advisory 604.7; Fig. 604.7
	2007 CBC 1115B.8.4; Fig. 11B-1A
	Other -

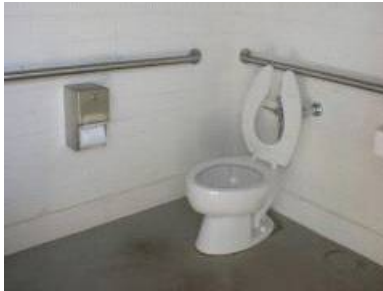
Keynote 44

Field Condition	
16.55A - Side Grab Bar Height - Side grab bar is not centered at 33" AFF. (ADA Standards require side grab bars to be centered from 33" to 36" AFF; CBC Standards require side grab bars to be centered at 33" AFF.)	1991 ADAAG 4.17.6; Figs. 29 & 30
Existing Condition: 33 3/8" high.	2004 ADAAG 604.5; Advisory 604.5; 604.5.2; Fig. 604.5.2; 609.4
	2007 CBC 1115B.4.1(3.1); Fig. 11B-1A
	Other -

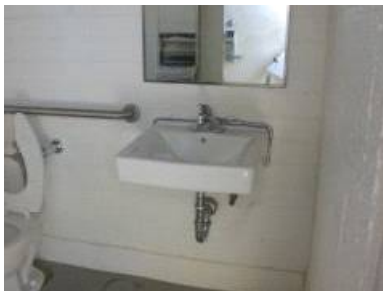
Keynote 45

Field Condition	
16.72 - Lavatory Apron Clearance - Lavatory does not provide accessible apron clearance (i.e. at least 29" clearance from the floor to the bottom of the apron).	1991 ADAAG 4.19.2; Fig. 31
Existing Condition: 27 1/2" high.	2004 ADAAG 606.3
	2007 CBC 1115B.4.3(2); Fig 11B-1D
	Other -

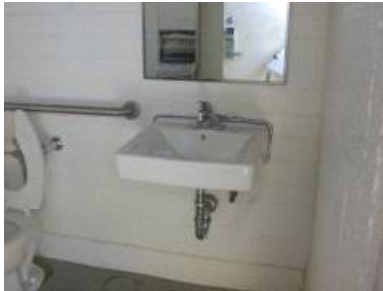
Keynote 46

Field Condition	
16.78 - Pipe Insulation at Lavatory - Drainpipes and hot water pipes are not insulated to protect against contact.	1991 ADAAG 4.19.4
Existing Condition:	2004 ADAAG 606.5
	2007 CBC 1115B.4.3(4)
	Other -

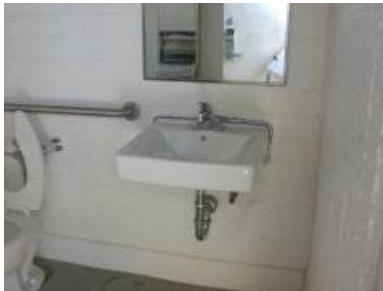
Keynote 47

Field Condition	
16.79 - Smooth Surfaces at Lavatory - The area below the lavatory is not free of sharp or abrasive surfaces.	1991 ADAAG 4.19.4
Existing Condition:	2004 ADAAG 606.5
	2007 CBC 1115B.4.3(4)
	Other -

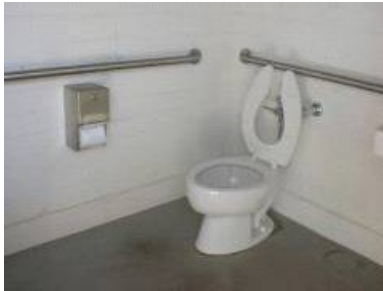
Keynote 48

Existing Condition: 33 3/8" high.

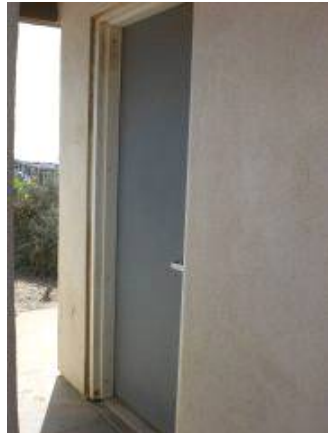
Keynote 50

Field Condition	
16.07 - Clear Door Opening - When the door is open 90 degrees, clear opening width is less than 32" measured between the face of the door and the doorstop on the latch side.	1991 ADAAG 4.13.5
Existing Condition: 29" wide.	2004 ADAAG 404.2.3
	2007 CBC 1133B.1.1.1.1; 1133B.2.2
	Other -

Corrective Action
056 - Widen Door Opening - Remove existing door and replace with new door and door frame. Cut existing wall to widen door opening. Provide new accessible door hardware.
Additional Comments: Reverse door swing.

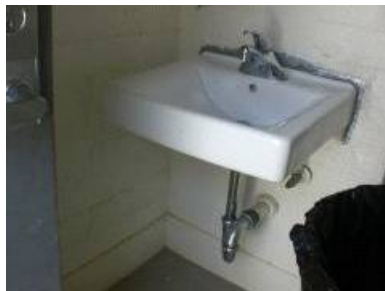
Keynote 51

Field Condition	
16.08A - Door Swing - The door swing intrudes into the clear floor space of one or more fixtures.	1991 ADAAG 4.22.2
Existing Condition: Encroaches lavatory clear floor space by 12".	2004 ADAAG 603.2.3; Advisory 603.2.3
	2007 CBC 1115B.3.1 item 2; 1115B.3.2 item 2; 1115B.5
	Other -

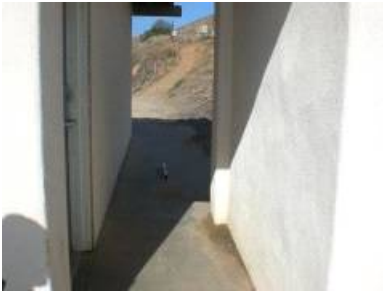
Keynote 52

Existing Condition: 46" on push side.

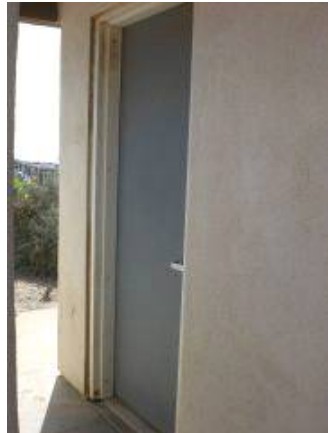
Keynote 53

Field Condition	
16.11A - Door Operating Effort - The force required to operate door exceeds 5 lbs. (Fire doors may have up to 15 lbs to achieve positive latching).	1991 ADAAG 4.13.11
Existing Condition: 15 LBF.	2004 ADAAG 404.2.9
	2007 CBC 1133B.2.5
	Other -

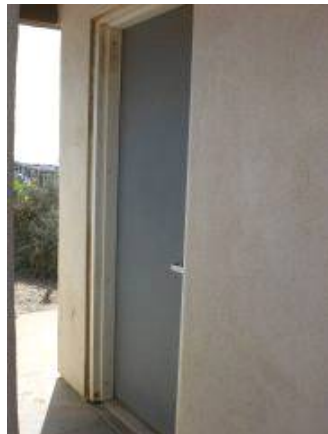
Keynote 54

Field Condition	
16.13A - Men's RR Geometric Symbol Signage - Triangle - Doorway leading to a men's toilet room is not identified by an equilateral triangle 1/4" thick with edges 12" long. OR Equilateral triangle is provided, however it is accompanied by words in raised characters and Braille. (ADA and CBC Standards require a separate sign with raised characters and Braille mounted on the wall adjacent to the latch side of the door.)	1991 ADAAG -
Existing Condition:	2004 ADAAG -
	2007 CBC 1115B.6
	Other -

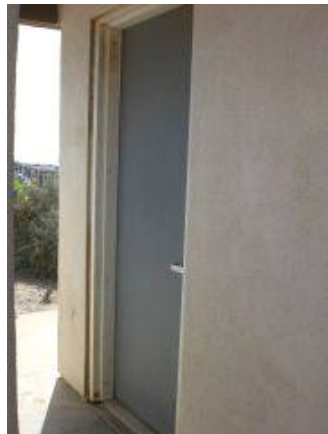
Keynote 55

Field Condition	
16.15A - Providing Room/Space ID Sign - A sign designating the permanent room or space has not been provided.	1991 ADAAG 4.30.1
Existing Condition:	2004 ADAAG 216.2; 703.1; 703.2; 703.5
	2007 CBC 1117B.5.1(1)
	Other -

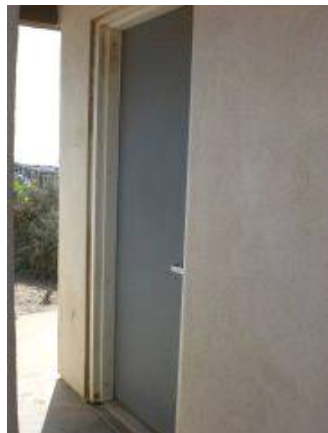
Keynote 56

Field Condition	
16.18A - ISA - Accessible toilet room is not identified by an ISA.	1991 ADAAG 4.1.3(16)(b)
Existing Condition:	2004 ADAAG 216.8
	2007 CBC 1117B.5.1(3)
	Other -

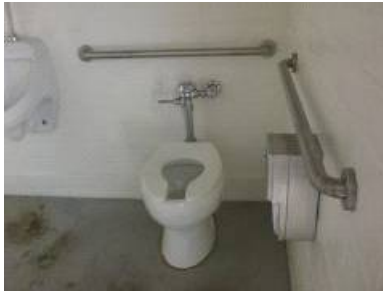
Keynote 57

Field Condition	
16.47A - WC Location from Sidewall - The centerline of the WC is not 18" absolute from a wall or partition.	1991 ADAAG 4.22.4
Existing Condition: 19 3/8".	2004 ADAAG -
	2007 CBC 1115B.4.1(1)
	Other -

Corrective Action	
319C - Water Closet - New Location - Replace existing water closet with compliant model in new location.	
Additional Comments:

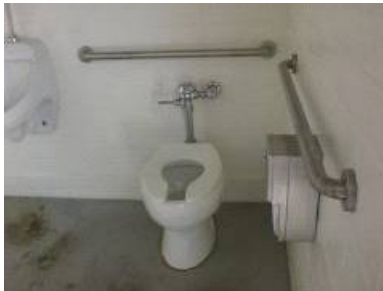
Keynote 58

Field Condition	
16.48 - WC Seat Height - The top of the WC seat is not between 17" and 19" AFF.	1991 ADAAG 4.16.3; Fig. 29(b)
Existing Condition: 16" high.	2004 ADAAG 604.4
	2007 CBC 1115B.4.1(4); Fig. 11B-1A
	Other -

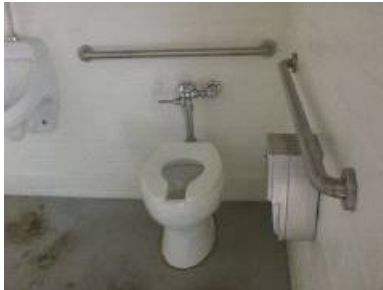
Keynote 59

Existing Condition: 16" in front of WC.

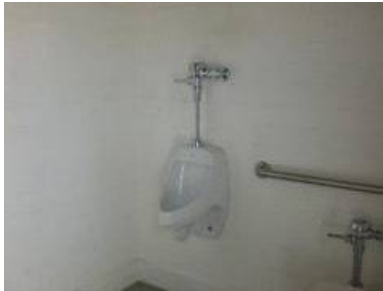
Keynote 61

Field Condition	
16.65B - Wall-Hung Urinal - Rim Height - Height of wall-hung urinal's rim exceeds 17" AFF. Existing Condition: 26" high.	1991 ADAAG 4.18.2 2004 ADAAG 605.2; Fig. 605.2(a) 2007 CBC 1115B.4.2(1) Other -

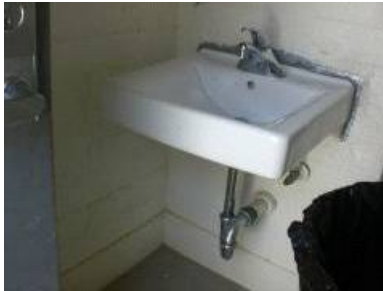
Keynote 63

16.72 - Lavatory Apron Clearance - Lavatory does not provide accessible apron clearance (i.e. at least 29" clearance from the floor to the bottom of the apron).
 Existing Condition: 27" high.

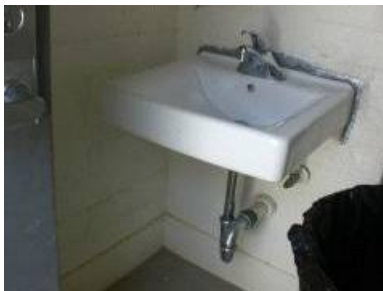
Keynote 64

16.73 - Lavatory Knee Clearance - Lavatory does not provide accessible knee clearance (i.e. at least 27" clearance from the floor to the underside of the lavatory, extending 8" min.. measured from the front edge underneath the lavatory back towards the wall).
 Existing Condition: 26 1/2" high.

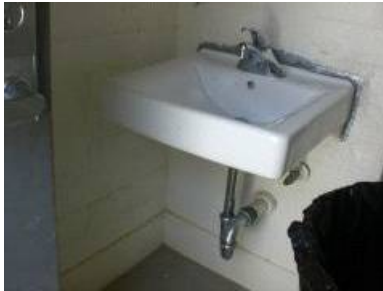
Keynote 65

Existing Condition: 13 3/4".

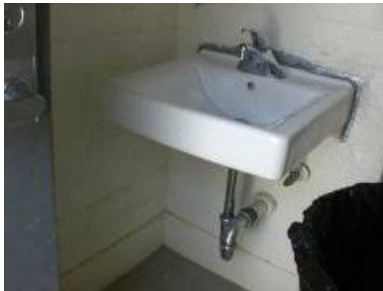
Keynote 66

Existing Condition: Door encroaches.

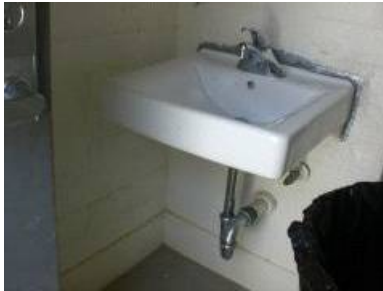
Keynote 67

Field Condition	
16.78 - Pipe Insulation at Lavatory - Drainpipes and hot water pipes are not insulated to protect against contact.	1991 ADAAG 4.19.4
Existing Condition:	2004 ADAAG 606.5
	2007 CBC 1115B.4.3(4)
	Other -

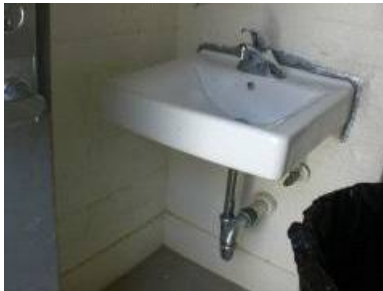
Keynote 68

Field Condition	
16.79 - Smooth Surfaces at Lavatory - The area below the lavatory is not free of sharp or abrasive surfaces.	1991 ADAAG 4.19.4
Existing Condition:	2004 ADAAG 606.5
	2007 CBC 1115B.4.3(4)
	Other -

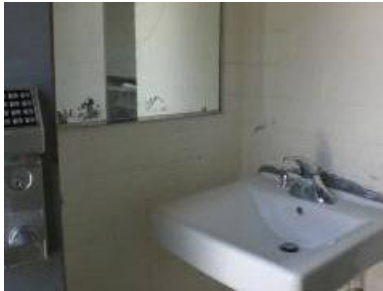
Keynote 69

Existing Condition: 40 1/4" high.

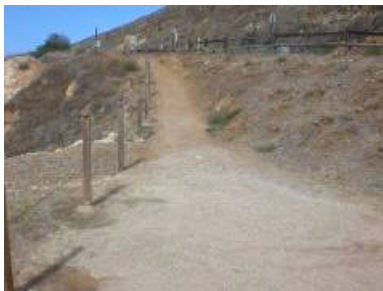
Keynote 70

30.10E - Trail Surface - The surface of the trail is not firm or stable.

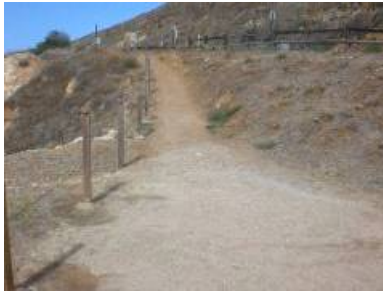
Keynote 72

Field Condition	
30.10C - Trail Segment - Cross Slope - Cross slope of the trail segment exceeds 1:20. Existing Condition: 12.3% to 17.6% CS.	1991 ADAAG - 2004 ADAAG - 2007 CBC - Other 1999 ADAAG-16.2.7.1

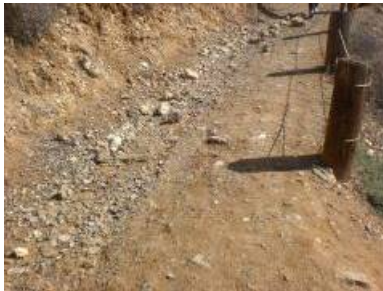
Keynote 73

Field Condition	
30.68 - Other - Parks - See Additional Comments Existing Condition: Loose rocks on trail.	1991 ADAAG - 2004 ADAAG - 2007 CBC - Other -

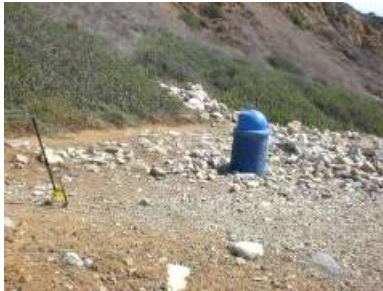
Keynote 74

Field Condition	30.48 - Trash & Recycling Receptacles - Landing - The trash and/or recycling receptacle is not located on stable, firm ground. OR A clear space min.. of 30" x 48" has not been provided. OR Slope is greater than 2% in some or all directions. (3% allowed if necessary for drainage).	1991 ADAAG 4.3.7
	Existing Condition:	2004 ADAAG 403.3
		2007 CBC -
		Other 1999 ADAAG-16.8.2; 16.8.3; 16.8.4

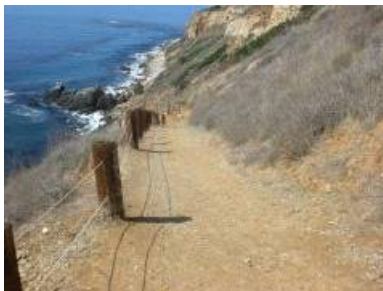
Keynote 75

Field Condition	30.10C - Trail Segment - Cross Slope - Cross slope of the trail segment exceeds 1:20.	1991 ADAAG -
	Existing Condition: 5.5% to 17.3% CS.	2004 ADAAG -
		2007 CBC -
		Other 1999 ADAAG-16.2.7.1
