*City of Rancho Palos Verdes*  
**Rancho Palos Verdes ADA Assessment**  
**Facility Report with Photos**

**Facility ID: # 13 - Vanderlip Park**

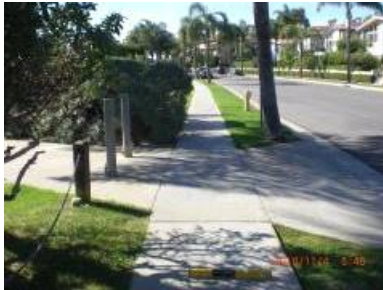
**Keynote 1**

03A.14A - Walk Bordering Vehicular Way - Detectable Warnings - Where a walk crosses or adjoins the vehicular way and the walking surface is not separated by curbs, railings, or other elements between the pedestrian areas and vehicular areas, the boundary between the areas is not defined by a continuous detectable warning at least 36" wide complying with CBC 1121B.3.1 item 8(a). (i.e., the warning surface shall contrast visually with adjoining surfaces, either light on dark or dark on light, and shall differ from adjoining walking surfaces in resiliency or sound on cane contact. Color: yellow conforming to Federal Color No. 33538, Table IV/ Standard No. 595B. Where the color value contrast between the yellow warning and the main walking surface is less than 70 percent, a 1" wide black strip shall separate the yellow warning from the main walking surface.)

<b>1991 ADAAG</b>	4.29.5
<b>2004 ADAAG</b>	705
<b>2007 CBC</b>	1133B.8.5
<b>Other</b>	2005 PROWAG-R303.3.2

<b>DOJ Location Type:</b>	1
<b>Use:</b>	PV
<b>Severity:</b>	A
<b>Level of Difficulty</b>	Moderate to High

024 - Blended Transitions - Detectable Warnings - Provide a continuous, yellow, 36" wide detectable warning surface (i.e. in-line truncated domes).

Additional Comments: Provide detectable warning at both ends of driveway.

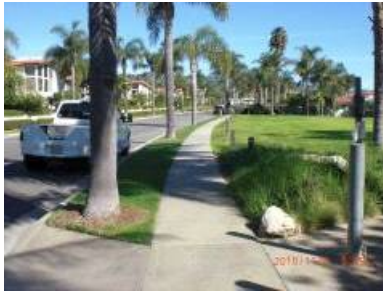
**Keynote 2**

Field Condition	
03A.07A - Cross Slope (PAR) - Cross slope of the pedestrian access route exceeds 1:50.	1991 ADAAG 4.3.7
Existing Condition: 2.1% to 4.6% CS.	2004 ADAAG 403.3
	2007 CBC 1133B.7.1.3
	Other 2005 PROWAG-R301.4.1

Classification	
DOJ Location Type:	1
Use:	PV
Severity:	C
Level of Difficulty	High

Corrective Action
006 - Concrete Walk - Remove non-compliant pavement and replace with new concrete (area as shown on the drawings). The walkway slope shall not exceed 5% along the POT and cross slope shall not exceed 2%.
Additional Comments:

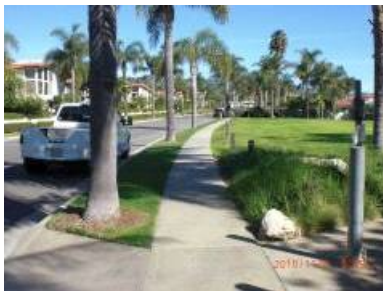
**Keynote 3**

Field Condition	
03A.02B - Passing Spaces - Where the accessible route of travel is less than 60" wide, passing spaces at least 60" by 60" or intersecting walks, allowing passing at reasonable intervals not exceeding 200', is not provided.	1991 ADAAG 4.3.4
Existing Condition: 48" wide walkway with no passing spaces.	2004 ADAAG 403.5.3
	2007 CBC 1133B.7.1
	Other 2005 PROWAG-R301.3.2

Classification	
DOJ Location Type:	1
Use:	PV
Severity:	C
Level of Difficulty	Moderate

Corrective Action
008 - Concrete Landing - Remove non-compliant pavement and replace with new concrete. The landing slope shall not exceed 2% in any direction.
Additional Comments: Provide one 60" x 60" passing space.

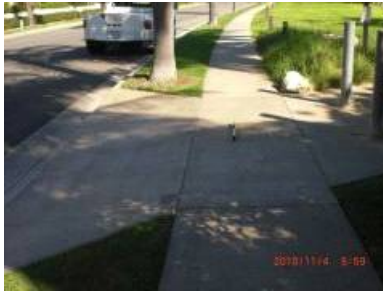
**Keynote 4**

03A.14A - Walk Bordering Vehicular Way - Detectable Warnings - Where a walk crosses or adjoins the vehicular way and the walking surface is not separated by curbs, railings, or other elements between the pedestrian areas and vehicular areas, the boundary between the areas is not defined by a continuous detectable warning at least 36" wide complying with CBC 1121B.3.1 item 8(a). (i.e., the warning surface shall contrast visually with adjoining surfaces, either light on dark or dark on light, and shall differ from adjoining walking surfaces in resiliency or sound on cane contact. Color: yellow conforming to Federal Color No. 33538, Table IV/ Standard No. 595B. Where the color value contrast between the yellow warning and the main walking surface is less than 70 percent, a 1" wide black strip shall separate the yellow warning from the main walking surface.)

<b>1991 ADAAG</b>	4.29.5
<b>2004 ADAAG</b>	705
<b>2007 CBC</b>	1133B.8.5
<b>Other</b>	2005 PROWAG-R303.3.2

<b>DOJ Location Type:</b>	1
<b>Use:</b>	PV
<b>Severity:</b>	A
<b>Level of Difficulty</b>	Moderate to High

024 - Blended Transitions - Detectable Warnings - Provide a continuous, yellow, 36" wide detectable warning surface (i.e. in-line truncated domes).

Additional Comments: Provide detectable warning at both ends of driveway.

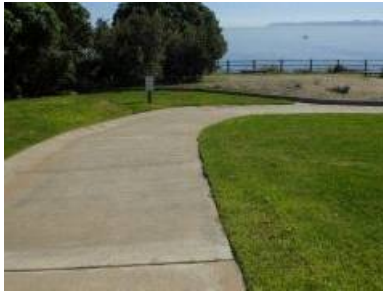
**Keynote 5**

<b>Field Condition</b>									
03B.09 - Cross Slope - Cross slope of the accessible route of travel exceeds 1:50. Existing Condition: 3.3% to 7.1% CS.

<b>Classification</b>	
<b>DOJ Location Type:</b>	1
<b>Use:</b>	PV
<b>Severity:</b>	C
<b>Level of Difficulty</b>	High

<b>Corrective Action</b>	
006 - Concrete Walk - Remove non-compliant pavement and replace with new concrete (area as shown on the drawings). The walkway slope shall not exceed 5% along the POT and cross slope shall not exceed 2%.	
Additional Comments:

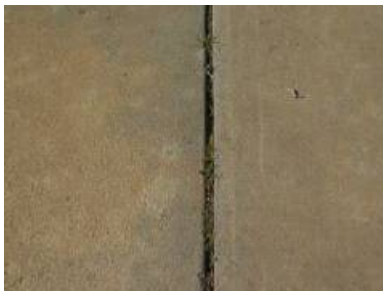
**Keynote 6**

<b>Field Condition</b>									
03B.22 - Other - On-Site Accessible Path of Travel - See Additional Comments Existing Condition: 1" gap.

<b>Classification</b>	
<b>DOJ Location Type:</b>	1
<b>Use:</b>	PV
<b>Severity:</b>	C
<b>Level of Difficulty</b>	Moderate

<b>Corrective Action</b>	
027 - Site Work - Miscellaneous - See Additional Comments	
Additional Comments: See Keynote 5 for corrective action.

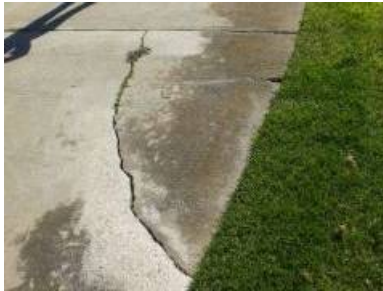
**Keynote 7**

<b>Field Condition</b>	
03B.15 - Surface - Accessible route surfaces are not stable, firm and slip-resistant.	1991 ADAAG 4.5.1
Existing Condition: Cracks.	2004 ADAAG 302.1; Advisory 302.1
	2007 CBC 1124B.1
	Other -

<b>Classification</b>	
DOJ Location Type:	1
Use:	PV
Severity:	C
Level of Difficulty	Moderate

<b>Corrective Action</b>
027 - Site Work - Miscellaneous - See Additional Comments
Additional Comments: See Keynote 5 for corrective action.

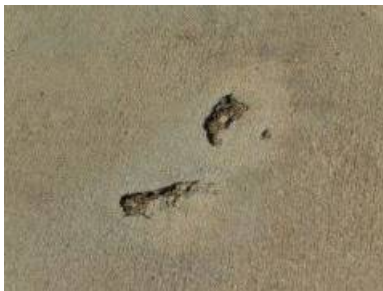
**Keynote 8**

<b>Field Condition</b>	
03B.15 - Surface - Accessible route surfaces are not stable, firm and slip-resistant.	1991 ADAAG 4.5.1
Existing Condition: Pot holes.	2004 ADAAG 302.1; Advisory 302.1
	2007 CBC 1124B.1
	Other -

<b>Classification</b>	
DOJ Location Type:	1
Use:	PV
Severity:	C
Level of Difficulty	Moderate

<b>Corrective Action</b>
027 - Site Work - Miscellaneous - See Additional Comments
Additional Comments: See Keynote 5 for corrective action.

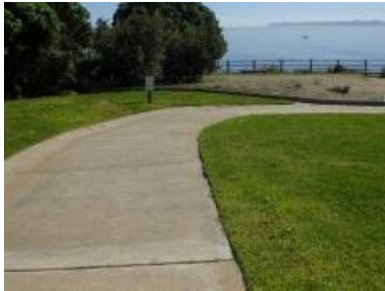
**Keynote 9**

Field Condition									
03B.10 - Running Slope - Slope of the accessible route of travel exceeds 1:20.  Existing Condition: 6.0% to 11.2% RS.

Classification	
DOJ Location Type:	1
Use:	PV
Severity:	C
Level of Difficulty	Moderate

Corrective Action
027 - Site Work - Miscellaneous - See Additional Comments  Additional Comments: See Keynote 5 for corrective action.

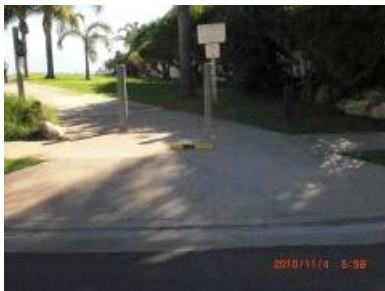
**Keynote 10**

Field Condition									
14.32A - Reach Range - Controls - Controls, dispensers, and similar devices are not between 9" and 54" AFF when the clear floor space allows a parallel approach. OR They are not between 15" and 48" AFF when the clear floor space allows only a forward approach.  Existing Condition: 51 1/2" high dispenser.

<table><tr> <td>1991 ADAAG</td> <td>4.1.3(13); 4.27.3; 4.2.5; 4.2.6 ; Fig. 5; Fig. 6</td> </tr><tr> <td>2007 CBC</td> <td>1117B.6(3); 1118.5; 1118.6; Fig. 11B-5C; Fig. 11B-5D</td> </tr></table>

Classification	
DOJ Location Type:	1
Use:	PV
Severity:	C
Level of Difficulty	Moderate

Corrective Action
890 - Miscellaneous - See Additional Comments  Additional Comments: Relocate along P.O.T.

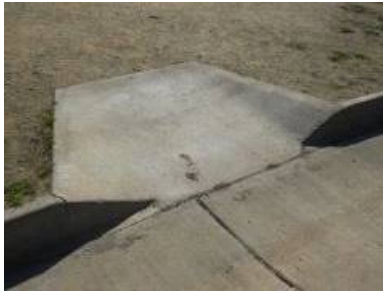
**Keynote 11**

Field Condition	
04.01B - Curb Ramp Compliance - Where accessible route crosses a curb, a curb ramp has not been provided.	1991 ADAAG 4.7.1
Existing Condition: Curb ramps are not compliant.	2004 ADAAG 406.1
	2007 CBC 1127B.5 item 1
	Other 2005 PROWAG-R303

Classification	
DOJ Location Type:	1
Use:	PV
Severity:	C
Level of Difficulty	High

Corrective Action	
120A - Curb Ramp - Provide compliant curb ramp.	
Additional Comments: At two locations. See plan.

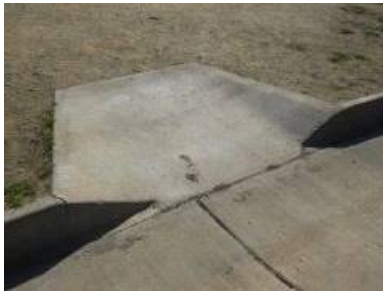
**Keynote 12**

Field Condition	
04.02 - Slope - Slope of the curb ramp exceeds 8.33% (or the least possible compliant slope).	1991 ADAAG 4.7.2; 4.8.2
Existing Condition: 19.85 and 20.8%.	2004 ADAAG 405.2; Advisory 405.2
	2007 CBC 1127B.5 item 3
	Other 2005 PROWAG-R303.2.1.1; R303.2.2.1

Classification	
DOJ Location Type:	1
Use:	PV
Severity:	C
Level of Difficulty	High

Corrective Action	
123 - Curb Ramps - Miscellaneous - See Additional Comments	
Additional Comments: See Keynote 11 for corrective action.

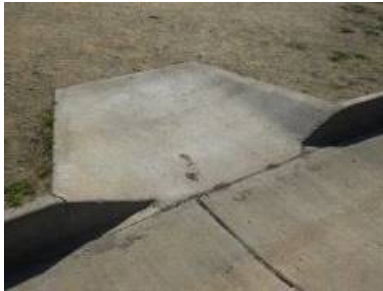
**Keynote 13**

Field Condition	
04.04 - Counter Slope - The running slopes of the road, gutter or accessible route adjoining the ramp exceed 5%.	1991 ADAAG 4.7.2
Existing Condition: 16.1% and 19.3%.	2004 ADAAG 406.2
	2007 CBC 1127B.5 item 3
	Other 2005 PROWAG-R303.3.5

Classification	
DOJ Location Type:	1
Use:	PV
Severity:	C
Level of Difficulty	High

Corrective Action
123 - Curb Ramps - Miscellaneous - See Additional Comments
Additional Comments: See Keynotes 11 for corrective action.

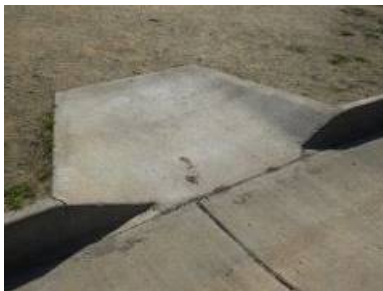
**Keynote 14**

Field Condition	
04.07A - Side Flare Slope (10% Max. Requirement) - The flared sides have a slope greater than 10% (measured along the curb).	1991 ADAAG 4.7.5
Existing Condition: Side flare slopes at 27.7% to 37.7%.	2004 ADAAG 406.3; Fig. 406.3
	2007 CBC 1127B.5 item 3
	Other 2005 PROWAG-R303.2.1.4

Classification	
DOJ Location Type:	1
Use:	PV
Severity:	C
Level of Difficulty	High

Corrective Action
123 - Curb Ramps - Miscellaneous - See Additional Comments
Additional Comments: See Keynote 11 for corrective action.

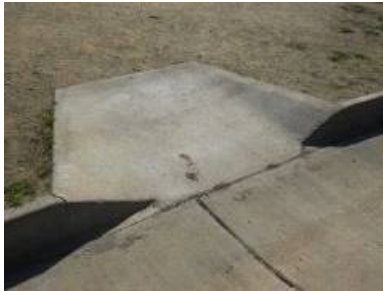
**Keynote 15**

<b>Field Condition</b>	
04.09A - Grooved Border Requirement - Curb ramp does not have a 12" wide grooved border around upper edges of curb ramp and flares to indicate transition from sidewalk to curb ramp.	1991 ADAAG -
Existing Condition:	2004 ADAAG -
	2007 CBC 1127B.5 item 6
	Other -

<b>Classification</b>	
DOJ Location Type:	1
Use:	PV
Severity:	C
Level of Difficulty	High

<b>Corrective Action</b>
123 - Curb Ramps - Miscellaneous - See Additional Comments
Additional Comments: See Keynote 11 for corrective action.

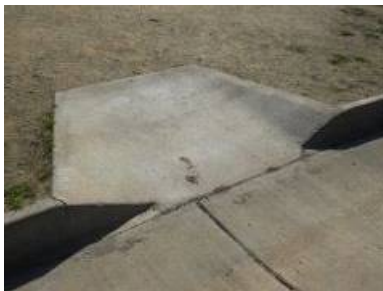
**Keynote 16**

<b>Field Condition</b>	
04.10 - Detectable Warning Requirement - Regardless of slope, the curb ramp does not have a detectable warning.	1991 ADAAG 4.7.7; 4.29.2
Existing Condition:	2004 ADAAG 705.1; Fig. 705.1
	2007 CBC 1127B.5 item 7
	Other 2005 PROWAG-R303.3.2

<b>Classification</b>	
DOJ Location Type:	1
Use:	PV
Severity:	C
Level of Difficulty	Moderate to High

<b>Corrective Action</b>
122A - Detectable Warnings - Provide detectable warning surface (i.e. in-line truncated domes) extending the full width and length of the curb ramp, excluding the flares.
Additional Comments: At two locations. See plan.

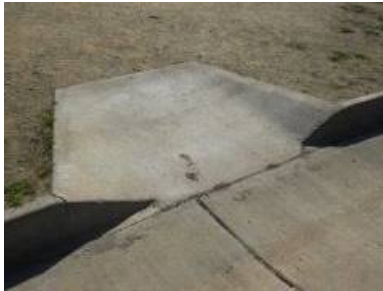
**Keynote 17**

<b>Field Condition</b>	
04.40 - Other - Curb Ramps and Pedestrian Crossings - See Additional Comments	1991 ADAAG -
Existing Condition: No top landing.	2004 ADAAG -
	2007 CBC -
	Other -

<b>Classification</b>	
DOJ Location Type:	1
Use:	PV
Severity:	C
Level of Difficulty	High

<b>Corrective Action</b>	
008 - Concrete Landing - Remove non-compliant pavement and replace with new concrete. The landing slope shall not exceed 2% in any direction.	
Additional Comments: At two locations.

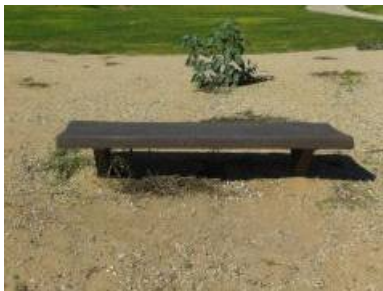
**Keynote 18**

<b>Field Condition</b>	
30.04 - Accessible Route - Facilities Connected - Accessible routes of travel do not connect all accessible buildings, facilities, elements and spaces on the same site with one another.	1991 ADAAG 4.1.2(2)(a)
Existing Condition: No accessible POT to bench.	2004 ADAAG 206.2.2; Advisory 206.2.2
	2007 CBC 1114B.1.2; 1127B.1
	Other -

<b>Classification</b>	
DOJ Location Type:	1
Use:	PV
Severity:	C
Level of Difficulty	High

<b>Corrective Action</b>	
015A - Decomposed Granite Pathway - New decomposed granite pathway. The walkway slope shall not exceed 5% along the POT and cross slope shall not exceed 2%.	
Additional Comments:

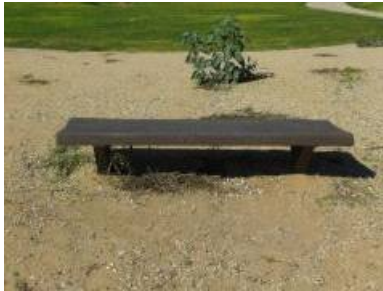
**Keynote 19**

Field Condition	
30.19 - Fixed Bench Height - The height of the front edge of the seating surface is not between 17" and 19" above the adjacent grade or floor space.	1991 ADAAG -
Existing Condition: Bench height varies from 12" to 17".	2004 ADAAG 903.5
	2007 CBC -
	Other 1999 ADAAG-16.12.3

Classification	
DOJ Location Type:	1
Use:	PV
Severity:	C
Level of Difficulty	Moderate

Corrective Action
027 - Site Work - Miscellaneous - See Additional Comments
Additional Comments: Provide compliant bench with clear WC seating space.

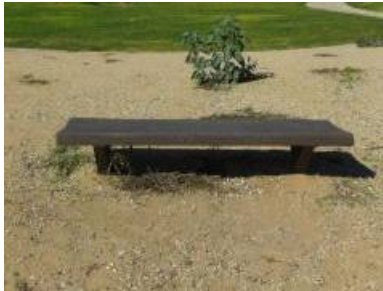
**Keynote 20**

30.21 - Fixed Bench Size - Accessible bench does not have seats that are 20" to 24" in depth and 42" min. in length. OR The back support does not extend from a point 2" maximum above the bench to 18" min. above the bench.

Existing Condition: No back support.

<b>1991 ADAAG</b>	-	
<b>2004 ADAAG</b>	903.3	Fig.
	903.4	
	903.4	
<b>2007 CBC</b>	-	
<b>Other</b>	-

027 - Site Work - Miscellaneous - See Additional Comments

Additional Comments: See Keynote 19 for corrective action.
