*City of Rancho Palos Verdes*  
**Rancho Palos Verdes ADA Assessment**  
**Facility Report with Photos**

**Facility ID: # 04 - Del Cerro Park**

**Author: Vaish, B**

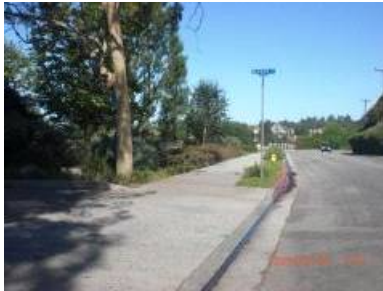
**Location:** Entry to Park  
**Photo #** 1

Field Condition	
30.02 - On-site Accessible Route of Travel - There is no accessible route within the property line of the site linking accessible site elements with site arrival points serving the following, if provided: public transportation stops, accessible parking, passenger loading zones, and public sidewalks.	<b>1991 ADAAG</b> 4.1.2(1) <b>2004 ADAAG</b> 202.2.1;Advisory206.2.1 <b>2007 CBC</b> 1114B.1.2; 1127B.1 <b>Other</b> -
Existing Condition:

Classification	
<b>DOJ Location Type:</b>	1
<b>Use:</b>	PV
<b>Severity:</b>	B
<b>Level of Difficulty</b>	Moderate to High

Corrective Action
001A - Accessible Route - Provide new accessible route.
Additional Comments:

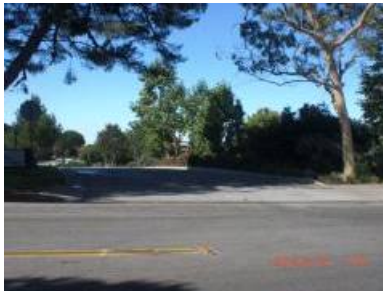
**Location:** Parking Lot  
**Photo #** 2

Field Condition	
01.19B - Tow-away Sign - A California tow-away sign is not posted in a conspicuous place at each entrance to off-street parking lot, or immediately adjacent to and visible from each accessible stall.	<b>1991 ADAAG</b> - <b>2004 ADAAG</b> - <b>2007 CBC</b> 1129B.4 <b>Other</b>
Existing Condition: None provided.

Classification	
<b>DOJ Location Type:</b>	1
<b>Use:</b>	PV
<b>Severity:</b>	B
<b>Level of Difficulty</b>	Moderate

Corrective Action
392 - Tow-away Sign - Provide pole-mounted California tow-away sign at a height of 80" above finish grade to bottom of sign.
Additional Comments:

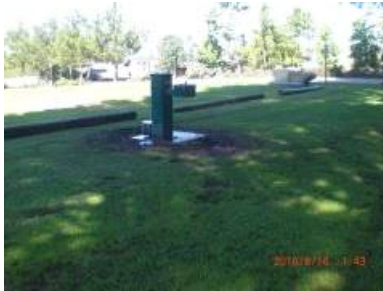
**Location:** North of Park  
**Photo #** 3

Field Condition	
05.03 - Accessible Route - The accessible drinking fountain is not located on an accessible route.	1991 ADAAG 4.1.3(10)(b)
Existing Condition:	2004 ADAAG 206.2.4
	2007 CBC 1115B.4.6 item 1
	Other -

Classification	
DOJ Location Type:	4
Use:	PV
Severity:	B
Level of Difficulty	Moderate to High

Corrective Action
001A - Accessible Route - Provide new accessible route.
Additional Comments: Provide accessible route to drinking fountain.

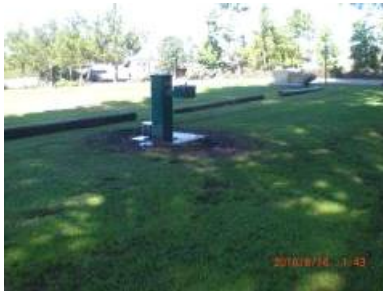
**Location:** North of Park  
**Photo #** 3

Field Condition	
05.05B - Knee Space Width - Drinking fountain provides less than 30" wide accessible knee clearance between the bottom of the apron and the floor.	1991 ADAAG 4.15.5(1); Figs. 27(a) and (b)
Existing Condition: Drinking fountain protrudes 17 1/4" at 27 1/2" high.	2004 ADAAG 306.3; Figs. 306.3
	2007 CBC 1115B.4.6 item 2
	Other -

Classification	
DOJ Location Type:	4
Use:	PV
Severity:	A
Level of Difficulty	Low to Moderate

Corrective Action
289 - Drinking Fountain - Miscellaneous - See Additional Comments
Additional Comments: See Keynote 5 for corrective action.

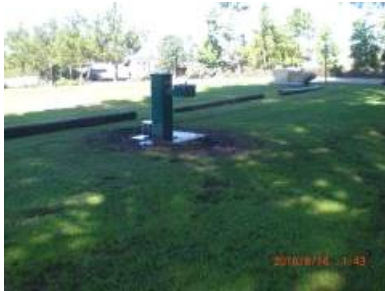
**Location:** North of Park  
**Photo #** 3

<b>Field Condition</b>	
05.04 - Depth - Drinking fountain is not 18" min.. to 19" max.. in depth. Existing Condition: 17 1/4" deep.	<b>1991 ADAAG</b> 4.15.5(1); Figs. 27(a) and (b)  <b>2004 ADAAG</b> -  <b>2007 CBC</b> 1115B.4.6 item 2  <b>Other</b> -

<b>Classification</b>	
<b>DOJ Location Type:</b>	4
<b>Use:</b>	PV
<b>Severity:</b>	B
<b>Level of Difficulty</b>	High

<b>Corrective Action</b>	
275D - Double Hi-Low Drinking Fountain - Provide new hi-low drinking fountain.	
Additional Comments:

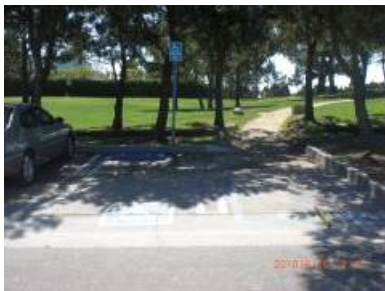
**Location:** Parking Lot  
**Photo #** 6

<b>Field Condition</b>	
01.04 - Van Accessible Spaces - Lot does not provides the required number of designated "van accessible" parking spaces (one in every eight accessible parking spaces; one in every six per 2004 ADAAG). Existing Condition: 17 parking spaces provided, 1 accessible (stall 8'-6" by 18', aisle 7'-1" by 18').	<b>1991 ADAAG</b> 4.1.2(5)(b); 4.6.4  <b>2004 ADAAG</b> 208.2.4  <b>2007 CBC</b> 1129B.3 item 2, 1129B.4  <b>Other</b>

<b>Classification</b>	
<b>DOJ Location Type:</b>	1
<b>Use:</b>	PV
<b>Severity:</b>	C
<b>Level of Difficulty</b>	Low to Moderate

<b>Corrective Action</b>	
193B - Re-stripe for Compliant Dimensions - Re-stripe to provide parking spaces with compliant dimensions.	
Additional Comments: Provide one compliant van-accessible parking stall.

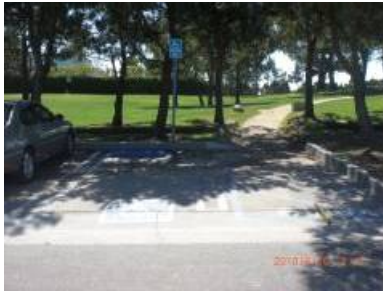
**Location:** Parking Lot  
**Photo #** 6

<b>Field Condition</b>	
01.10A - Van Access Aisle - Dimensions - Where the parking space is designated as "van accessible," the adjacent access aisle is not at least 8' wide by 18' long. (Aisle width is measured from the center line of the stripe on one side to the center line of the stripe on the other.)	1991 ADAAG 4.1.2(5)(b)
Existing Condition:	2004 ADAAG -
	2007 CBC 1129B.3 item 2
	Other

<b>Classification</b>	
DOJ Location Type:	1
Use:	PV
Severity:	C
Level of Difficulty	Moderate to High

<b>Corrective Action</b>
199 - Parking Spaces - Miscellaneous - See Additional Comments
Additional Comments: See Keynote 6 for corrective action.

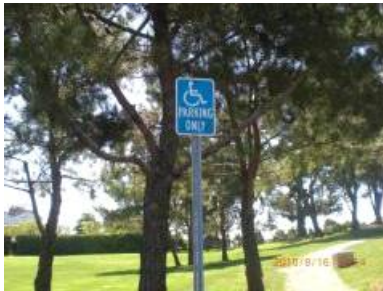
**Location:** Parking Lot  
**Photo #** 8

<b>Field Condition</b>	
01.15C - Minimum Fine Sign - Accessible parking space has no sign stating "Minimum Fine \$250" below the ISA.	1991 ADAAG -
Existing Condition: No minimum fine sign.	2004 ADAAG -
	2007 CBC 1129B.4
	Other

<b>Classification</b>	
DOJ Location Type:	4
Use:	PV
Severity:	C
Level of Difficulty	Low to Moderate

<b>Corrective Action</b>
394D - Sign - Fine for Unauthorized Parking - Provide sign stating minimum fine for unauthorized parking.
Additional Comments:

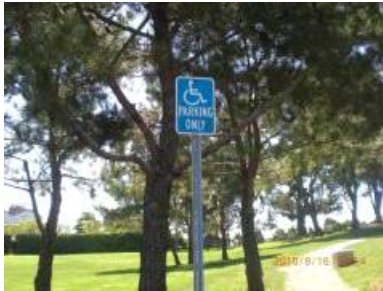
Location: Parking Lot      Photo # 8

<b>Field Condition</b>		
01.17 - Van Accessible Sign - Van accessible space has no sign stating "Van Accessible" below the ISA.	1991 ADAAG	4.6.4
Existing Condition: No van-accessible sign.	2004 ADAAG	502.6
	2007 CBC	1129B.4
	Other

<b>Classification</b>	
DOJ Location Type:	4
Use:	PV
Severity:	C
Level of Difficulty	Moderate

<b>Corrective Action</b>
398 - Van Accessible Parking Sign - Provide accessible parking sign with "Van Accessible" sign, pole-mounted to a height of 80" above finish grade measured to bottom of sign.
Additional Comments:

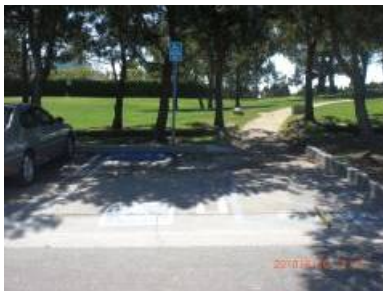
Location: Parking Lot      Photo # 6

<b>Field Condition</b>		
01.13 - Level Surface - The accessible parking spaces and access aisles are not level (slope is greater than 2%).	1991 ADAAG	4.6.3
Existing Condition: 3.5% - 3.7% CS & RS at disable parking, stall and access aisle vary from 2.3% - 11.2%.	2004 ADAAG	502.4; advisory 502.4
	2007 CBC	1129B.3 items 3 & 4
	Other

<b>Classification</b>	
DOJ Location Type:	1
Use:	PV
Severity:	C
Level of Difficulty	Moderate to High

<b>Corrective Action</b>
194 - Asphalt Paved Parking Stall and Access Aisle - Remove non-compliant pavement and replace with new asphalt paving. The parking space and access aisle slope shall not exceed 2% in any direction.
Additional Comments: Re-route concrete swale away from accessible parking.

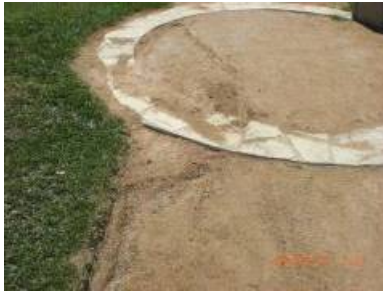
Location: DG Trail      Photo # 11

<b>Field Condition</b>	
30.68 - Other - Parks - See Additional Comments	1991 ADAAG -
Existing Condition: Level change due to water erosion.	2004 ADAAG -
	2007 CBC -
	Other -

<b>Classification</b>	
DOJ Location Type:	1
Use:	PV
Severity:	B
Level of Difficulty	Moderate to High

<b>Corrective Action</b>	
015C - Decomposed Granite Trail - New decomposed granite outdoor recreation access route (area as shown on the drawings). Slope along the POT shall conform to the following: PercentSlope//MaximumLength//RestInterval ; 0% - 5.0% // No Restriction // No Restriction ; 5.1% - 8.33% //	
Additional Comments:

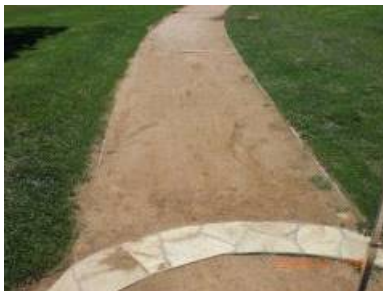
Location: DG Trail      Photo # 12

<b>Field Condition</b>	
30.10E - Trail Surface - The surface of the trail is not firm or stable.	1991 ADAAG -
Existing Condition: 1/2" level change from decomposed granite to concrete.	2004 ADAAG -
	2007 CBC -
	Other 1999 ADAAG-16.2.1

<b>Classification</b>	
DOJ Location Type:	1
Use:	PV
Severity:	C
Level of Difficulty	Moderate

<b>Corrective Action</b>	
027 - Site Work - Miscellaneous - See Additional Comments	
Additional Comments: See Keynote 11 for corrective action.

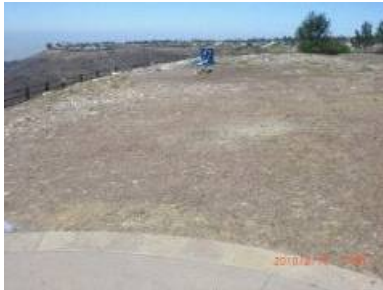
Location: Center Point of View  
 Photo # 24

<b>Field Condition</b>	
30.04 - Accessible Route - Facilities Connected - Accessible routes of travel do not connect all accessible buildings, facilities, elements and spaces on the same site with one another.	1991 ADAAG 4.1.2(2)(a)
Existing Condition: No accessible path of travel connects to bench.	2004 ADAAG 206.2.2; Advisory 206.2.2
	2007 CBC 1114B.1.2; 1127B.1
	Other -

<b>Classification</b>	
DOJ Location Type:	1
Use:	PV
Severity:	B
Level of Difficulty	Moderate to High

<b>Corrective Action</b>	
015C - Decomposed Granite Trail - New decomposed granite outdoor recreation access route (area as shown on the drawings). Slope along the POT shall conform to the following: PercentSlope//MaximumLength//RestInterval ; 0% - 5.0% // No Restriction // No Restriction ; 5.1% - 8.33% //	
Additional Comments:

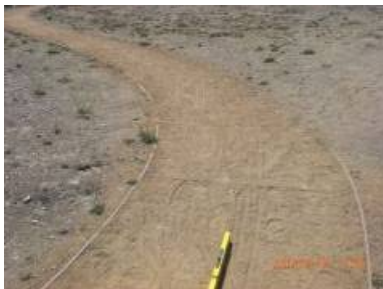
Location: DG Trail  
 Photo # 14

<b>Field Condition</b>	
30.10E - Trail Surface - The surface of the trail is not firm or stable.	1991 ADAAG -
Existing Condition: Loose surface.	2004 ADAAG -
	2007 CBC -
	Other 1999 ADAAG-16.2.1

<b>Classification</b>	
DOJ Location Type:	1
Use:	PV
Severity:	C
Level of Difficulty	Moderate to High

<b>Corrective Action</b>	
015C - Decomposed Granite Trail - New decomposed granite outdoor recreation access route (area as shown on the drawings). Slope along the POT shall conform to the following: PercentSlope//MaximumLength//RestInterval ; 0% - 5.0% // No Restriction // No Restriction ; 5.1% - 8.33% //	
Additional Comments:

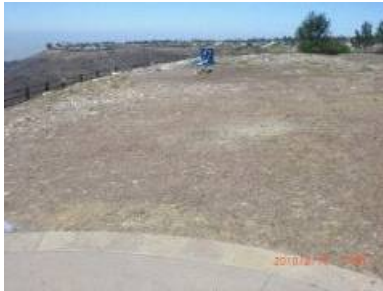
Location: Center Point of View  
 Photo # 24

Field Condition	
30.12 - Fixed Bench - Fixed bench is not accessible for users with various types of disabilities.	1991 ADAAG -
Existing Condition: No accessible bench.	2004 ADAAG 903.1
	2007 CBC -
	Other 1999 ADAAG-16.12.2.1

Classification	
DOJ Location Type:	1
Use:	PV
Severity:	C
Level of Difficulty	Moderate

Corrective Action
027 - Site Work - Miscellaneous - See Additional Comments
Additional Comments: Provide compliant bench with clear WC seating space.

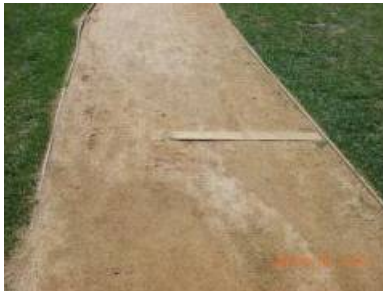
Location: DG Trail  
 Photo # 16

Field Condition	
30.08 - Maintenance of Accessible Trail - Title II Entity - Accessible trail is not in operable working condition. (28 CFR 35.133)	1991 ADAAG -
Existing Condition: Level change due to water erosion.	2004 ADAAG -
	2007 CBC 1101B.3
	Other 28 CFR 35.133

Classification	
DOJ Location Type:	1
Use:	PV
Severity:	C
Level of Difficulty	Moderate

Corrective Action
027 - Site Work - Miscellaneous - See Additional Comments
Additional Comments: See Keynote 14 for corrective action.

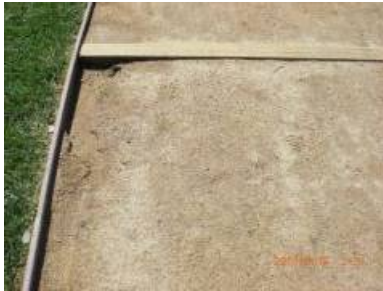
Location: DG Trail Photo # 17

<b>Field Condition</b>	
30.08 - Maintenance of Accessible Trail - Title II Entity - Accessible trail is not in operable working condition. (28 CFR 35.133)	1991 ADAAG -
Existing Condition: Level change.	2004 ADAAG -
	2007 CBC 1101B.3
	Other 28 CFR 35.133

<b>Classification</b>	
DOJ Location Type:	1
Use:	PV
Severity:	C
Level of Difficulty	Moderate

<b>Corrective Action</b>
027 - Site Work - Miscellaneous - See Additional Comments
Additional Comments: See Keynote 14 for corrective action.

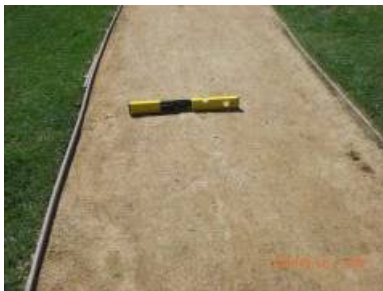
Location: DG Trail Photo # 18

<b>Field Condition</b>	
30.10C - Trail Segment - Cross Slope - Cross slope of the trail segment exceeds 1:20.	1991 ADAAG -
Existing Condition: 6.6% CS.	2004 ADAAG -
	2007 CBC -
	Other 1999 ADAAG-16.2.7.1

<b>Classification</b>	
DOJ Location Type:	1
Use:	PV
Severity:	C
Level of Difficulty	Moderate

<b>Corrective Action</b>
027 - Site Work - Miscellaneous - See Additional Comments
Additional Comments: See Keynote 14 for corrective action.

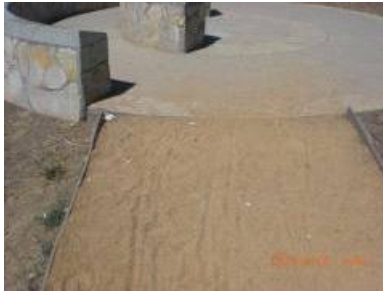
Location: South Point of View      Photo # 21

Field Condition	
30.68 - Other - Parks - See Additional Comments	1991 ADAAG -
Existing Condition: Level change from decomposed granite to concrete is > than 1/2".	2004 ADAAG -
	2007 CBC -
	Other -

Classification	
DOJ Location Type:	1
Use:	PV
Severity:	C
Level of Difficulty	Moderate

Corrective Action	
027 - Site Work - Miscellaneous - See Additional Comments	
Additional Comments: See Keynote 14 for corrective action.
