*City of Rancho Palos Verdes*  
**Rancho Palos Verdes ADA Assessment**  
**Facility Report with Photos**

**Facility ID: # 06 - Founders Park**

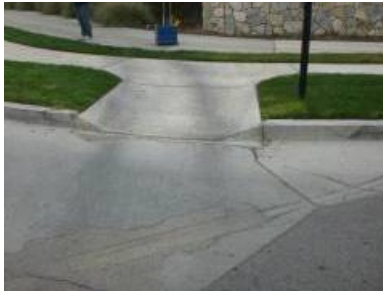
**Keynote 1**

Field Condition	
04.02 - Slope - Slope of the curb ramp exceeds 8.33% (or the least possible compliant slope).	1991 ADAAG 4.7.2; 4.8.2
Existing Condition: 9.3%.	2004 ADAAG 405.2; Advisory 405.2
	2007 CBC 1127B.5 item 3
	Other 2005 PROWAG-R303.2.1.1; R303.2.2.1

Classification	
DOJ Location Type:	1
Use:	PV
Severity:	C
Level of Difficulty	High

Corrective Action
120D - Replace Curb Ramp - Remove existing curb ramp, provide new.
Additional Comments:

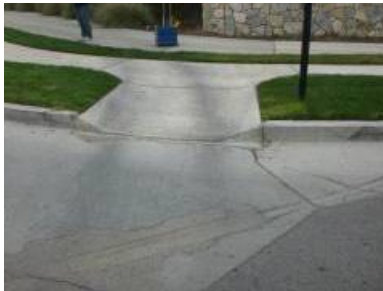
**Keynote 2**

Field Condition	
04.03 - Transition - The transition from the curb ramp to the road or gutter is not flush or free of abrupt changes.	1991 ADAAG 4.7.2
Existing Condition: 1/2" lip.	2004 ADAAG 406.2; Fig. 406.2
	2007 CBC 1127B.5 item 3
	Other 2005 PROWAG-R301.5.1

Classification	
DOJ Location Type:	1
Use:	PV
Severity:	C
Level of Difficulty	High

Corrective Action
123 - Curb Ramps - Miscellaneous - See Additional Comments
Additional Comments: See Keynote 1 for corrective action.

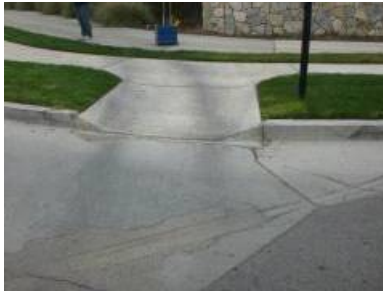
**Keynote 3**

Field Condition	
04.04 - Counter Slope - The running slopes of the road, gutter or accessible route adjoining the ramp exceed 5%.	1991 ADAAG 4.7.2
Existing Condition: 8.3%.	2004 ADAAG 406.2
	2007 CBC 1127B.5 item 3
	Other 2005 PROWAG-R303.3.5

Classification	
DOJ Location Type:	1
Use:	PV
Severity:	C
Level of Difficulty	High

Corrective Action	
006 - Concrete Walk - Remove non-compliant pavement and replace with new concrete (area as shown on the drawings). The walkway slope shall not exceed 5% along the POT and cross slope shall not exceed 2%.	
Additional Comments: Modify curb ramp bottom landing.

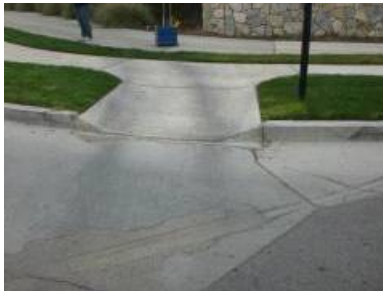
**Keynote 4**

Field Condition	
04.05 - Width - The width of the curb ramp, not including the flared sides, is less than 48".	1991 ADAAG 4.7.3
Existing Condition: 46 1/2" wide.	2004 ADAAG 406.1; 405.5
	2007 CBC 1127B.5 item 2
	Other 2005 PROWAG-R303.3.1

Classification	
DOJ Location Type:	1
Use:	PV
Severity:	C
Level of Difficulty	High

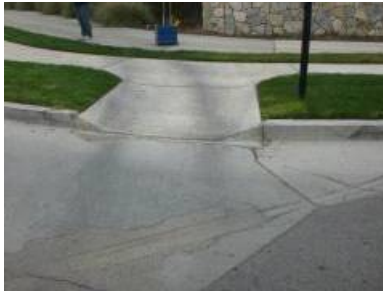
**Keynote 5**

Field Condition	
04.07A - Side Flare Slope (10% Max. Requirement) - The flared sides have a slope greater than 10% (measured along the curb).	1991 ADAAG 4.7.5
Existing Condition: 27.1% and 37.3%.	2004 ADAAG 406.3; Fig. 406.3
	2007 CBC 1127B.5 item 3
	Other 2005 PROWAG-R303.2.1.4

Classification	
DOJ Location Type:	1
Use:	PV
Severity:	C
Level of Difficulty	High

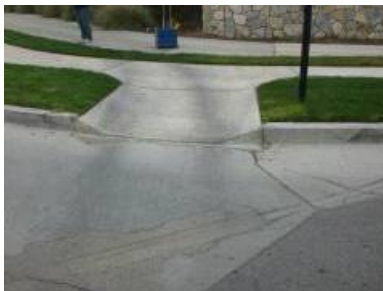
**Keynote 6**

Field Condition	
04.09B - Grooved Border - Location - A 12" wide grooved border has not been provided on the level surface of the walkway.	1991 ADAAG -
Existing Condition: None provided.	2004 ADAAG -
	2007 CBC 1127B.5 item 6
	Other -

Classification	
DOJ Location Type:	1
Use:	PV
Severity:	C
Level of Difficulty	High

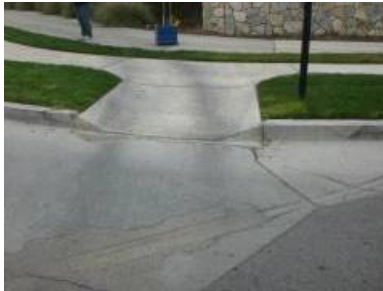
**Keynote 7**

Field Condition	
04.10 - Detectable Warning Requirement - Regardless of slope, the curb ramp does not have a detectable warning.	1991 ADAAG 4.7.7; 4.29.2
Existing Condition: None provided.	2004 ADAAG 705.1; Fig. 705.1
	2007 CBC 1127B.5 item 7
	Other 2005 PROWAG-R303.3.2

Classification	
DOJ Location Type:	1
Use:	PV
Severity:	A
Level of Difficulty	Moderate to High

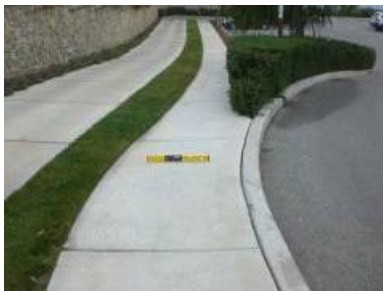
**Keynote 8**

Field Condition	
03B.09 - Cross Slope - Cross slope of the accessible route of travel exceeds 1:50.	1991 ADAAG 4.3.7
Existing Condition: 6.8% to 8.1% CS.	2004 ADAAG 403.3
	2007 CBC 1133B.7.1.3
	Other -

Classification	
DOJ Location Type:	1
Use:	PV
Severity:	C
Level of Difficulty	High

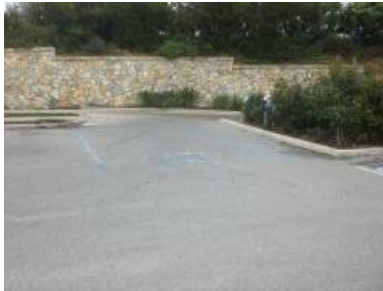
**Keynote 11**

<b>Field Condition</b>	
01.11 - Car Access Aisle - Dimensions - Car access aisle is not at least 5' wide and 18' long. (Aisle width is measured from the center line of the stripe on one side to the center line of the stripe on the other.)	1991 ADAAG 4.1.2(5)(a)
Existing Condition: 4'-11" wide by 20' long.	2004 ADAAG 502.3.1
	2007 CBC 1129B.3 item 1
	Other

<b>Classification</b>	
DOJ Location Type:	1
Use:	PV
Severity:	C
Level of Difficulty	Low to Moderate

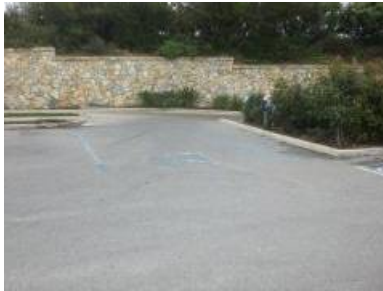
**Keynote 13**

<b>Field Condition</b>	
01.15C - Minimum Fine Sign - Accessible parking space has no sign stating "Minimum Fine \$250" below the ISA.	1991 ADAAG -
Existing Condition:	2004 ADAAG -
	2007 CBC 1129B.4
	Other

<b>Classification</b>	
DOJ Location Type:	1
Use:	PV
Severity:	C
Level of Difficulty	Low to Moderate

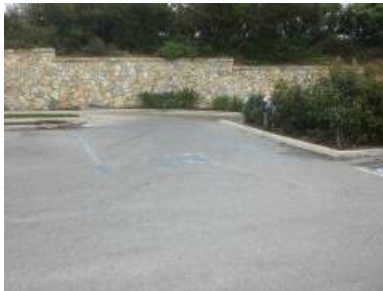
**Keynote 14**

<b>Field Condition</b>	
01.18 - Pavement Sign - A 36" square ISA is not painted on the pavement at the rear of the stall.	1991 ADAAG -
Existing Condition:	2004 ADAAG 502.6
	2007 CBC 1129B.4
	Other

<b>Classification</b>	
DOJ Location Type:	1
Use:	PV
Severity:	C
Level of Difficulty	Low

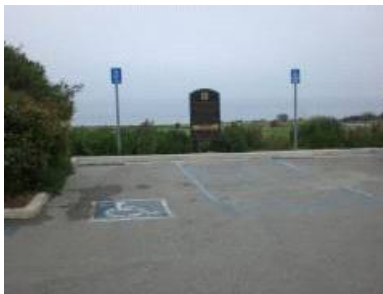
**Keynote 18**

<b>Field Condition</b>	
01.23 - Other - Parking - See Additional Comments	1991 ADAAG -
Existing Condition: Tire stop located adjacent to access aisle.	2004 ADAAG -
	2007 CBC -
	Other

<b>Classification</b>	
DOJ Location Type:	1
Use:	PV
Severity:	C
Level of Difficulty	Low to Moderate

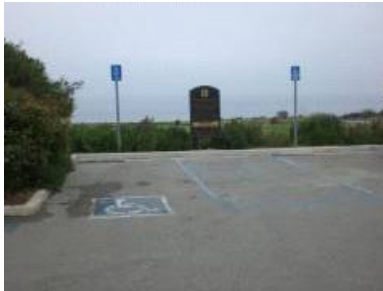
**Keynote 19**

<b>Field Condition</b>	
01.15C - Minimum Fine Sign - Accessible parking space has no sign stating "Minimum Fine \$250" below the ISA.	1991 ADAAG -
Existing Condition:	2004 ADAAG -
	2007 CBC 1129B.4
	Other

<b>Classification</b>	
DOJ Location Type:	1
Use:	PV
Severity:	C
Level of Difficulty	Low to Moderate

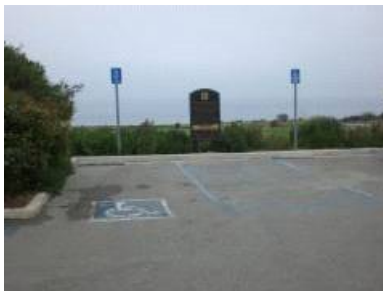
**Keynote 20**

<b>Field Condition</b>	
01.18 - Pavement Sign - A 36" square ISA is not painted on the pavement at the rear of the stall.	1991 ADAAG -
Existing Condition: 48" x 49".	2004 ADAAG 502.6
	2007 CBC 1129B.4
	Other

<b>Classification</b>	
DOJ Location Type:	1
Use:	PV
Severity:	C
Level of Difficulty	Low

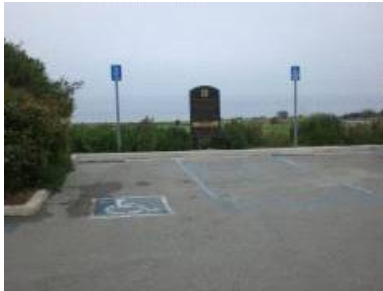
**Keynote 23**

<b>Field Condition</b>	
01.19A - Lettering - The words "NO PARKING" is not provided in each access aisle, painted in white, 12" high letters.	1991 ADAAG -
Existing Condition:	2004 ADAAG -
	2007 CBC 1129B.3 items 1 & 2
	Other

<b>Classification</b>	
DOJ Location Type:	1
Use:	PV
Severity:	C
Level of Difficulty	Low

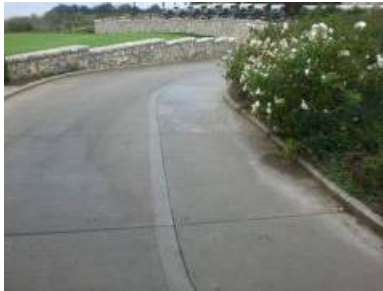
**Keynote 25**

03B.21 - Hazardous Vehicular Areas - Detectable Warnings - Where a walk crosses or adjoins the vehicular way and the walking surface is not separated by curbs, railings, or other elements between the pedestrian areas and vehicular areas, the boundary between the areas is not defined by a continuous detectable warning at least 36" wide complying with CBC 1121B.3.1 item 8(a). (i.e., the warning surface shall contrast visually with adjoining surfaces, either light on dark or dark on light, and shall differ from adjoining walking surfaces in resiliency or sound on cane contact. Color: yellow conforming to Federal Color No. 33538, Table IV/ Standard No. 595B. Where the color value contrast between the yellow warning and the main walking surface is less than 70 percent, a 1" wide black strip shall separate the yellow warning from the main walking surface.)

Existing Condition: Walkway is adjacent to vehicular way.

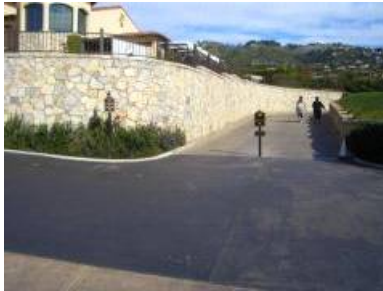
**Keynote 26**

Field Condition									
03B.10 - Running Slope - Slope of the accessible route of travel exceeds 1:20.  Existing Condition: 5.8% to 13.7% RS.

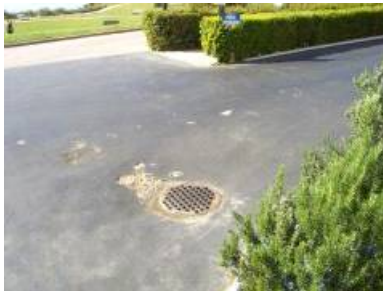
**Keynote 27**

Field Condition									
03B.09 - Cross Slope - Cross slope of the accessible route of travel exceeds 1:50.  Existing Condition: 17.8% CS around floor drain.

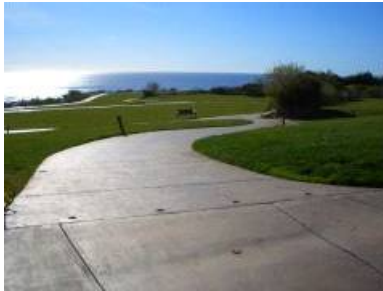
**Keynote 28**

03B.21 - Hazardous Vehicular Areas - Detectable Warnings - Where a walk crosses or adjoins the vehicular way and the walking surface is not separated by curbs, railings, or other elements between the pedestrian areas and vehicular areas, the boundary between the areas is not defined by a continuous detectable warning at least 36" wide complying with CBC 1121B.3.1 item 8(a). (i.e., the warning surface shall contrast visually with adjoining surfaces, either light on dark or dark on light, and shall differ from adjoining walking surfaces in resiliency or sound on cane contact. Color: yellow conforming to Federal Color No. 33538, Table IV/ Standard No. 595B. Where the color value contrast between the yellow warning and the main walking surface is less than 70 percent, a 1" wide black strip shall separate the yellow warning from the main walking surface.)

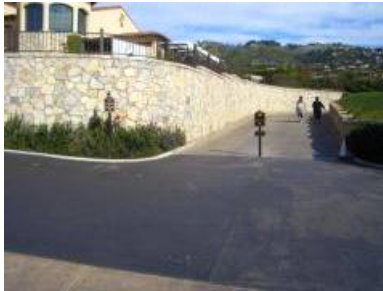
**Keynote 29**

03B.21 - Hazardous Vehicular Areas - Detectable Warnings - Where a walk crosses or adjoins the vehicular way and the walking surface is not separated by curbs, railings, or other elements between the pedestrian areas and vehicular areas, the boundary between the areas is not defined by a continuous detectable warning at least 36" wide complying with CBC 1121B.3.1 item 8(a). (i.e., the warning surface shall contrast visually with adjoining surfaces, either light on dark or dark on light, and shall differ from adjoining walking surfaces in resiliency or sound on cane contact. Color: yellow conforming to Federal Color No. 33538, Table IV/ Standard No. 595B. Where the color value contrast between the yellow warning and the main walking surface is less than 70 percent, a 1" wide black strip shall separate the yellow warning from the main walking surface.)

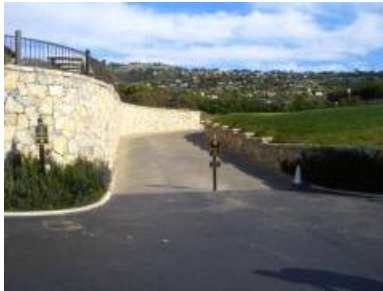
**Keynote 30**

Field Condition									
03B.09 - Cross Slope - Cross slope of the accessible route of travel exceeds 1:50. Existing Condition: 2.7% to 4.2% CS.

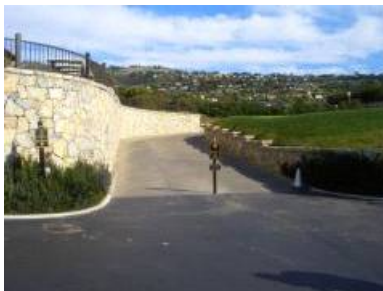
**Keynote 31**

Field Condition									
03B.10 - Running Slope - Slope of the accessible route of travel exceeds 1:20. Existing Condition: 5.6% to 10.4% RS.

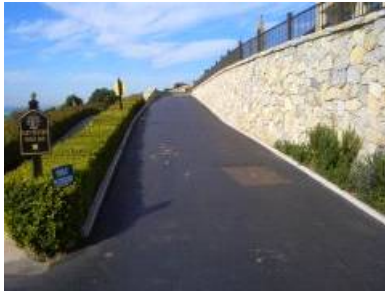
**Keynote 32**

Field Condition									
03B.10 - Running Slope - Slope of the accessible route of travel exceeds 1:20.  Existing Condition: 5.1% to 6.8% RS.

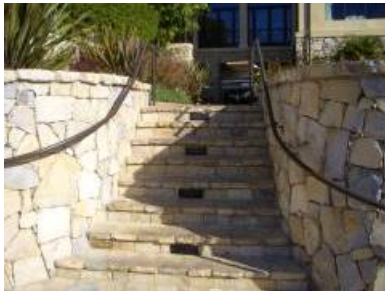
**Keynote 33**

Field Condition									
08.05A - Exterior Stairs - Color Strip - Contrasting color strips have not been provided.  Existing Condition: None provided.

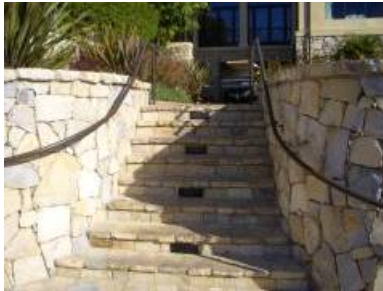
**Keynote 34**

<b>Field Condition</b>	
08.06A - Nosings - Edges - Stair nosings have abrupt edges at the lower front edge.	<b>1991 ADAAG</b> 4.9.3
Existing Condition:	<b>2004 ADAAG</b> 504.5; Fig. 504.5
	<b>2007 CBC</b> 1133B.4.5.1
	<b>Other</b> -

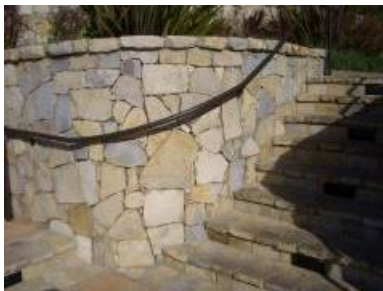
**Keynote 35**

<b>Field Condition</b>	
08.09B - Handrail Extensions - Bottom Landing - At ends of handrails, less than 12" plus the tread width extends beyond the bottom nosing. (Top and bottom handrail extensions are important safety features for persons with balance problems and must extend in the direction of the stair run to permit the intended use.) (Per ADA/CBC Standards, in existing buildings and facilities, full extension of handrails at stairs shall not be required in alterations where such extensions would be hazardous or impossible due to plan configuration.)	<b>1991 ADAAG</b> 4.9.4(2)
Existing Condition: None provided.	<b>2004 ADAAG</b> 505.10; 505.10.3; Fig. 505.10.3
	<b>2007 CBC</b> 1133B.4.2.2
	<b>Other</b> -

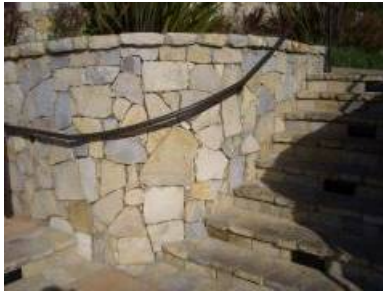
**Keynote 36**

Field Condition	
08.09E - Handrails - Height above Stair Nosings - The tops of handrails are not between 34" and 38" above the stair nosings.	1991 ADAAG 4.9.4(5)
Existing Condition: 42" high at curbing wall.	2004 ADAAG 505.4; Advisory 505.4; Fig. 505.4
	2007 CBC 1133B.4.2.1
	Other -

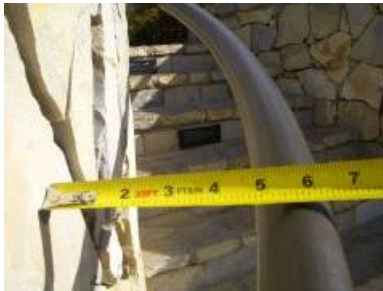
**Keynote 37**

Field Condition	
08.10B - Clearance - The clear space between handrails and walls is not 1-1/2" absolute. (ADA/CBC Standards apply an absolute dimension of 1-1/2", which provides knuckle clearance while generally disallowing entrapment of the forearm or elbow.)	1991 ADAAG 4.9.5(3)
Existing Condition: Handrail to wall clearance varies from 2 1/2" to 5".	2004 ADAAG 505.5
	2007 CBC 1133B.4.2.5
	Other -

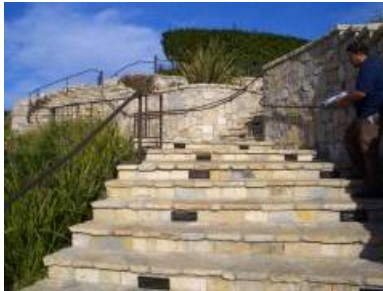
**Keynote 38**

Field Condition	
08.05A - Exterior Stairs - Color Strip - Contrasting color strips have not been provided.	1991 ADAAG -
Existing Condition: None provided.	2004 ADAAG -
	2007 CBC 1133B.4.4
	Other -

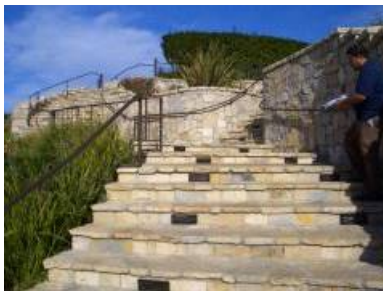
**Keynote 39**

Field Condition	
08.06A - Nosings - Edges - Stair nosings have abrupt edges at the lower front edge.	1991 ADAAG 4.9.3
Existing Condition:	2004 ADAAG 504.5; Fig. 504.5
	2007 CBC 1133B.4.5.1
	Other -

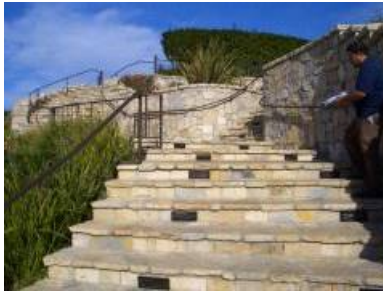
**Keynote 40**

<b>Field Condition</b>	08.07B - Intermediate Handrail - At stair required to be more than 88" wide, there is not at least one intermediate handrail for each 88" of required width.	<b>1991 ADAAG</b>	-
Existing Condition:		<b>2004 ADAAG</b>	-
		<b>2007 CBC</b>	1133B.4.1.1
		<b>Other</b>	-

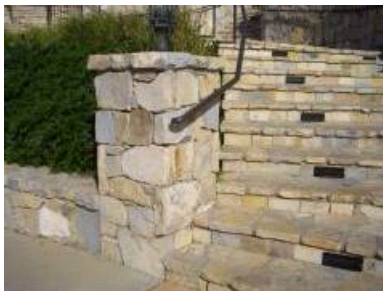
**Keynote 41**

<b>Field Condition</b>	08.09B - Handrail Extensions - Bottom Landing - At ends of handrails, less than 12" plus the tread width extends beyond the bottom nosing. (Top and bottom handrail extensions are important safety features for persons with balance problems and must extend in the direction of the stair run to permit the intended use.) (Per ADA/CBC Standards, in existing buildings and facilities, full extension of handrails at stairs shall not be required in alterations where such extensions would be hazardous or impossible due to plan configuration.)	<b>1991 ADAAG</b>	4.9.4(2)
Existing Condition:		<b>2004 ADAAG</b>	505.10; 505.10.3; Fig. 505.10.3
		<b>2007 CBC</b>	1133B.4.2.2
		<b>Other</b>	-

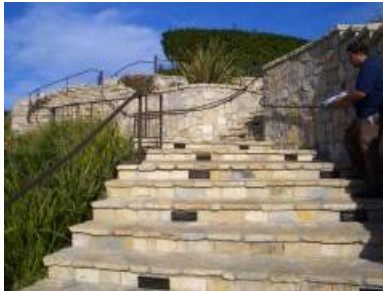
**Keynote 42**

Field Condition	
08.09E - Handrails - Height above Stair Nosings - The tops of handrails are not between 34" and 38" above the stair nosings.	1991 ADAAG 4.9.4(5)
Existing Condition: Height varies from 31" to 33".	2004 ADAAG 505.4; Advisory 505.4; Fig. 505.4
	2007 CBC 1133B.4.2.1
	Other -

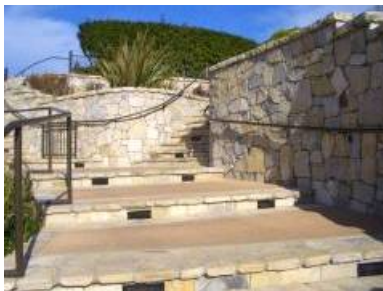
**Keynote 43**

Field Condition	
08.10B - Clearance - The clear space between handrails and walls is not 1-1/2" absolute. (ADA/CBC Standards apply an absolute dimension of 1-1/2", which provides knuckle clearance while generally disallowing entrapment of the forearm or elbow.)	1991 ADAAG 4.9.5(3)
Existing Condition: Handrail to wall clearance varies from 2 1/4" to 3 1/2".	2004 ADAAG 505.5
	2007 CBC 1133B.4.2.5
	Other -

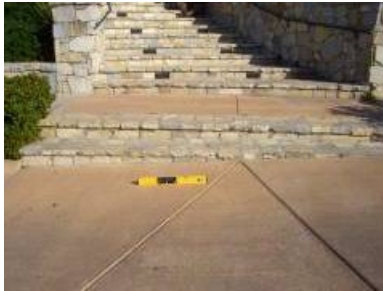
**Keynote 44**

<b>Field Condition</b>			
08.15 - Landing Size - Landing depth in the direction of travel is not at least equal to the width of the stairway.	1991 ADAAG	-	
Existing Condition:	2004 ADAAG	-	
	2007 CBC	1009.4	
	Other	-

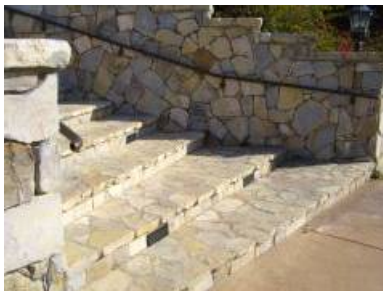
**Keynote 45**

<b>Field Condition</b>			
08.03A - Tread Depth - The treads are not uniform. OR The treads are less than 11" deep measured from riser to riser.	1991 ADAAG	4.9.2	
Existing Condition: Uneven tread depth due to curved stair.	2004 ADAAG	504.2	
	2007 CBC	1009.3; 1133B.4.5.3	
	Other	-

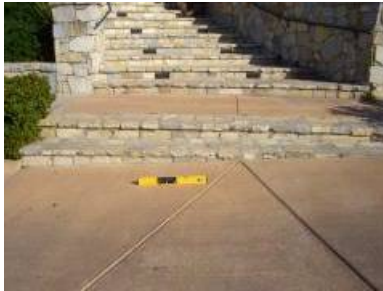
**Keynote 46**

Field Condition	
08.03E - Drainage - Design of outside stairs and their approaches allows water to accumulate on walking surfaces.	1991 ADAAG 4.9.6
Existing Condition: Slope varies from 2.8% & 4.1%.	2004 ADAAG 504.7
	2007 CBC 1133B.4.5.1
	Other -

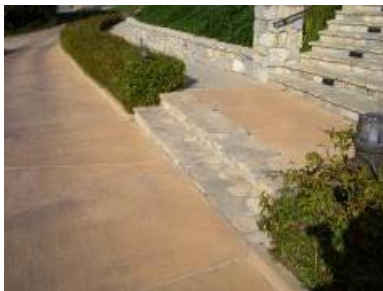
**Keynote 47**

Field Condition	
08.05A - Exterior Stairs - Color Strip - Contrasting color strips have not been provided.	1991 ADAAG -
Existing Condition: None provided.	2004 ADAAG -
	2007 CBC 1133B.4.4
	Other -

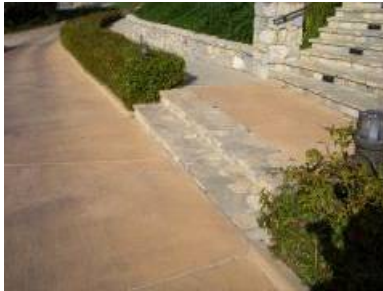
**Keynote 48**

<b>Field Condition</b>	
08.06A - Nosings - Edges - Stair nosings have abrupt edges at the lower front edge.	<b>1991 ADAAG</b> 4.9.3
Existing Condition:	<b>2004 ADAAG</b> 504.5; Fig. 504.5
	<b>2007 CBC</b> 1133B.4.5.1
	<b>Other</b> -

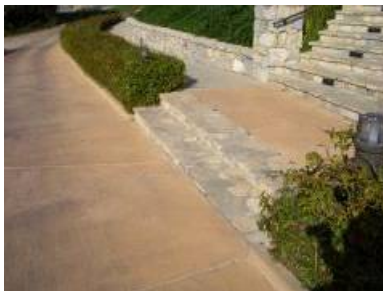
**Keynote 49**

<b>Field Condition</b>	
08.07A - Continuous Handrails - Continuous handrails are not provided along both sides.	<b>1991 ADAAG</b> 4.9.4
Existing Condition:	<b>2004 ADAAG</b> 504.6; 505.2
	<b>2007 CBC</b> 1133B.4.1.1
	<b>Other</b> -

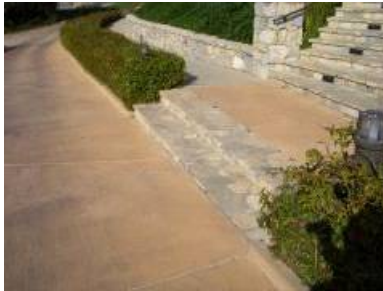
**Keynote 52**

03B.21 - Hazardous Vehicular Areas - Detectable Warnings - Where a walk crosses or adjoins the vehicular way and the walking surface is not separated by curbs, railings, or other elements between the pedestrian areas and vehicular areas, the boundary between the areas is not defined by a continuous detectable warning at least 36" wide complying with CBC 1121B.3.1 item 8(a). (i.e., the warning surface shall contrast visually with adjoining surfaces, either light on dark or dark on light, and shall differ from adjoining walking surfaces in resiliency or sound on cane contact. Color: yellow conforming to Federal Color No. 33538, Table IV/ Standard No. 595B. Where the color value contrast between the yellow warning and the main walking surface is less than 70 percent, a 1" wide black strip shall separate the yellow warning from the main walking surface.)

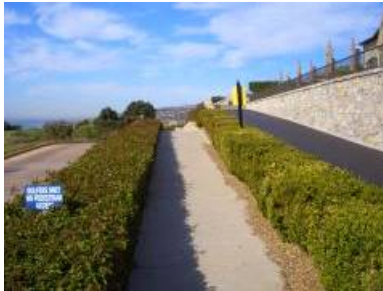
**Keynote 53**

Field Condition	
07.02 - Running Slope - Slope of the ramp exceeds 8.33% (or the least possible compliant slope).	1991 ADAAG 4.8.2
Existing Condition: 6.0% to 8.7%, & 4.7% RS at ramp intermediate landing.	2004 ADAAG 405.2; Advisory 405.2
	2007 CBC 1133B.5.3
	Other -

Corrective Action	
090B - Ramp with Handrails - Remove non-compliant pavement and replace with new ramp with handrails. The ramp slope shall not exceed 8.33% along the POT and cross slope shall not exceed 2%.	
Additional Comments: Provide new handrails.

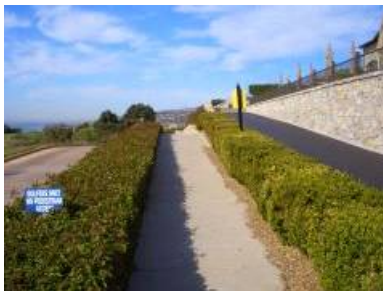
**Keynote 54**

Field Condition	
07.03 - Maximum Rise - The rise for any continuous run exceeds 30" high.	1991 ADAAG 4.8.2
Existing Condition:	2004 ADAAG 405.6
	2007 CBC 1133B.5.4.1
	Other -

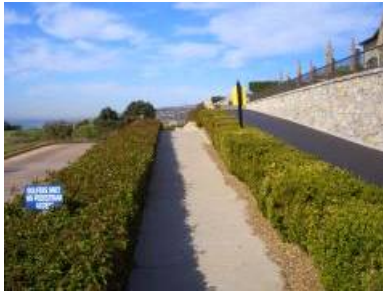
**Keynote 55**

Field Condition	
07.07A - Level Landings - Landings at the top or bottom of each ramp or each ramp run is not level (slope is greater than 2% in some or all directions).	1991 ADAAG 4.8.4
Existing Condition: 4.7% at intermediate landing.	2004 ADAAG 405.7; 405.7.1
	2007 CBC 1133B.5.4.1
	Other -

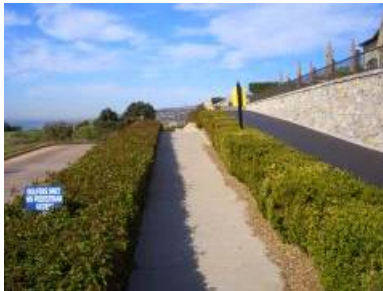
**Keynote 56**

Field Condition	
07.16 - Handrails - Slope of the ramp exceeds 5%, and handrails are not provided on each side. (Per CBC 1133B.5.5.1, at exterior door landings, handrails are not required on ramps less than 6" high or 72" long. Handrails are not required on curb ramps or adjacent to fixed seating in assembly areas.)	1991 ADAAG 4.8.5
Existing Condition: None provided.	2004 ADAAG 405.8; 505.2
	2007 CBC 1133B.5.5.1
	Other -

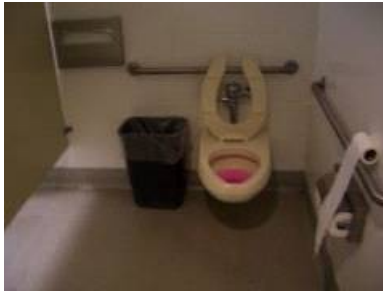
**Keynote 64**

<b>Field Condition</b>	
16.47A - WC Location from Sidewall - The centerline of the WC is not 18" absolute from a wall or partition.	1991 ADAAG 4.22.4
Existing Condition: 18 1/2".	2004 ADAAG -
	2007 CBC 1115B.4.1(1)
	Other -

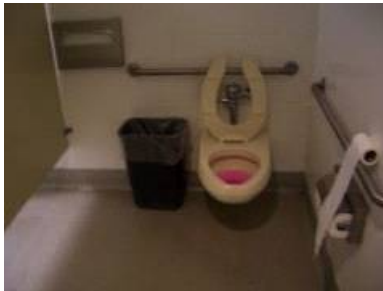
**Keynote 65**

<b>Field Condition</b>	
16.55A - Side Grab Bar Height - Side grab bar is not centered at 33" AFF. (ADA Standards require side grab bars to be centered from 33" to 36" AFF; CBC Standards require side grab bars to be centered at 33" AFF.)	1991 ADAAG 4.17.6; Figs. 29 & 30
Existing Condition: 32" high.	2004 ADAAG 604.5; Advisory 604.5; 604.5.2; Fig. 604.5.2; 609.4
	2007 CBC 1115B.4.1(3.1); Fig. 11B-1A
	Other -

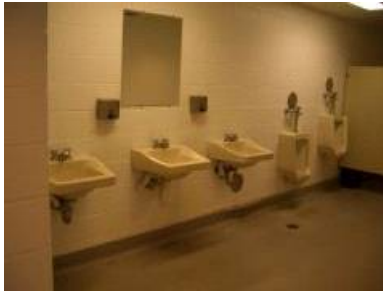
**Keynote 72**

Field Condition	
16.84C - Soap Dispenser - Operating Height - Mounting height of soap dispenser's highest operable part exceeds 40" AFF. (Where provided, ADA Standards require at least one soap dispenser to be accessible with the highest operable part placed within at least one of the reach ranges specified in 4.2.5 and 4.2.6; where provided, CBC Standards require at least one soap dispenser to be accessible with the highest operable part no higher than 40" AFF.)	<b>1991 ADAAG</b> 4.22.7; 4.27.3; 4.2.5; 4.2.6 <b>2004 ADAAG</b> 308; 309 <b>2007 CBC</b> 1115B.8.3 <b>Other</b> -
Existing Condition: 46" high.

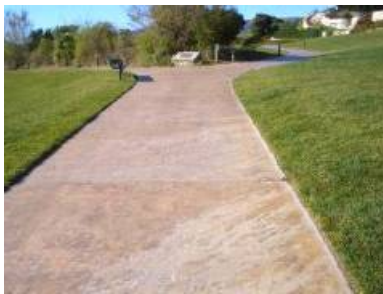
**Keynote 91**

Field Condition									
03B.09 - Cross Slope - Cross slope of the accessible route of travel exceeds 1:50.  Existing Condition: 2.6% to 4.5% CS.

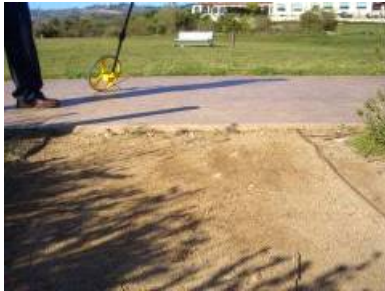
**Keynote 92**

Field Condition	
03B.13 - > 1/2" Changes in Level - Curb ramps, ramps, or elevators are not used for changes in level greater than 1/2 inch. (Lifts may only be used in certain limited situations.)	1991 ADAAG 4.5.2
	2004 ADAAG 303.4
Existing Condition: 1 1/2" level change.	2007 CBC 1124B.2
	Other -

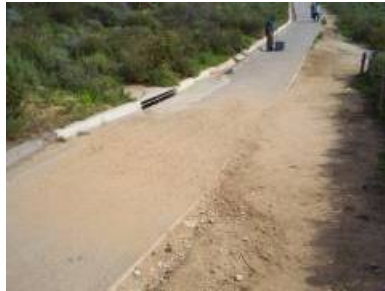
**Keynote 113**

Field Condition	
03B.13 - > 1/2" Changes in Level - Curb ramps, ramps, or elevators are not used for changes in level greater than 1/2 inch. (Lifts may only be used in certain limited situations.)	1991 ADAAG 4.5.2
	2004 ADAAG 303.4
Existing Condition: Level change greater than 1/2".	2007 CBC 1124B.2
	Other -

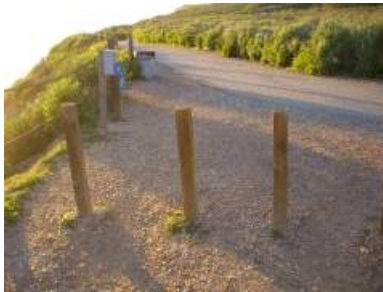
**Keynote 121**

<b>Field Condition</b>	
30.10C - Trail Segment - Cross Slope - Cross slope of the trail segment exceeds 1:20.	1991 ADAAG -
Existing Condition: 2.0% to 5.9% CS.	2004 ADAAG -
	2007 CBC -
	Other 1999 ADAAG-16.2.7.1
