City of Rancho Palos Verdes
Rancho Palos Verdes ADA Assessment
Facility Report with Photos

Facility ID: # 10 - Marilyn Ryan Sunset Point Park

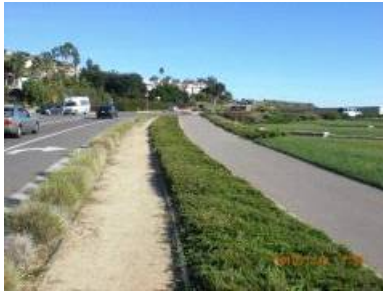
Keynote 1

Field Condition	
03A.07A - Cross Slope (PAR) - Cross slope of the pedestrian access route exceeds 1:50.	1991 ADAAG 4.3.7
Existing Condition: 2.2% to 5.0% CS.	2004 ADAAG 403.3
	2007 CBC 1133B.7.1.3
	Other 2005 PROWAG-R301.4.1

Corrective Action	
015A - Decomposed Granite Pathway - New decomposed granite pathway. The walkway slope shall not exceed 5% along the POT and cross slope shall not exceed 2%.	
Additional Comments:

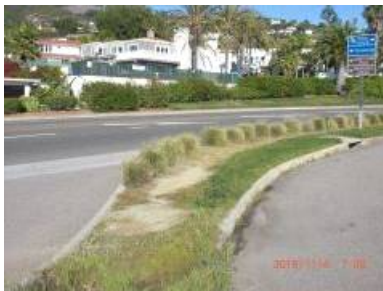
Keynote 2

Field Condition	
04.01A - Curb Ramp Location - Where accessible route crosses a curb, a curb ramp has not been provided.	1991 ADAAG 4.7.1
Existing Condition: No Path of Travel from DG to asphalt.	2004 ADAAG 406.1; 406.5
	2007 CBC 1127B.5 item 1
	Other 2005 PROWAG-R207

Corrective Action	
120A - Curb Ramp - Provide compliant curb ramp.	
Additional Comments:

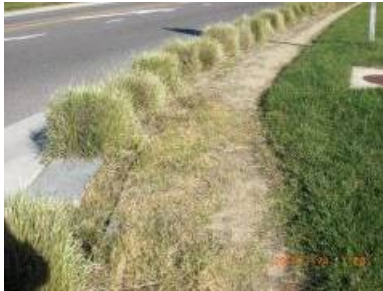
Keynote 3

Field Condition	
03A.03 - Surface (PAR) - Accessible route surfaces are not stable, firm, and slip-resistant.	1991 ADAAG 4.5.1
Existing Condition: Uneven surface at decomposed granite path due to grass on path.	2004 ADAAG 302.1; Advisory 302.1; 403.2
	2007 CBC 1124B.1
	Other 2005 PROWAG-R301.5

Corrective Action
027 - Site Work - Miscellaneous - See Additional Comments
Additional Comments: Provide maintenance to path.

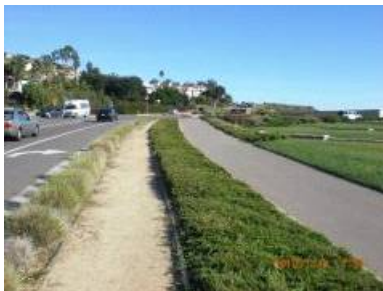
Keynote 4

Field Condition	
30.07E - Outdoor Recreation Access Routes (ORAR) - Passing Space - Where the width of the access route is less than 60", passing spaces measuring 60" x 60" are not provided at intervals of 200' maximum.	1991 ADAAG -
Existing Condition: 47" wide DG path, provide 2 60" x60" passing spaces.	2004 ADAAG -
	2007 CBC -
	Other 1999 ADAAG-16.3.6

Corrective Action
015A - Decomposed Granite Pathway - New decomposed granite pathway. The walkway slope shall not exceed 5% along the POT and cross slope shall not exceed 2%.
Additional Comments:

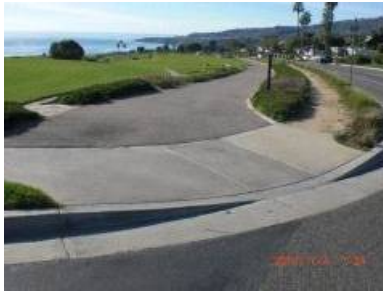
Keynote 5

Field Condition	
30.68 - Other - Parks - See Additional Comments	1991 ADAAG -
Existing Condition: Provide sign to clarify pedestrian path vs. bike path.	2004 ADAAG -
	2007 CBC -
	Other -

Corrective Action
429 - Signs - Miscellaneous - See Additional Comments
Additional Comments:

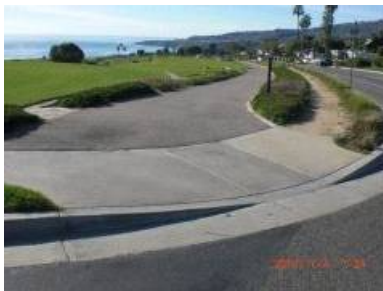
Keynote 6

Field Condition	
04.05 - Width - The width of the curb ramp, not including the flared sides, is less than 48".	1991 ADAAG 4.7.3
Existing Condition: 45" wide. Walkway to DG at 2.6% CS.	2004 ADAAG 406.1; 405.5
	2007 CBC 1127B.5 item 2
	Other 2005 PROWAG-R303.3.1

Corrective Action
120A - Curb Ramp - Provide compliant curb ramp.
Additional Comments: Retrofit CS near DG and opposite walkway.

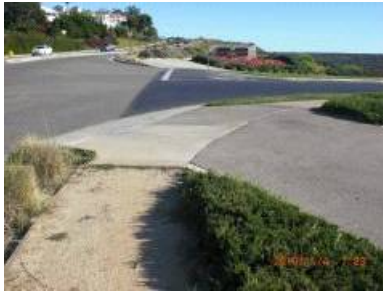
Keynote 7

Field Condition	03A.09 - > 1/4" Changes in Level - Where walkway levels change abruptly, the vertical difference between them exceed 1/4 inch. OR Changes in level between 1/4 inch and 1/2 inch are beveled with a slope greater than 1:2.	1991 ADAAG 4.5.2
	Existing Condition: 2" level change from concrete to decomposed granite.	2004 ADAAG 303.2; 303.3
		2007 CBC 1124B.2
		Other 2005 PROWAG-R301.5.2

Corrective Action	027 - Site Work - Miscellaneous - See Additional Comments
Additional Comments:	See Keynote 1 for corrective action.

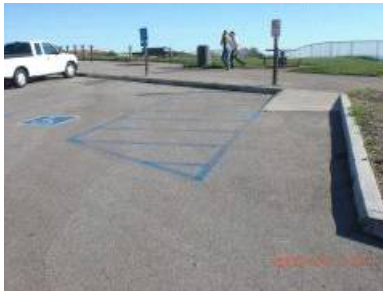
Keynote 8

Field Condition	01.13 - Level Surface - The accessible parking spaces and access aisles are not level (slope is greater than 2%).	1991 ADAAG 4.6.3
	Existing Condition: 2.8% CS & 2.8% to 4.0% RS.	2004 ADAAG 502.4; advisory 502.4
		2007 CBC 1129B.3 items 3 & 4
		Other

Corrective Action	194 - Asphalt Paved Parking Stall and Access Aisle - Remove non-compliant pavement and replace with new asphalt paving. The parking space and access aisle slope shall not exceed 2% in any direction.
Additional Comments:

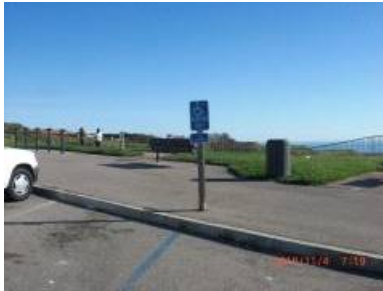
Keynote 9

Field Condition	01.15C - Minimum Fine Sign - Accessible parking space has no sign stating "Minimum Fine \$250" below the ISA.	1991 ADAAG -
Existing Condition:		2004 ADAAG -
		2007 CBC 1129B.4
		Other

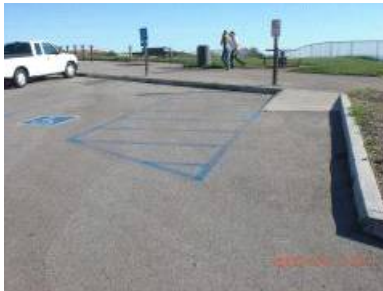
Keynote 10

Field Condition	01.19A - Lettering - The words "NO PARKING" is not provided in each access aisle, painted in white, 12" high letters.	1991 ADAAG -
Existing Condition:		2004 ADAAG -
		2007 CBC 1129B.3 items 1 & 2
		Other

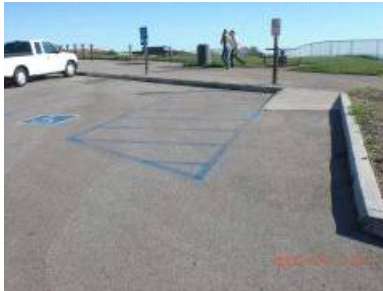
Keynote 11

Field Condition	
01.19B - Tow-away Sign - A California tow-away sign is not posted in a conspicuous place at each entrance to off-street parking lot, or immediately adjacent to and visible from each accessible stall.	1991 ADAAG -
Existing Condition:	2004 ADAAG -
	2007 CBC 1129B.4
	Other

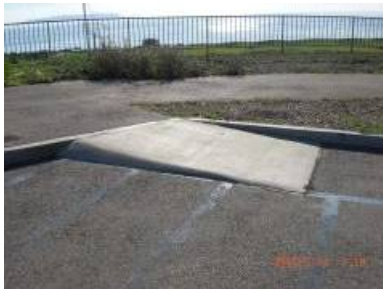
Keynote 12

Field Condition	
04.02 - Slope - Slope of the curb ramp exceeds 8.33% (or the least possible compliant slope).	1991 ADAAG 4.7.2; 4.8.2
Existing Condition: 9.3% RS.	2004 ADAAG 405.2; Advisory 405.2
	2007 CBC 1127B.5 item 3
	Other 2005 PROWAG-R303.2.1.1; R303.2.2.1

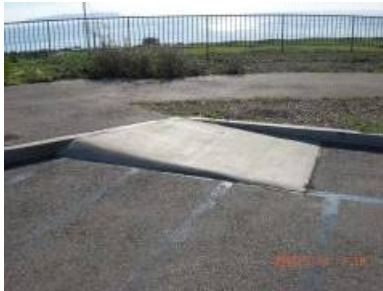
Keynote 13

Field Condition	
04.10 - Detectable Warning Requirement - Regardless of slope, the curb ramp does not have a detectable warning.	1991 ADAAG 4.7.7; 4.29.2
Existing Condition:	2004 ADAAG 705.1; Fig. 705.1
	2007 CBC 1127B.5 item 7
	Other 2005 PROWAG-R303.3.2

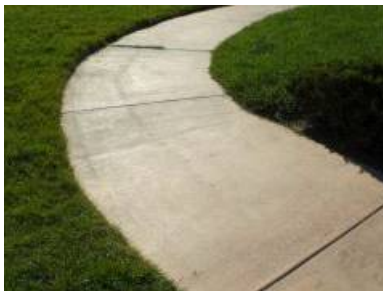
Keynote 14

Field Condition	
03B.09 - Cross Slope - Cross slope of the accessible route of travel exceeds 1:50.	1991 ADAAG 4.3.7
Existing Condition: 2.6% to 3.1% CS.	2004 ADAAG 403.3
	2007 CBC 1133B.7.1.3
	Other -

Corrective Action
006 - Concrete Walk - Remove non-compliant pavement and replace with new concrete (area as shown on the drawings). The walkway slope shall not exceed 5% along the POT and cross slope shall not exceed 2%.
Additional Comments:

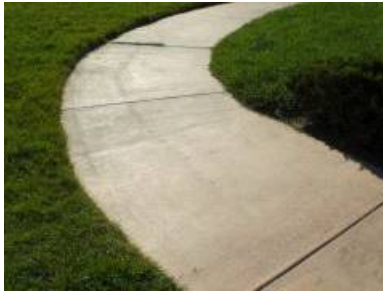
Keynote 15

Field Condition									
03B.10 - Running Slope - Slope of the accessible route of travel exceeds 1:20. Existing Condition: 5.1% RS.

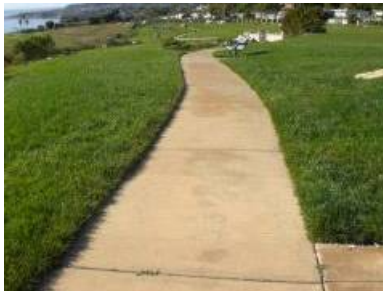
Keynote 16

Field Condition									
03B.09 - Cross Slope - Cross slope of the accessible route of travel exceeds 1:50. Existing Condition: 2.3% to 3.2% CS at various locations.

Corrective Action
006 - Concrete Walk - Remove non-compliant pavement and replace with new concrete (area as shown on the drawings). The walkway slope shall not exceed 5% along the POT and cross slope shall not exceed 2%. Additional Comments:

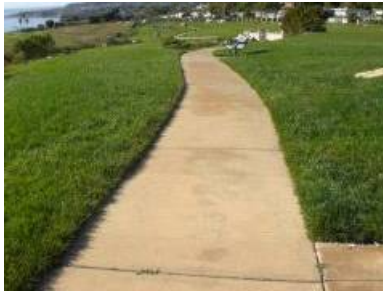
Keynote 17

Field Condition									
03B.10 - Running Slope - Slope of the accessible route of travel exceeds 1:20. Existing Condition: 5.3% to 7.9% RS at various locations.

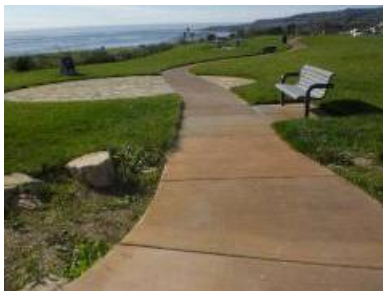
Keynote 18

Field Condition									
03B.22 - Other - On-Site Accessible Path of Travel - See Additional Comments Existing Condition: 2.2% to 4.7% slope.

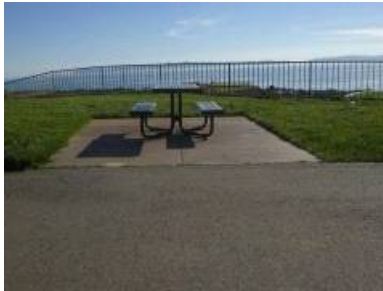
Keynote 19

Field Condition	
30.34B - Picnic Table - Knee Space Width - Picnic table does not provide at least 30" wide accessible knee clearance.	1991 ADAAG 4.32.3
Existing Condition: 27" clear width space.	2004 ADAAG 305; 306
	2007 CBC 1122B.3
	Other 1999 ADAAG-16.5.4

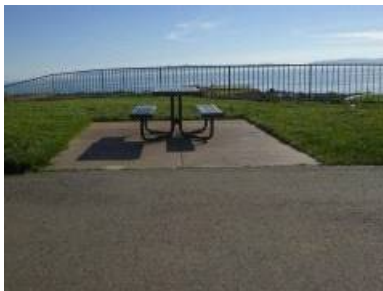
Keynote 20

Field Condition	
30.32 - 36" Aisle Width Standard - Around the picnic table, there is less than 36" clear space measured from the seat.	1991 ADAAG -
Existing Condition: 20 1/2" to 38 1/2".	2004 ADAAG -
	2007 CBC -
	Other 1999 ADAAG-16.5.5

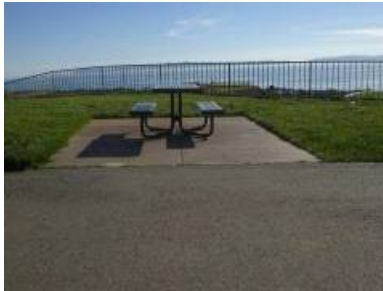
Keynote 21

Existing Condition: 3.0% to 3.9% slope.

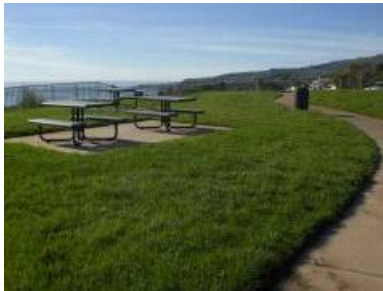
Keynote 22

Existing Condition: 4 picnic tables, 1 accessible.

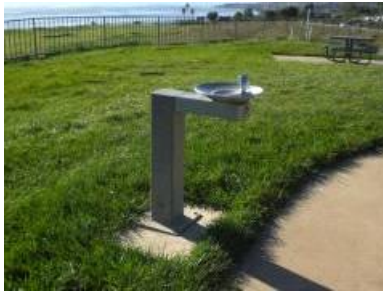
Keynote 23

Field Condition	05.13 - Operation - The controls are not compliant.(Accessible controls shall be operable with one hand, and without tight grasping, pinching, or twisting of the wrist, and the force to operate the controls shall be no greater than 5 lbs.)	1991 ADAAG 4.27.4
	Existing Condition: Greater than 5 LBF.	2004 ADAAG 602.3; 309.4
		2007 CBC 1115B.4.6 item 4
		Other -

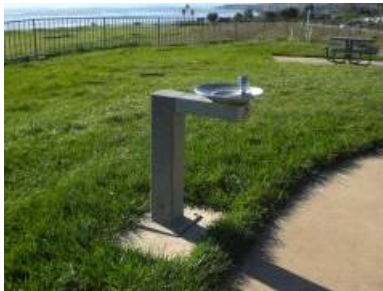
Keynote 24

Field Condition	05.01A - "Hi" Drinking Fountain Requirement - Where there is only one drinking fountain area on a floor (e.g., an area with a drinking fountain or separate drinking fountains), it is accessible to wheelchair users and not to persons who have difficulty bending or stooping (i.e., the required accessibility for persons who have difficulty bending or stooping on each floor has not been provided).	1991 ADAAG 4.1.3(10)(a); 4.15.1
	Existing Condition:	2004 ADAAG 211.1; 211.2
		2007 CBC 1115B.4.6 item 1
		Other -

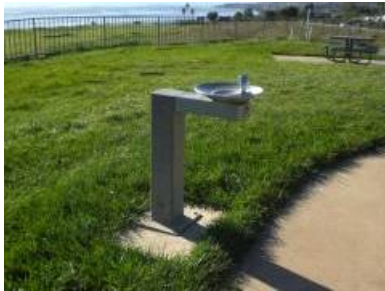
Keynote 25

Field Condition	
05.03 - Accessible Route - The accessible drinking fountain is not located on an accessible route.	1991 ADAAG 4.1.3(10)(b)
Existing Condition: Grass on approach.	2004 ADAAG 206.2.4
	2007 CBC 1115B.4.6 item 1
	Other -

Corrective Action	
006 - Concrete Walk - Remove non-compliant pavement and replace with new concrete (area as shown on the drawings). The walkway slope shall not exceed 5% along the POT and cross slope shall not exceed 2%.	
Additional Comments:

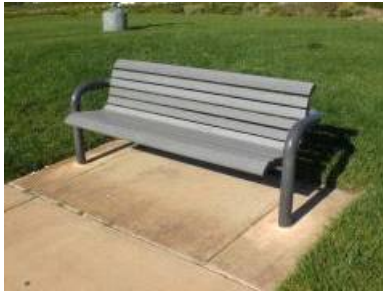
Keynote 26

Field Condition	
30.21 - Fixed Bench Size - Accessible bench does not have seats that are 20" to 24" in depth and 42" min. in length. OR The back support does not extend from a point 2" maximum above the bench to 18" min. above the bench.	1991 ADAAG -
Existing Condition: 16" deep seat, 17" back support.	2004 ADAAG 903.3
	903.4 Fig.
	903.4
	2007 CBC -
	Other -

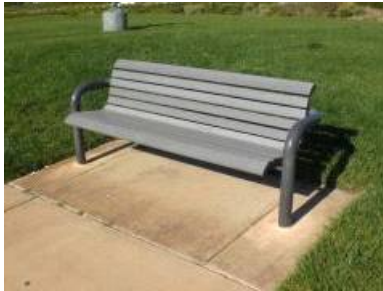
Keynote 27

Field Condition	30.17 - Fixed Bench - Surface Slope - Clear space has a slope greater than 2% in some or all directions.(1999 ADAAG: 3% slope is allowed when necessary for drainage). Existing Condition: 2.15 to 4.0% slope.	1991 ADAAG 4.3.7
		2004 ADAAG 403.3
		2007 CBC -
		Other 1999 ADAAG-16.12.7

Corrective Action	006 - Concrete Walk - Remove non-compliant pavement and replace with new concrete (area as shown on the drawings). The walkway slope shall not exceed 5% along the POT and cross slope shall not exceed 2%. Additional Comments: Replace concrete to provide compliant slope and allow for wheelchair seating space.
--------------------------	---

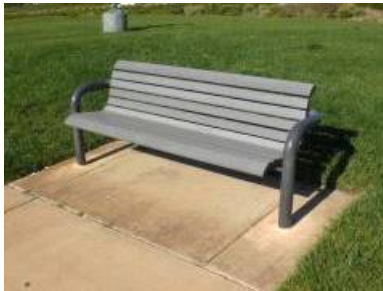
Keynote 28

Field Condition	30.16 - Fixed Bench / Wheelchair Seating Space - Shoulder Alignment - A clear space at least 30" x 48" in size has not been provided at one end of the fixed bench so that a wheelchair user may be seated shoulder-to-shoulder with an individual seated on the bench. Existing Condition: None provided.	1991 ADAAG -
		2004 ADAAG -
		2007 CBC -
		Other 1999 ADAAG-16.12.4

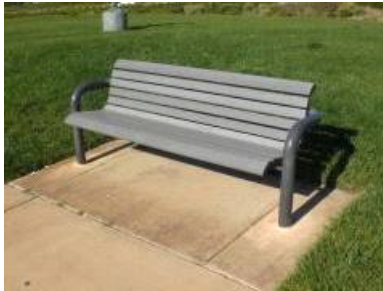
Keynote 29

Field Condition	30.13 - Number and Dispersal - Accessible Fixed Benches - Less than 50% of the fixed benches being provided in an area are accessible. OR They are not dispersed among the types provided.	1991 ADAAG -
	Existing Condition: 5 benches, 0 accessible.	2004 ADAAG -
		2007 CBC -
		Other 1999 ADAAG-16.12.2.2; 16.12.2

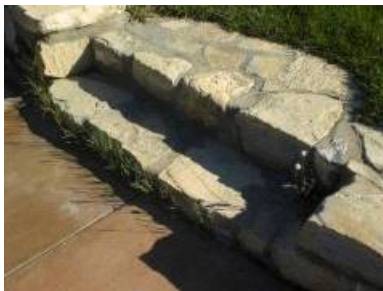
Keynote 30

Field Condition	08.02B - Riser Height - The risers are not uniform. OR The risers are not between 4" and 7" in height.	1991 ADAAG 4.9.2
	Existing Condition: Height varies from 4" to 7", at 3 locations.	2004 ADAAG 504.2
		2007 CBC 1009.3; 1133B.4.5.3
		Other -

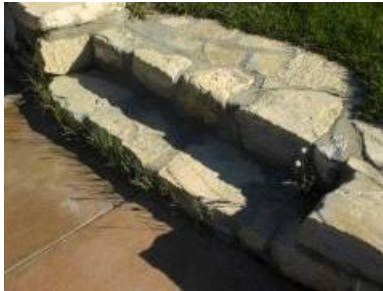
Keynote 31

Field Condition	
08.05A - Exterior Stairs - Color Strip - Contrasting color strips have not been provided.	1991 ADAAG -
Existing Condition: None provided at 3 locations.	2004 ADAAG -
	2007 CBC 1133B.4.4
	Other -

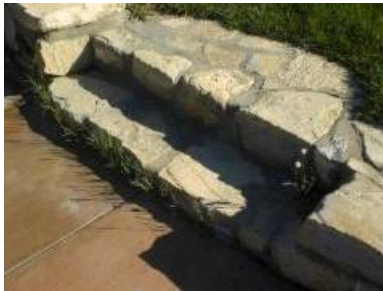
Keynote 32

Field Condition	
08.07A - Continuous Handrails - Continuous handrails are not provided along both sides.	1991 ADAAG 4.9.4
Existing Condition: None provided.	2004 ADAAG 504.6; 505.2
	2007 CBC 1133B.4.1.1
	Other -

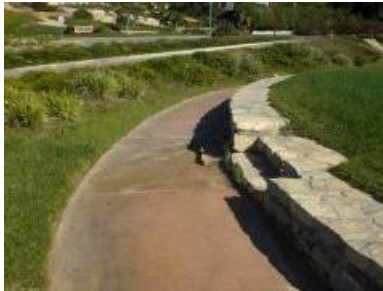
Keynote 33

Field Condition	
08.18 - Other - Stairs - See Additional Comments	1991 ADAAG -
Existing Condition: No POT provided to connect stairs.	2004 ADAAG -
	2007 CBC -
	Other -

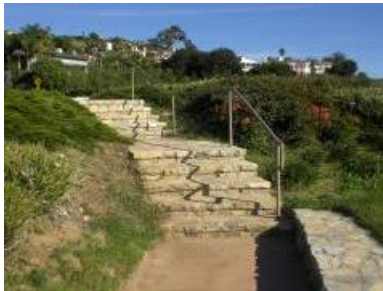
Keynote 34

Field Condition	
08.07A - Continuous Handrails - Continuous handrails are not provided along both sides.	1991 ADAAG 4.9.4
Existing Condition: Handrail not provided on both sides.	2004 ADAAG 504.6; 505.2
	2007 CBC 1133B.4.1.1
	Other -

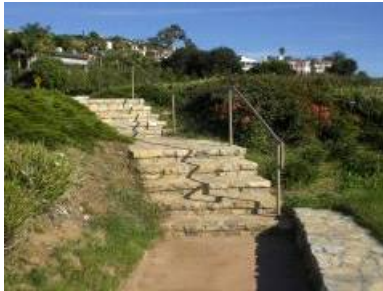
Keynote 35

Field Condition	
08.05A - Exterior Stairs - Color Strip - Contrasting color strips have not been provided.	1991 ADAAG -
Existing Condition:	2004 ADAAG -
	2007 CBC 1133B.4.4
	Other -

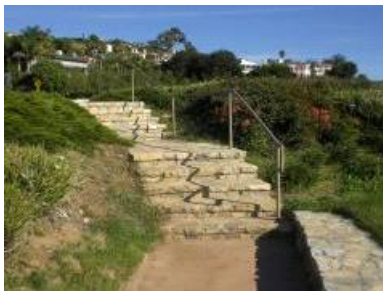
Keynote 36

Field Condition	
08.02B - Riser Height - The risers are not uniform. OR The risers are not between 4" and 7" in height.	1991 ADAAG 4.9.2
Existing Condition: 5 1/2" to 6" high risers.	2004 ADAAG 504.2
	2007 CBC 1009.3; 1133B.4.5.3
	Other -

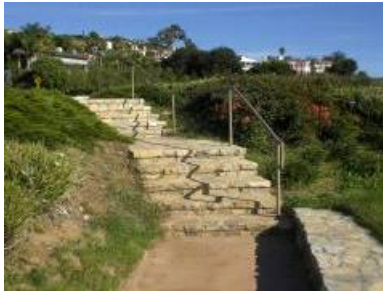
Keynote 37

Field Condition	08.09B - Handrail Extensions - Bottom Landing - At ends of handrails, less than 12" plus the tread width extends beyond the bottom nosing. (Top and bottom handrail extensions are important safety features for persons with balance problems and must extend in the direction of the stair run to permit the intended use.) (Per ADA/CBC Standards, in existing buildings and facilities, full extension of handrails at stairs shall not be required in alterations where such extensions would be hazardous or impossible due to plan configuration.)	1991 ADAAG 4.9.4(2)
Existing Condition:		2004 ADAAG 505.10; 505.10.3; Fig. 505.10.3
		2007 CBC 1133B.4.2.2
		Other -

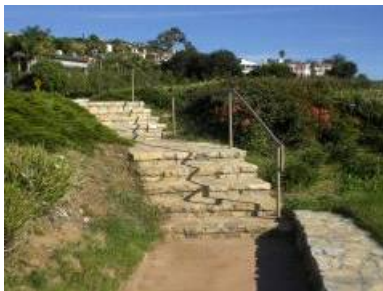
Keynote 38

Field Condition	08.03A - Tread Depth - The treads are not uniform. OR The treads are less than 11" deep measured from riser to riser.	1991 ADAAG 4.9.2
Existing Condition:	Tread depth varies from 14" to 15 1/2".	2004 ADAAG 504.2
		2007 CBC 1009.3; 1133B.4.5.3
		Other -

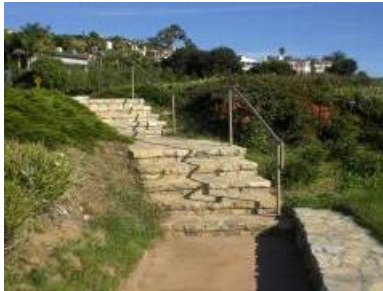
Keynote 39

Field Condition	
08.03D - Level Landing - Landing is not level (slope is greater than 2% in some or all directions).	1991 ADAAG -
Existing Condition: 4.4% RS at top landing.	2004 ADAAG -
	2007 CBC 1009.5.1
	Other -

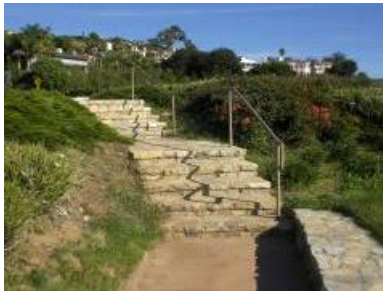
Keynote 40

Field Condition	
08.03C - Tread Slope - The treads have a slope steeper than 2%.	1991 ADAAG -
Existing Condition: 4.4% to 5.7%.	2004 ADAAG 504.4 [Exception]
	2007 CBC 1009.5.1
	Other -

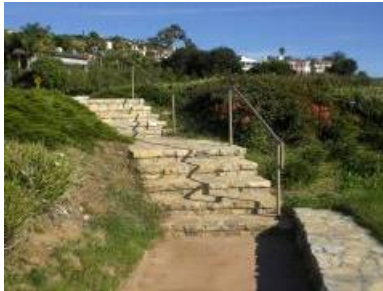
Keynote 41

Field Condition	
08.09E - Handrails - Height above Stair Nosings - The tops of handrails are not between 34" and 38" above the stair nosings.	1991 ADAAG 4.9.4(5)
Existing Condition: 33" high.	2004 ADAAG 505.4; Advisory 505.4; Fig. 505.4
	2007 CBC 1133B.4.2.1
	Other -

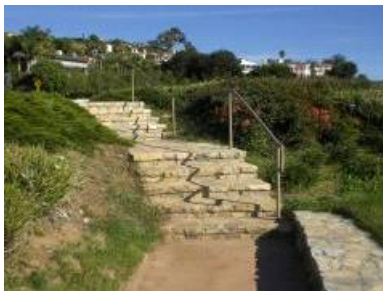
Keynote 42

Field Condition	
08.03D - Level Landing - Landing is not level (slope is greater than 2% in some or all directions).	1991 ADAAG -
Existing Condition: 4.4% RS at intermediate landing.	2004 ADAAG -
	2007 CBC 1009.5.1
	Other -

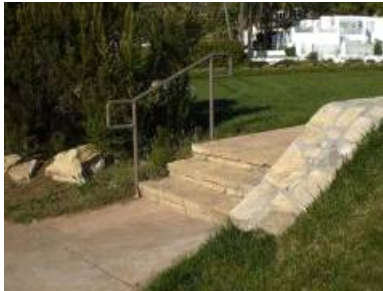
Keynote 43

Field Condition	
08.07A - Continuous Handrails - Continuous handrails are not provided along both sides.	1991 ADAAG 4.9.4
Existing Condition: Handrail only provided on one side.	2004 ADAAG 504.6; 505.2
	2007 CBC 1133B.4.1.1
	Other -

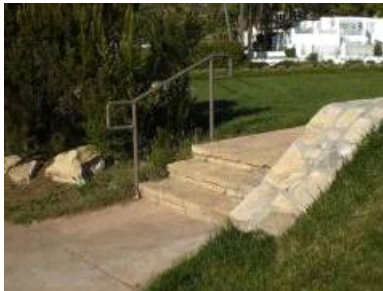
Keynote 44

Field Condition	
08.05A - Exterior Stairs - Color Strip - Contrasting color strips have not been provided.	1991 ADAAG -
Existing Condition:	2004 ADAAG -
	2007 CBC 1133B.4.4
	Other -

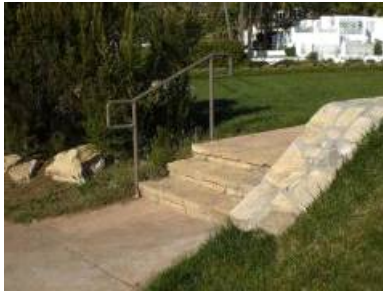
Keynote 45

Field Condition	
08.03D - Level Landing - Landing is not level (slope is greater than 2% in some or all directions).	1991 ADAAG -
Existing Condition: 7.1% RS at bottom landing.	2004 ADAAG -
	2007 CBC 1009.5.1
	Other -

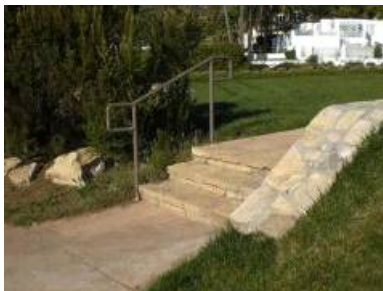
Keynote 46

Field Condition	
08.02B - Riser Height - The risers are not uniform. OR The risers are not between 4" and 7" in height.	1991 ADAAG 4.9.2
Existing Condition: 5 1/2" to 6" high risers.	2004 ADAAG 504.2
	2007 CBC 1009.3; 1133B.4.5.3
	Other -

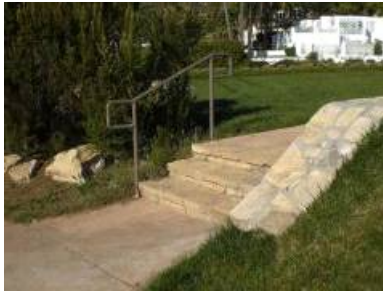
Keynote 47

Field Condition	
08.09B - Handrail Extensions - Bottom Landing - At ends of handrails, less than 12" plus the tread width extends beyond the bottom nosing. (Top and bottom handrail extensions are important safety features for persons with balance problems and must extend in the direction of the stair run to permit the intended use.) (Per ADA/CBC Standards, in existing buildings and facilities, full extension of handrails at stairs shall not be required in alterations where such extensions would be hazardous or impossible due to plan configuration.)	1991 ADAAG 4.9.4(2) 2004 ADAAG 505.10; 505.10.3; Fig. 505.10.3 2007 CBC 1133B.4.2.2 Other -
Existing Condition: 12".

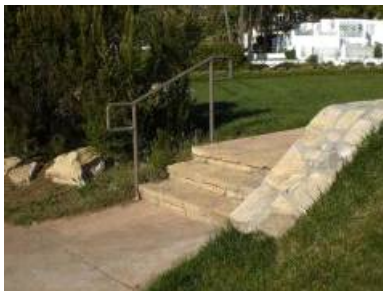
Keynote 48

Field Condition	
08.03C - Tread Slope - The treads have a slope steeper than 2%. Existing Condition: 4.9%.	1991 ADAAG - 2004 ADAAG 504.4 [Exception] 2007 CBC 1009.5.1 Other -

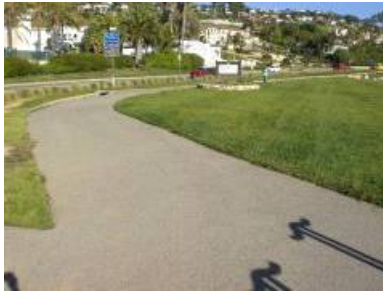
Keynote 49

Field Condition	
03B.09 - Cross Slope - Cross slope of the accessible route of travel exceeds 1:50. Existing Condition: 2.7% to 3.3% CS.	1991 ADAAG 4.3.7 2004 ADAAG 403.3 2007 CBC 1133B.7.1.3 Other -

Corrective Action	
004A - Asphalt Paving - Remove non-compliant pavement and replace with new asphalt paving (area as shown on the drawings). The walkway slope shall not exceed 5% along the POT and cross slope shall not exceed 2%.	
Additional Comments:

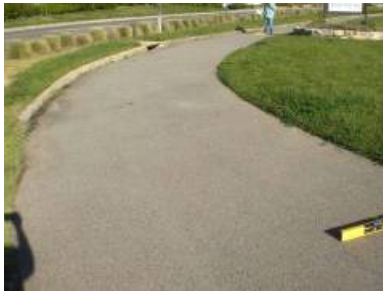
Keynote 50

Field Condition	
03B.10 - Running Slope - Slope of the accessible route of travel exceeds 1:20. Existing Condition: 5.2% to 5.9% RS.	1991 ADAAG 4.3.7 2004 ADAAG 403.3 2007 CBC 1133B.7.3 Other -

Corrective Action	
004A - Asphalt Paving - Remove non-compliant pavement and replace with new asphalt paving (area as shown on the drawings). The walkway slope shall not exceed 5% along the POT and cross slope shall not exceed 2%.	
Additional Comments:

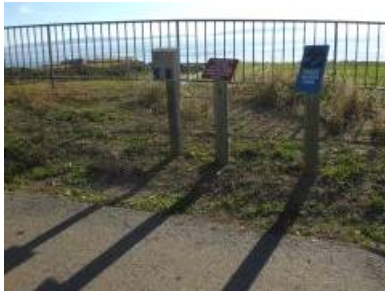
Keynote 51

Field Condition	
03B.22 - Other - On-Site Accessible Path of Travel - See Additional Comments	1991 ADAAG -
Existing Condition: Dog waste bag not adjacent to POT.	2004 ADAAG -
	2007 CBC -
	Other -

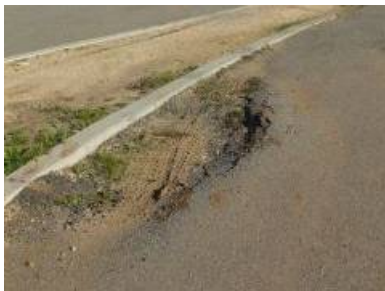
Keynote 52

Field Condition	
03B.15 - Surface - Accessible route surfaces are not stable, firm and slip-resistant.	1991 ADAAG 4.5.1
Existing Condition: Uneven surface.	2004 ADAAG 302.1; Advisory 302.1
	2007 CBC 1124B.1
	Other -

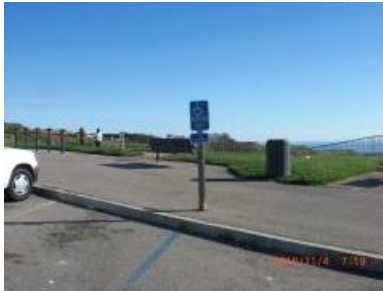
Keynote 53

Field Condition	
01.17 - Van Accessible Sign - Van accessible space has no sign stating "Van Accessible" below the ISA.	1991 ADAAG 4.6.4
Existing Condition: Sign is not provided at accessible parking space.	2004 ADAAG 502.6
	2007 CBC 1129B.4
	Other

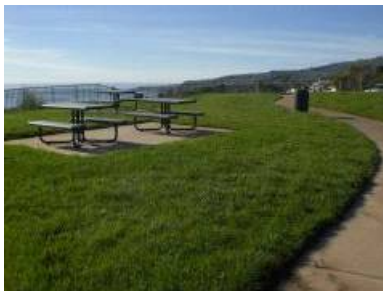
Keynote 54

Field Condition	
03B.22 - Other - On-Site Accessible Path of Travel - See Additional Comments	1991 ADAAG -
Existing Condition:	2004 ADAAG -
	2007 CBC -
	Other -

Corrective Action	
006 - Concrete Walk - Remove non-compliant pavement and replace with new concrete (area as shown on the drawings). The walkway slope shall not exceed 5% along the POT and cross slope shall not exceed 2%.	
Additional Comments:

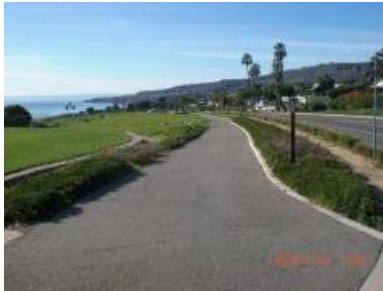
Keynote 55

Field Condition									
03B.10 - Running Slope - Slope of the accessible route of travel exceeds 1:20. Existing Condition: 2.8% to 3.7%

Corrective Action	
004A - Asphalt Paving - Remove non-compliant pavement and replace with new asphalt paving (area as shown on the drawings). The walkway slope shall not exceed 5% along the POT and cross slope shall not exceed 2%. Additional Comments:

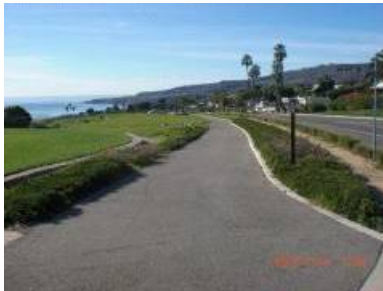
Keynote 56

Field Condition									
03B.11 - Ramps - This portion of an accessible route with a slope greater than 5% does not comply with the requirements for compliant ramps. Existing Condition: 5.3% to 5.6%
