City of Rancho Palos Verdes
Rancho Palos Verdes ADA Assessment
Facility Report with Photos

Facility ID: # Area 1 Pedestrian Signals

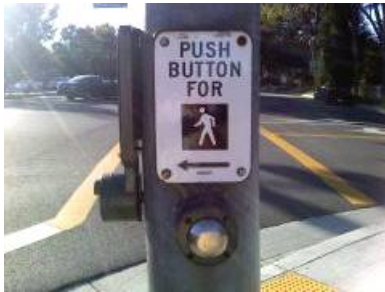
Location: Hawthorne Blvd. & Grayslake Rd.
Photo # 1

Field Condition	04.32A - Push Button Operating Effort - The force required to activate operable part(s) of pedestrian signal device exceeds 5 lbs.	1991 ADAAG 4.27.4
	Existing Condition: 7 LBF.	2004 ADAAG 309.4
		2007 CBC 1117B.6 item 4
		Other 2005 PROWAG-R306.3.1; R405.4

Corrective Action	039 - Operable Parts - Miscellaneous - See Additional Comments
	Additional Comments: See Keynote 4 for corrective action.

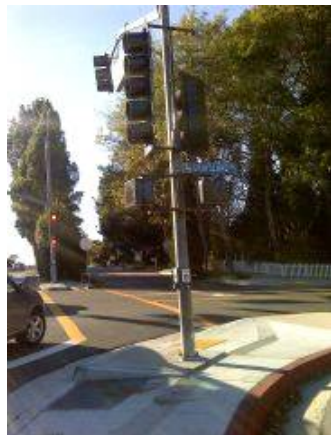
Location: Hawthorne Blvd. & Grayslake Rd.
Photo # 2

Field Condition	04.25 - Pedestrian Signal Device - Clear Floor Space - Location of pedestrian signal device does not accommodate a level 30" x 48" min.. clear space, centered and parallel to the pedestrian signal push button. (Accessible pedestrian signals shall be located so that the vibrotactile feature can be contacted from the level landing serving a curb ramp, if provided, or from a clear floor or ground space that is in line with the crosswalk line adjacent to the vehicle stop line.)	1991 ADAAG 4.2.4
	Existing Condition: 3.3% CS & 2.6% RS.	2004 ADAAG 305.3; Fig. 305.3
		2007 CBC 1118B.4 item 1
		Other 2005 PROWAG-R306.2.1

Corrective Action	008 - Concrete Landing - Remove non-compliant pavement and replace with new concrete. The landing slope shall not exceed 2% in any direction.
	Additional Comments: Provide new curb ramps at new location.

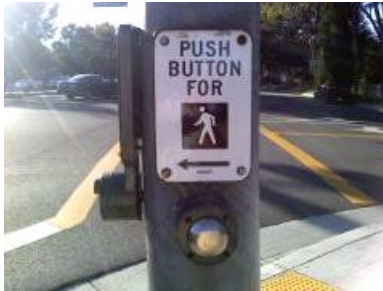
Location: Hawthorne Blvd. & Grayslake Rd.
Photo # 1

Existing Condition: Not provided.

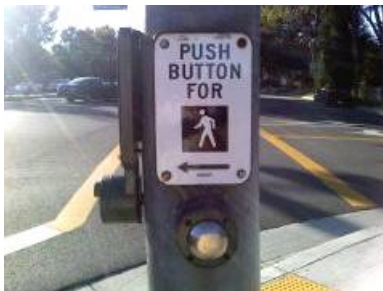
Location: Hawthorne Blvd. & Grayslake Rd.
Photo # 1

Existing Condition: Not provided.

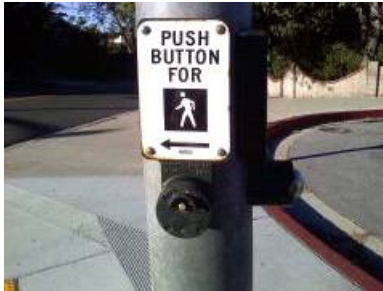
Field Condition	
04.32C - Push Button Size - The pedestrian signal push button is not a min.. 2" across in one dimension.	1991 ADAAG -
Existing Condition: 1/2" diameter.	2004 ADAAG -
	2007 CBC -
	Other 2005 PROWAG-R306.3.3

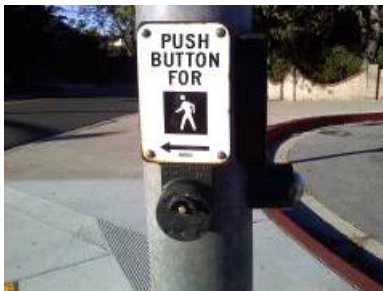
Field Condition	
04.32A - Push Button Operating Effort - The force required to activate operable part(s) of pedestrian signal device exceeds 5 lbs.	1991 ADAAG 4.27.4
Existing Condition: 6 LBF.	2004 ADAAG 309.4
	2007 CBC 1117B.6 item 4
	Other 2005 PROWAG-R306.3.1; R405.4

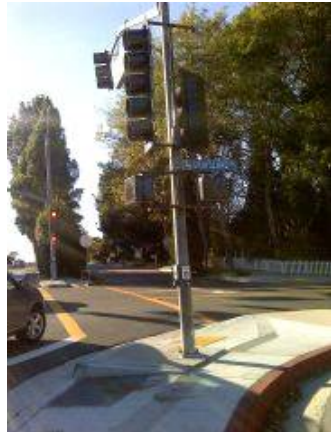
Location: Hawthorne Blvd. & Grayslake Rd.
Photo # 2

Field Condition	
04.25 - Pedestrian Signal Device - Clear Floor Space - Location of pedestrian signal device does not accommodate a level 30" x 48" min.. clear space, centered and parallel to the pedestrian signal push button. (Accessible pedestrian signals shall be located so that the vibrotactile feature can be contacted from the level landing serving a curb ramp, if provided, or from a clear floor or ground space that is in line with the crosswalk line adjacent to the vehicle stop line.)	1991 ADAAG 4.2.4 2004 ADAAG 305.3; Fig. 305.3 2007 CBC 1118B.4 item 1 Other 2005 PROWAG-R306.2.1
Existing Condition: 2.2% CS.

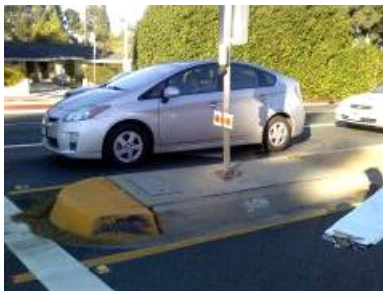
Location: Hawthorne Blvd. & Grayslake Rd.
Photo # 8

Field Condition	
04.24A - Audible Signal Device - A crosswalk with pedestrian signal indication does not have an audible signal device to indicate the WALK interval.	1991 ADAAG - 2004 ADAAG - 2007 CBC - Other 2005 PROWAG-R306.2
Existing Condition: Path of travel to push button not provided.

Corrective Action
039 - Operable Parts - Miscellaneous - See Additional Comments
Additional Comments: Recommendation: Remove pedestrian push button control.

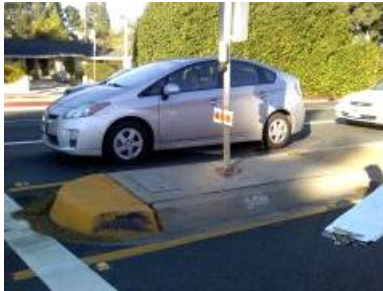
Field Condition	
04.25 - Pedestrian Signal Device - Clear Floor Space - Location of pedestrian signal device does not accommodate a level 30" x 48" min.. clear space, centered and parallel to the pedestrian signal push button. (Accessible pedestrian signals shall be located so that the vibrotactile feature can be contacted from the level landing serving a curb ramp, if provided, or from a clear floor or ground space that is in line with the crosswalk line adjacent to the vehicle stop line.)	1991 ADAAG 4.2.4 2004 ADAAG 305.3; Fig. 305.3 2007 CBC 1118B.4 item 1 Other 2005 PROWAG-R306.2.1
Existing Condition: 4.4% CS.

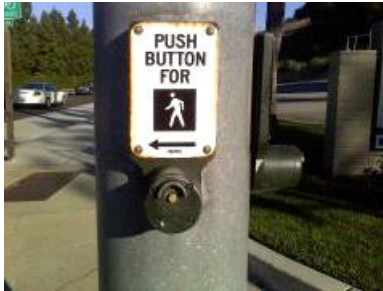
Field Condition	
04.24A - Audible Signal Device - A crosswalk with pedestrian signal indication does not have an audible signal device to indicate the WALK interval.	1991 ADAAG -
Existing Condition:	2004 ADAAG -
	2007 CBC -
	Other 2005 PROWAG-R306.2

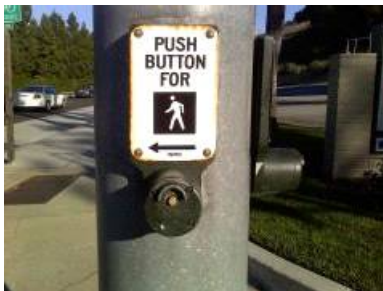
Field Condition	
04.24B - Vibrotactile Signal Device - A crosswalk with pedestrian signal indication does not have a vibrotactile signal device integrated into the signal device to indicate the WALK interval.	1991 ADAAG -
Existing Condition:	2004 ADAAG -
	2007 CBC -
	Other 2005 PROWAG-R306.2

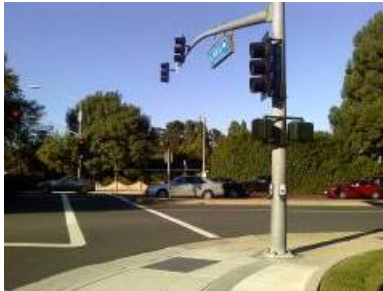
Field Condition	
04.25 - Pedestrian Signal Device - Clear Floor Space - Location of pedestrian signal device does not accommodate a level 30" x 48" min.. clear space, centered and parallel to the pedestrian signal push button. (Accessible pedestrian signals shall be located so that the vibrotactile feature can be contacted from the level landing serving a curb ramp, if provided, or from a clear floor or ground space that is in line with the crosswalk line adjacent to the vehicle stop line.)	1991 ADAAG 4.2.4 2004 ADAAG 305.3; Fig. 305.3 2007 CBC 1118B.4 item 1 Other 2005 PROWAG-R306.2.1
Existing Condition: 3.1% CS.

Corrective Action	
008 - Concrete Landing - Remove non-compliant pavement and replace with new concrete. The landing slope shall not exceed 2% in any direction.	
Additional Comments: Relocate curb ramp.

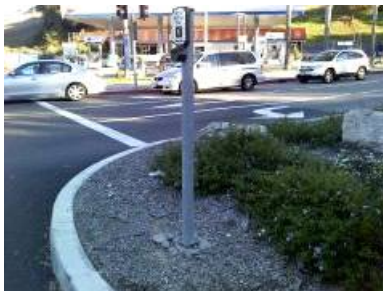
Field Condition	
04.40 - Other - Curb Ramps and Pedestrian Crossings - See Additional Comments	1991 ADAAG - 2004 ADAAG - 2007 CBC - Other -
Existing Condition: Path of travel to push button not provided.

Corrective Action	
006 - Concrete Walk - Remove non-compliant pavement and replace with new concrete (area as shown on the drawings). The walkway slope shall not exceed 5% along the POT and cross slope shall not exceed 2%.	
Additional Comments: Provide new vibrotactile signal device at new location.

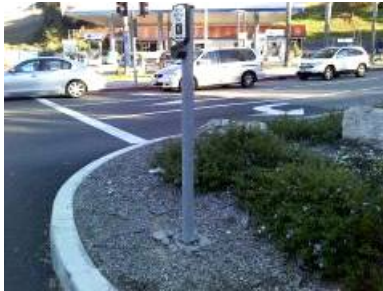
Field Condition	
04.25 - Pedestrian Signal Device - Clear Floor Space - Location of pedestrian signal device does not accommodate a level 30" x 48" min.. clear space, centered and parallel to the pedestrian signal push button. (Accessible pedestrian signals shall be located so that the vibrotactile feature can be contacted from the level landing serving a curb ramp, if provided, or from a clear floor or ground space that is in line with the crosswalk line adjacent to the vehicle stop line.)	1991 ADAAG 4.2.4 2004 ADAAG 305.3; Fig. 305.3 2007 CBC 1118B.4 item 1 Other 2005 PROWAG-R306.2.1
Existing Condition: Surface material is not stable or firm.

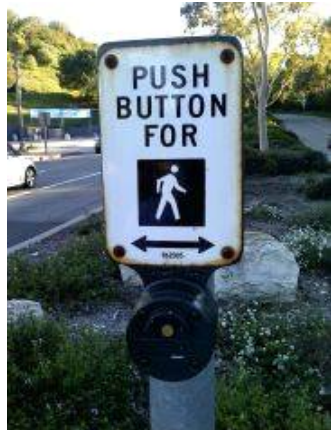
Field Condition	
04.32C - Push Button Size - The pedestrian signal push button is not a min.. 2" across in one dimension.	1991 ADAAG - 2004 ADAAG - 2007 CBC - Other 2005 PROWAG-R306.3.3
Existing Condition: 1/2" diameter.

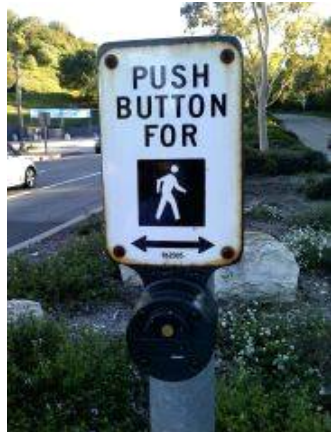
Location: Hawthorne Blvd. & Grayslake Rd. **Photo #** 18

Field Condition	04.24B - Vibrotactile Signal Device - A crosswalk with pedestrian signal indication does not have a vibrotactile signal device integrated into the signal device to indicate the WALK interval.	1991 ADAAG -
	Existing Condition:	2004 ADAAG -
		2007 CBC -
		Other 2005 PROWAG-R306.2

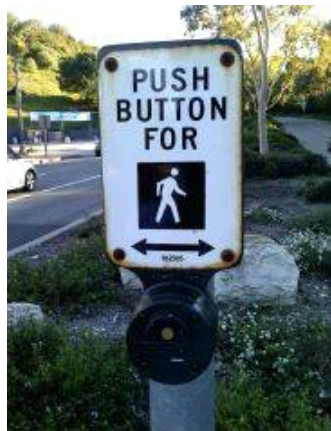
Location: Hawthorne Blvd. & Grayslake Rd. **Photo #** 18

Field Condition	04.24A - Audible Signal Device - A crosswalk with pedestrian signal indication does not have an audible signal device to indicate the WALK interval.	1991 ADAAG -
	Existing Condition:	2004 ADAAG -
		2007 CBC -
		Other 2005 PROWAG-R306.2

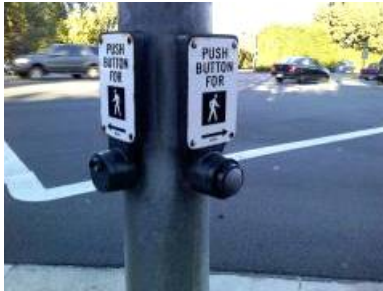
Location: Hawthorne Blvd. & Grayslake Rd.
Photo # 21

Field Condition	
04.32C - Push Button Size - The pedestrian signal push button is not a min.. 2" across in one dimension.	1991 ADAAG -
Existing Condition: 1/2" diameter.	2004 ADAAG -
	2007 CBC -
	Other 2005 PROWAG-R306.3.3

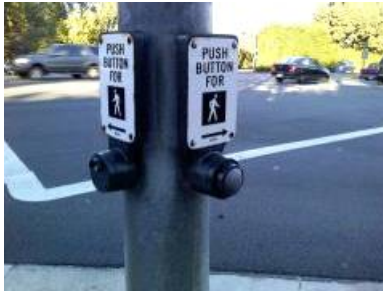
Location: Hawthorne Blvd. & Grayslake Rd.
Photo # 21

Field Condition	
04.24A - Audible Signal Device - A crosswalk with pedestrian signal indication does not have an audible signal device to indicate the WALK interval.	1991 ADAAG -
Existing Condition:	2004 ADAAG -
	2007 CBC -
	Other 2005 PROWAG-R306.2

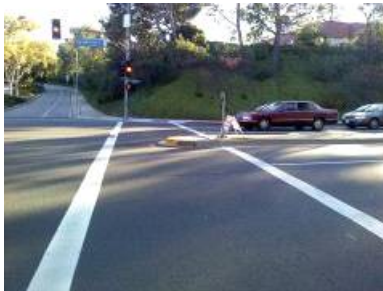
Location: Hawthorne Blvd. & Grayslake Rd.
Photo # 24

Field Condition	
04.40 - Other - Curb Ramps and Pedestrian Crossings - See Additional Comments	1991 ADAAG -
Existing Condition: Path of travel to push button not provided.	2004 ADAAG -
	2007 CBC -
	Other -

Corrective Action
039 - Operable Parts - Miscellaneous - See Additional Comments
Additional Comments: Recommendation: Remove pedestrian push button device.

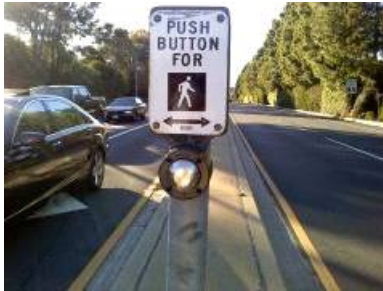
Field Condition	
04.24A - Audible Signal Device - A crosswalk with pedestrian signal indication does not have an audible signal device to indicate the WALK interval.	1991 ADAAG -
Existing Condition:	2004 ADAAG -
	2007 CBC -
	Other 2005 PROWAG-R306.2

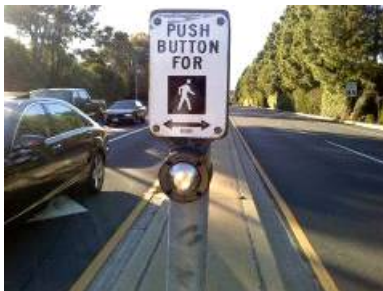
Field Condition	
04.24B - Vibrotactile Signal Device - A crosswalk with pedestrian signal indication does not have a vibrotactile signal device integrated into the signal device to indicate the WALK interval.	1991 ADAAG -
Existing Condition:	2004 ADAAG -
	2007 CBC -
	Other 2005 PROWAG-R306.2

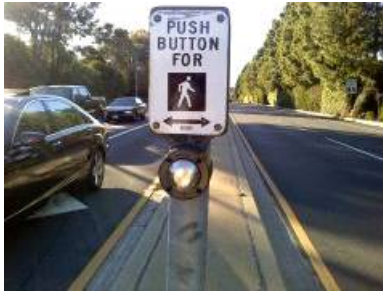
Location: Hawthorne Blvd. & Grayslake Rd.
Photo # 26

Field Condition	
04.32A - Push Button Operating Effort - The force required to activate operable part(s) of pedestrian signal device exceeds 5 lbs.	1991 ADAAG 4.27.4
Existing Condition: 6 LBF.	2004 ADAAG 309.4
	2007 CBC 1117B.6 item 4
	Other 2005 PROWAG-R306.3.1; R405.4

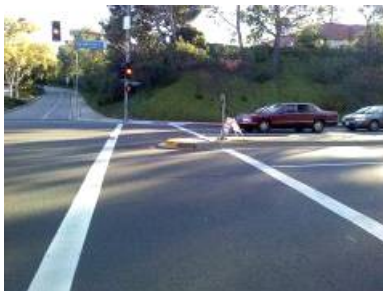
Location: Hawthorne Blvd. & Grayslake Rd.
Photo # 24

Field Condition	
04.25 - Pedestrian Signal Device - Clear Floor Space - Location of pedestrian signal device does not accommodate a level 30" x 48" min.. clear space, centered and parallel to the pedestrian signal push button. (Accessible pedestrian signals shall be located so that the vibrotactile feature can be contacted from the level landing serving a curb ramp, if provided, or from a clear floor or ground space that is in line with the crosswalk line adjacent to the vehicle stop line.)	1991 ADAAG 4.2.4
Existing Condition: 3.5% CS.	2004 ADAAG 305.3; Fig. 305.3
	2007 CBC 1118B.4 item 1
	Other 2005 PROWAG-R306.2.1

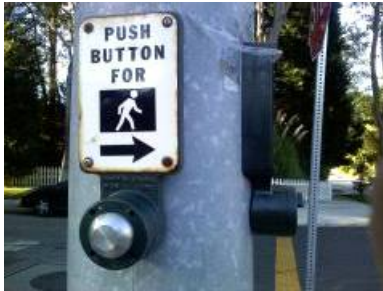
Field Condition	
04.32A - Push Button Operating Effort - The force required to activate operable part(s) of pedestrian signal device exceeds 5 lbs.	1991 ADAAG 4.27.4
Existing Condition: 6 LBF.	2004 ADAAG 309.4
	2007 CBC 1117B.6 item 4
	Other 2005 PROWAG-R306.3.1; R405.4

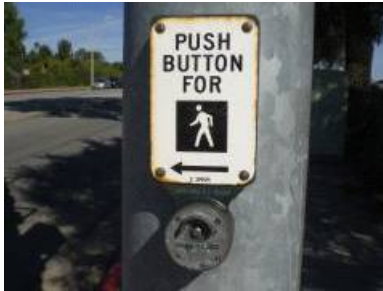
Field Condition	
04.24A - Audible Signal Device - A crosswalk with pedestrian signal indication does not have an audible signal device to indicate the WALK interval.	1991 ADAAG -
Existing Condition:	2004 ADAAG -
	2007 CBC -
	Other 2005 PROWAG-R306.2

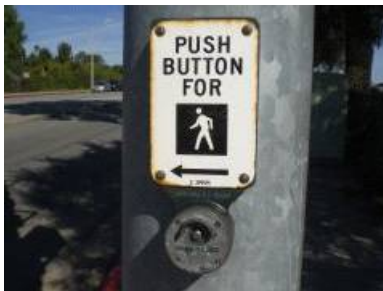
Field Condition	
04.24B - Vibrotactile Signal Device - A crosswalk with pedestrian signal indication does not have a vibrotactile signal device integrated into the signal device to indicate the WALK interval.	1991 ADAAG -
Existing Condition:	2004 ADAAG -
	2007 CBC -
	Other 2005 PROWAG-R306.2

Corrective Action
039 - Operable Parts - Miscellaneous - See Additional Comments
Additional Comments: Replace with vibrotactile signal device.

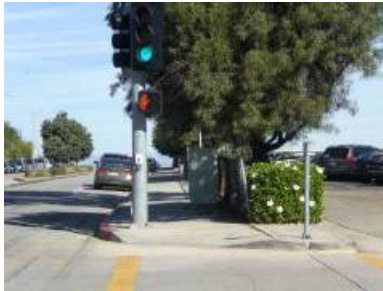
Location: Silver Spur Rd. & Basswood Ave.
Photo # 39

Field Condition	04.25 - Pedestrian Signal Device - Clear Floor Space - Location of pedestrian signal device does not accommodate a level 30" x 48" min.. clear space, centered and parallel to the pedestrian signal push button. (Accessible pedestrian signals shall be located so that the vibrotactile feature can be contacted from the level landing serving a curb ramp, if provided, or from a clear floor or ground space that is in line with the crosswalk line adjacent to the vehicle stop line.)	1991 ADAAG 4.2.4
	Existing Condition: 6.1% CS.	2004 ADAAG 305.3; Fig. 305.3
		2007 CBC 1118B.4 item 1
		Other 2005 PROWAG-R306.2.1

Corrective Action	008 - Concrete Landing - Remove non-compliant pavement and replace with new concrete. The landing slope shall not exceed 2% in any direction.
Additional Comments:	Relocate curb ramp.

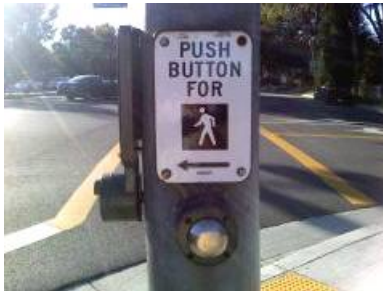
Location: Hawthorne Blvd. & Grayslake Rd.
Photo # 1

Field Condition	04.26C - Pedestrian Signal Device - Spacing - Pedestrian signal devices at a crossing are spaced less than 10' apart.	1991 ADAAG -
	Existing Condition: Pedestrian signal devices mounted on same pole.	2004 ADAAG -
		2007 CBC -
		Other 2005 PROWAG-R306.2.1.1

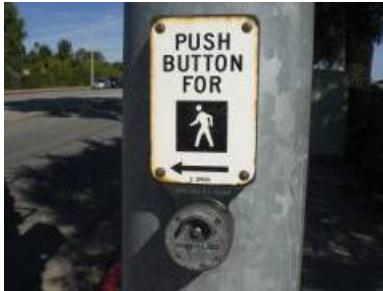
Field Condition	
04.32B - Push Button Locator Tone - The pedestrian signal push button does not incorporate a locator tone at the push button.	1991 ADAAG -
Existing Condition:	2004 ADAAG -
	2007 CBC -
	Other 2005 PROWAG-R306.3.2

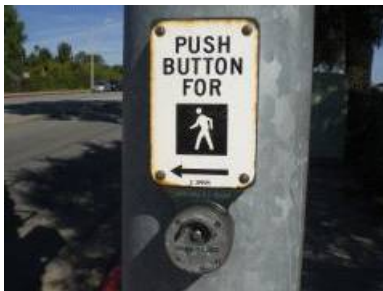
Field Condition	
04.32C - Push Button Size - The pedestrian signal push button is not a min.. 2" across in one dimension.	1991 ADAAG -
Existing Condition: 1/2" diameter.	2004 ADAAG -
	2007 CBC -
	Other 2005 PROWAG-R306.3.3

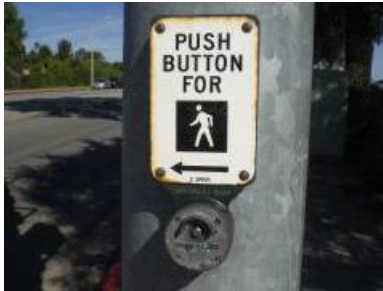
Field Condition	
04.33A - Directional Information and Signs - Pedestrian signal device does not provides compliant tactile or visual signs on the face of the device or its housing or mounting to indicate crosswalk direction and the name of the street containing the crosswalk served by the pedestrian signal.	1991 ADAAG 4.30.4
Existing Condition:	2004 ADAAG 703.1
	2007 CBC 1117B.5.1 item 2; 1117B.5.6
	Other 2005 PROWAG-R306.4

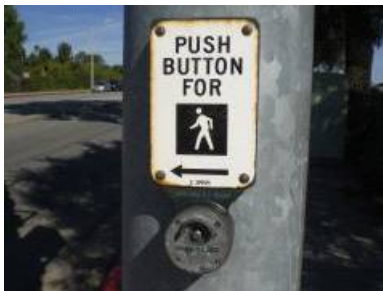
Field Condition	
04.33B - Arrow - Pedestrian signal device does not includes a tactile arrow that contrasts with the background and is aligned parallel to the crosswalk direction.	1991 ADAAG -
Existing Condition:	2004 ADAAG -
	2007 CBC -
	Other 2005 PROWAG-R306.4.1

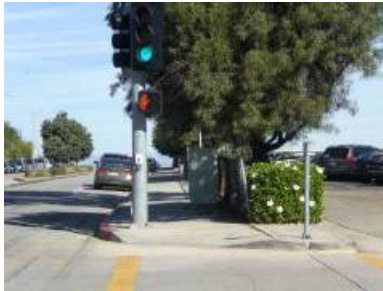
Field Condition	
04.26A - Pedestrian Signal Device - Location versus Crosswalk Line - Location of pedestrian signal device is not within 5' of crosswalk line.	1991 ADAAG -
Existing Condition: 6'-0"	2004 ADAAG -
	2007 CBC -
	Other 2006 Cal MUTCD-Sec. 4E-09, Fig. 4E-2

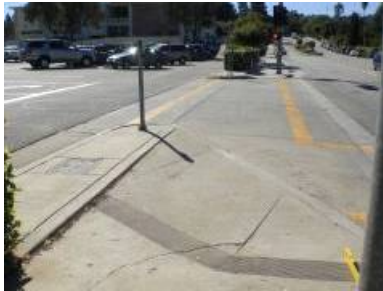
Field Condition	04.25 - Pedestrian Signal Device - Clear Floor Space - Location of pedestrian signal device does not accommodate a level 30" x 48" min.. clear space, centered and parallel to the pedestrian signal push button. (Accessible pedestrian signals shall be located so that the vibrotactile feature can be contacted from the level landing serving a curb ramp, if provided, or from a clear floor or ground space that is in line with the crosswalk line adjacent to the vehicle stop line.)	1991 ADAAG 4.2.4
	Existing Condition: 16.7% CS.	2004 ADAAG 305.3; Fig. 305.3
		2007 CBC 1118B.4 item 1
		Other 2005 PROWAG-R306.2.1

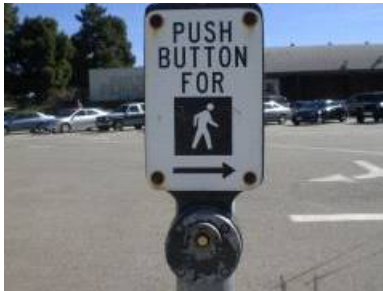
Field Condition	04.33A - Directional Information and Signs - Pedestrian signal device does not provides compliant tactile or visual signs on the face of the device or its housing or mounting to indicate crosswalk direction and the name of the street containing the crosswalk served by the pedestrian signal.	1991 ADAAG 4.30.4
	Existing Condition:	2004 ADAAG 703.1
		2007 CBC 1117B.5.1 item 2; 1117B.5.6
		Other 2005 PROWAG-R306.4

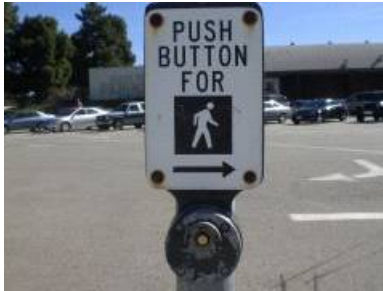
Field Condition	
04.32C - Push Button Size - The pedestrian signal push button is not a min.. 2" across in one dimension.	1991 ADAAG -
Existing Condition: 1/2" diameter.	2004 ADAAG -
	2007 CBC -
	Other 2005 PROWAG-R306.3.3

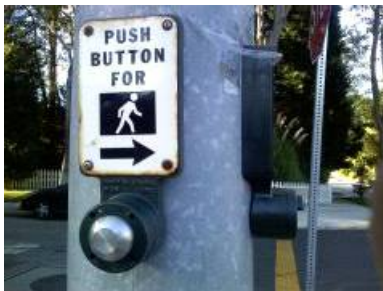
Field Condition	
04.26C - Pedestrian Signal Device - Spacing - Pedestrian signal devices at a crossing are spaced less than 10' apart.	1991 ADAAG -
Existing Condition: Pedestrian signal devices mounted on same pole.	2004 ADAAG -
	2007 CBC -
	Other 2005 PROWAG-R306.2.1.1

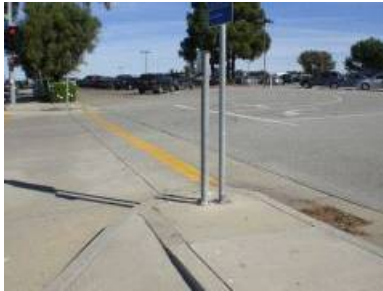
Field Condition	
04.24A - Audible Signal Device - A crosswalk with pedestrian signal indication does not have an audible signal device to indicate the WALK interval.	1991 ADAAG -
Existing Condition:	2004 ADAAG -
	2007 CBC -
	Other 2005 PROWAG-R306.2

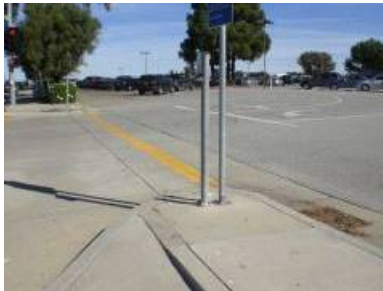
Field Condition	
04.25 - Pedestrian Signal Device - Clear Floor Space - Location of pedestrian signal device does not accommodate a level 30" x 48" min.. clear space, centered and parallel to the pedestrian signal push button. (Accessible pedestrian signals shall be located so that the vibrotactile feature can be contacted from the level landing serving a curb ramp, if provided, or from a clear floor or ground space that is in line with the crosswalk line adjacent to the vehicle stop line.)	1991 ADAAG 4.2.4
Existing Condition: 17.3% CS.	2004 ADAAG 305.3; Fig. 305.3
	2007 CBC 1118B.4 item 1
	Other 2005 PROWAG-R306.2.1

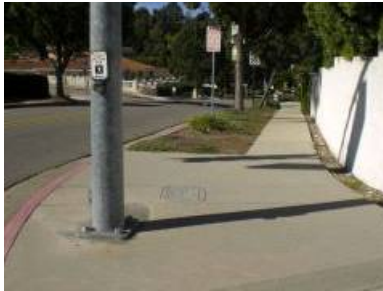
Field Condition	
04.26A - Pedestrian Signal Device - Location versus Crosswalk Line - Location of pedestrian signal device is not within 5' of crosswalk line.	1991 ADAAG -
Existing Condition: 7'-0"	2004 ADAAG -
	2007 CBC -
	Other 2006 Cal MUTCD-Sec. 4E-09, Fig. 4E-2

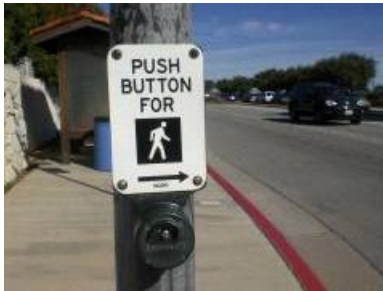
Field Condition	
04.24A - Audible Signal Device - A crosswalk with pedestrian signal indication does not have an audible signal device to indicate the WALK interval.	1991 ADAAG -
Existing Condition:	2004 ADAAG -
	2007 CBC -
	Other 2005 PROWAG-R306.2

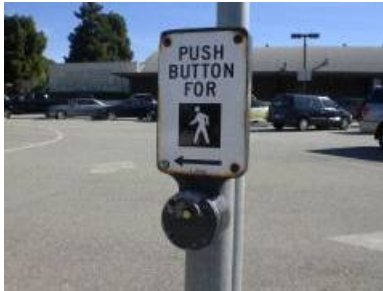
Field Condition	
04.32B - Push Button Locator Tone - The pedestrian signal push button does not incorporate a locator tone at the push button.	1991 ADAAG -
Existing Condition:	2004 ADAAG -
	2007 CBC -
	Other 2005 PROWAG-R306.3.2

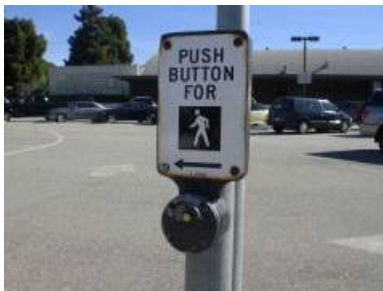
Field Condition	
04.33B - Arrow - Pedestrian signal device does not includes a tactile arrow that contrasts with the background and is aligned parallel to the crosswalk direction.	1991 ADAAG -
Existing Condition:	2004 ADAAG -
	2007 CBC -
	Other 2005 PROWAG-R306.4.1

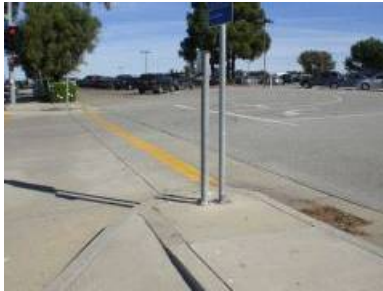
Field Condition	
04.40 - Other - Curb Ramps and Pedestrian Crossings - See Additional Comments	1991 ADAAG -
Existing Condition: Accessible path of travel to pedestrian signal device is not provided.	2004 ADAAG -
	2007 CBC -
	Other -

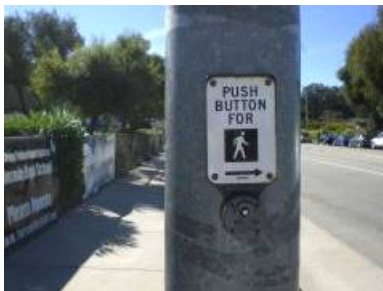
Field Condition	
04.24A - Audible Signal Device - A crosswalk with pedestrian signal indication does not have an audible signal device to indicate the WALK interval.	1991 ADAAG -
Existing Condition:	2004 ADAAG -
	2007 CBC -
	Other 2005 PROWAG-R306.2

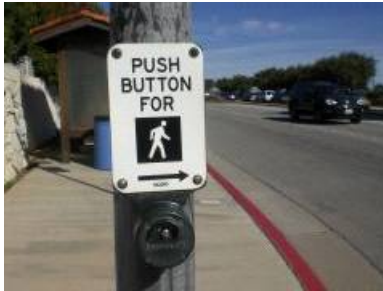
Field Condition	04.24B - Vibrotactile Signal Device - A crosswalk with pedestrian signal indication does not have a vibrotactile signal device integrated into the signal device to indicate the WALK interval.	1991 ADAAG -
	Existing Condition:	2004 ADAAG -
		2007 CBC -
		Other 2005 PROWAG-R306.2

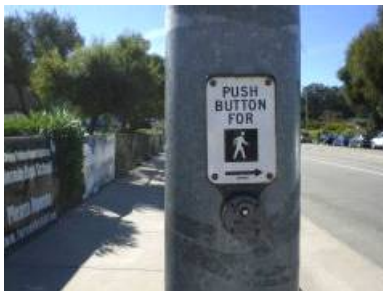
Field Condition	04.32B - Push Button Locator Tone - The pedestrian signal push button does not incorporate a locator tone at the push button.	1991 ADAAG -
	Existing Condition:	2004 ADAAG -
		2007 CBC -
		Other 2005 PROWAG-R306.3.2

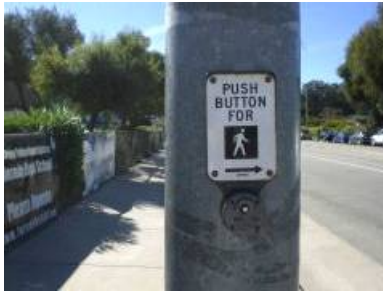
Field Condition	
04.33B - Arrow - Pedestrian signal device does not includes a tactile arrow that contrasts with the background and is aligned parallel to the crosswalk direction.	1991 ADAAG -
Existing Condition:	2004 ADAAG -
	2007 CBC -
	Other 2005 PROWAG-R306.4.1

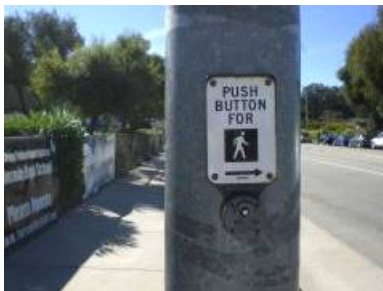
Field Condition	
04.33C - Street Name - Pedestrian signal device does not includes street name information consisting of California Grade 2 Braille and aligned parallel to the crosswalk direction. OR Pedestrian signal device does not provide street name information in audible format. (Street name information in one format or the other is required to be compliant.)	1991 ADAAG -
Existing Condition:	2004 ADAAG -
	2007 CBC -
	Other 2005 PROWAG-R306.4.2

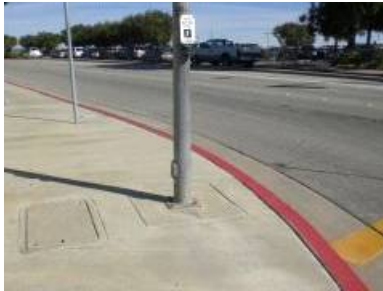
Field Condition	
04.25 - Pedestrian Signal Device - Clear Floor Space - Location of pedestrian signal device does not accommodate a level 30" x 48" min.. clear space, centered and parallel to the pedestrian signal push button. (Accessible pedestrian signals shall be located so that the vibrotactile feature can be contacted from the level landing serving a curb ramp, if provided, or from a clear floor or ground space that is in line with the crosswalk line adjacent to the vehicle stop line.)	1991 ADAAG 4.2.4 2004 ADAAG 305.3; Fig. 305.3 2007 CBC 1118B.4 item 1 Other 2005 PROWAG-R306.2.1
Existing Condition: 2.8% CS.

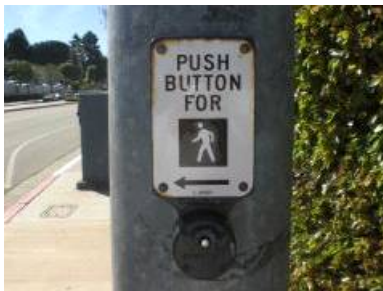
Field Condition	
04.24A - Audible Signal Device - A crosswalk with pedestrian signal indication does not have an audible signal device to indicate the WALK interval.	1991 ADAAG - 2004 ADAAG - 2007 CBC - Other 2005 PROWAG-R306.2
Existing Condition:

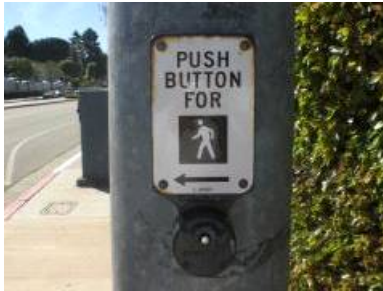
Field Condition	04.24B - Vibrotactile Signal Device - A crosswalk with pedestrian signal indication does not have a vibrotactile signal device integrated into the signal device to indicate the WALK interval.	1991 ADAAG -
	Existing Condition:	2004 ADAAG -
		2007 CBC -
		Other 2005 PROWAG-R306.2

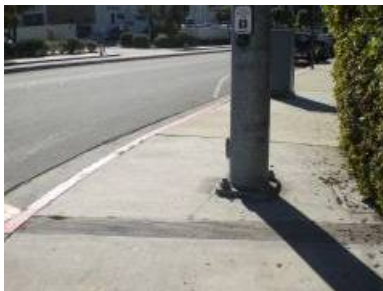
Field Condition	04.25 - Pedestrian Signal Device - Clear Floor Space - Location of pedestrian signal device does not accommodate a level 30" x 48" min.. clear space, centered and parallel to the pedestrian signal push button. (Accessible pedestrian signals shall be located so that the vibrotactile feature can be contacted from the level landing serving a curb ramp, if provided, or from a clear floor or ground space that is in line with the crosswalk line adjacent to the vehicle stop line.)	1991 ADAAG 4.2.4
	Existing Condition: 2.2% CS.	2004 ADAAG 305.3; Fig. 305.3
		2007 CBC 1118B.4 item 1
		Other 2005 PROWAG-R306.2.1

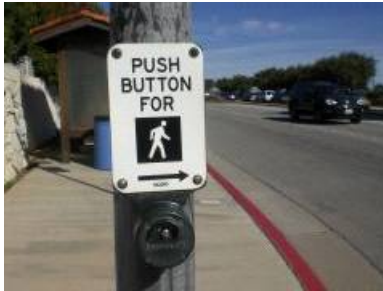
Field Condition	
04.32B - Push Button Locator Tone - The pedestrian signal push button does not incorporate a locator tone at the push button.	1991 ADAAG -
Existing Condition:	2004 ADAAG -
	2007 CBC -
	Other 2005 PROWAG-R306.3.2

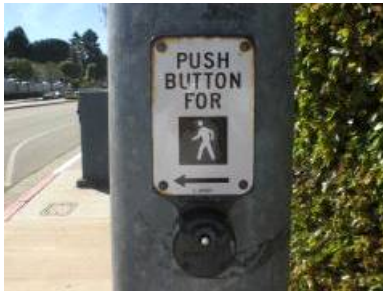
Field Condition	
04.32B - Push Button Locator Tone - The pedestrian signal push button does not incorporate a locator tone at the push button.	1991 ADAAG -
Existing Condition:	2004 ADAAG -
	2007 CBC -
	Other 2005 PROWAG-R306.3.2

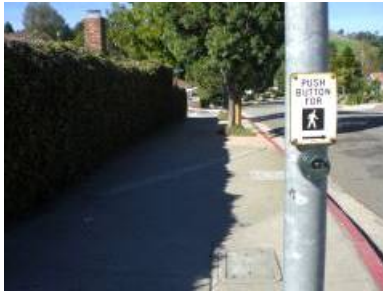
Field Condition	04.24B - Vibrotactile Signal Device - A crosswalk with pedestrian signal indication does not have a vibrotactile signal device integrated into the signal device to indicate the WALK interval.	1991 ADAAG -
	Existing Condition:	2004 ADAAG -
		2007 CBC -
		Other 2005 PROWAG-R306.2
