City of Rancho Palos Verdes
Rancho Palos Verdes ADA Assessment
Facility Report with Photos

Facility ID: # Area 6 Pedestrian Signals

Author: Vaish, B

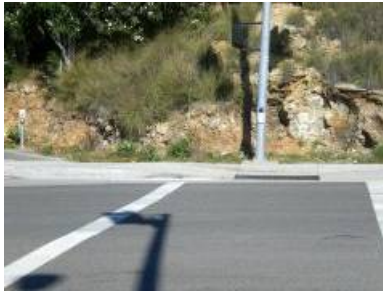
Keynote 1

Field Condition	
04.25 - Pedestrian Signal Device - Clear Floor Space - Location of pedestrian signal device does not accommodate a level 30" x 48" min.. clear space, centered and parallel to the pedestrian signal push button. (Accessible pedestrian signals shall be located so that the vibrotactile feature can be contacted from the level landing serving a curb ramp, if provided, or from a clear floor or ground space that is in line with the crosswalk line adjacent to the vehicle stop line.)	1991 ADAAG 4.2.4 2004 ADAAG 305.3; Fig. 305.3 2007 CBC 1118B.4 item 1 Other 2005 PROWAG-R306.2.1
Existing Condition:

Classification	
DOJ Location Type:	1
Use:	PV
Severity:	C
Level of Difficulty	High

Corrective Action	
008 - Concrete Landing - Remove non-compliant pavement and replace with new concrete. The landing slope shall not exceed 2% in any direction.	
Additional Comments: Relocate curb ramp.

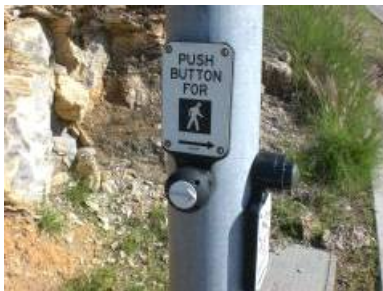
Keynote 2

Field Condition	
04.32A - Push Button Operating Effort - The force required to activate operable part(s) of pedestrian signal device exceeds 5 lbs.	1991 ADAAG 4.27.4 2004 ADAAG 309.4 2007 CBC 1117B.6 item 4 Other 2005 PROWAG-R306.3.1; R405.4
Existing Condition:

Classification	
DOJ Location Type:	1
Use:	PV
Severity:	C
Level of Difficulty	Moderate

Corrective Action	
039 - Operable Parts - Miscellaneous - See Additional Comments	
Additional Comments: Replace with compliant vibrotactile signal device at compliant location.

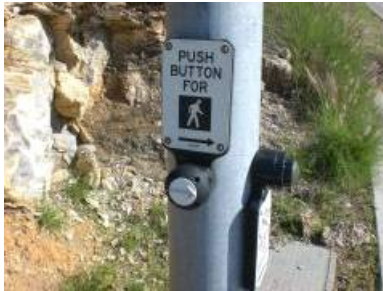
Keynote 3

Field Condition	04.32B - Push Button Locator Tone - The pedestrian signal push button does not incorporate a locator tone at the push button.	1991 ADAAG -
Existing Condition:		2004 ADAAG -
		2007 CBC -
		Other 2005 PROWAG-R306.3.2

Classification	
DOJ Location Type:	1
Use:	PV
Severity:	C
Level of Difficulty	Moderate

Corrective Action	039 - Operable Parts - Miscellaneous - See Additional Comments
Additional Comments:	See Keynote 2 for corrective action.

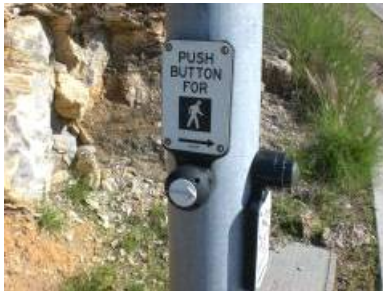
Keynote 4

Field Condition	04.33A - Directional Information and Signs - Pedestrian signal device does not provides compliant tactile or visual signs on the face of the device or its housing or mounting to indicate crosswalk direction and the name of the street containing the crosswalk served by the pedestrian signal.	1991 ADAAG 4.30.4
Existing Condition:		2004 ADAAG 703.1
		2007 CBC 1117B.5.1 item 2; 1117B.5.6
		Other 2005 PROWAG-R306.4

Classification	
DOJ Location Type:	1
Use:	PV
Severity:	C
Level of Difficulty	Moderate

Corrective Action	039 - Operable Parts - Miscellaneous - See Additional Comments
Additional Comments:	See Keynote 2 for corrective action.

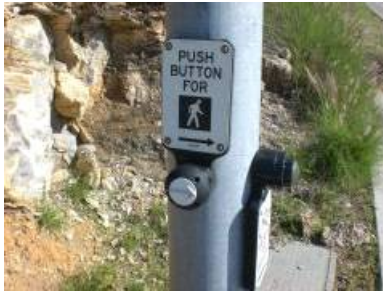
Keynote 5

Field Condition	
04.33B - Arrow - Pedestrian signal device does not includes a tactile arrow that contrasts with the background and is aligned parallel to the crosswalk direction.	1991 ADAAG -
Existing Condition: Arrow has faded.	2004 ADAAG -
	2007 CBC -
	Other 2005 PROWAG-R306.4.1

Classification	
DOJ Location Type:	1
Use:	PV
Severity:	C
Level of Difficulty	Moderate

Corrective Action
039 - Operable Parts - Miscellaneous - See Additional Comments
Additional Comments: See Keynote 2 for corrective action.

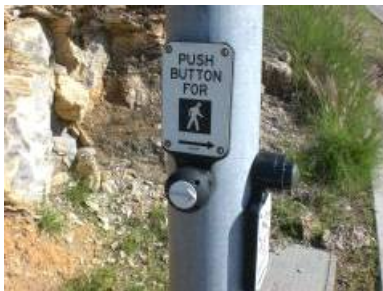
Keynote 6

Field Condition	
04.33C - Street Name - Pedestrian signal device does not includes street name information consisting of California Grade 2 Braille and aligned parallel to the crosswalk direction. OR Pedestrian signal device does not provide street name information in audible format. (Street name information in one format or the other is required to be compliant.)	1991 ADAAG -
Existing Condition:	2004 ADAAG -
	2007 CBC -
	Other 2005 PROWAG-R306.4.2

Classification	
DOJ Location Type:	1
Use:	PV
Severity:	C
Level of Difficulty	Moderate

Corrective Action
039 - Operable Parts - Miscellaneous - See Additional Comments
Additional Comments: See Keynote 2 for corrective action.

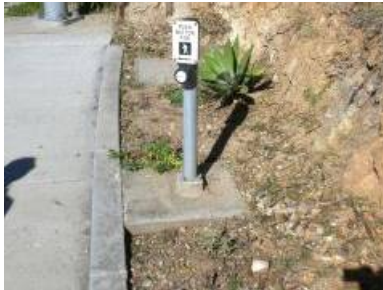
Keynote 7

Field Condition									
04.25 - Pedestrian Signal Device - Clear Floor Space - Location of pedestrian signal device does not accommodate a level 30" x 48" min.. clear space, centered and parallel to the pedestrian signal push button. (Accessible pedestrian signals shall be located so that the vibrotactile feature can be contacted from the level landing serving a curb ramp, if provided, or from a clear floor or ground space that is in line with the crosswalk line adjacent to the vehicle stop line.)

Classification	
DOJ Location Type:	1
Use:	PV
Severity:	C
Level of Difficulty	High

Corrective Action
008 - Concrete Landing - Remove non-compliant pavement and replace with new concrete. The landing slope shall not exceed 2% in any direction.
Additional Comments:

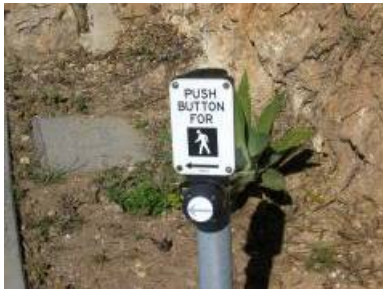
Keynote 8

Field Condition									
04.32A - Push Button Operating Effort - The force required to activate operable part(s) of pedestrian signal device exceeds 5 lbs.

Classification	
DOJ Location Type:	1
Use:	PV
Severity:	C
Level of Difficulty	Moderate

Corrective Action
039 - Operable Parts - Miscellaneous - See Additional Comments
Additional Comments: Replace with compliant vibrotactile signal device.

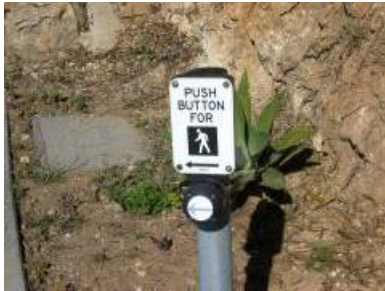
Keynote 9

Field Condition	
04.32B - Push Button Locator Tone - The pedestrian signal push button does not incorporate a locator tone at the push button.	1991 ADAAG -
Existing Condition:	2004 ADAAG -
	2007 CBC -
	Other 2005 PROWAG-R306.3.2

Classification	
DOJ Location Type:	1
Use:	PV
Severity:	C
Level of Difficulty	Moderate

Corrective Action
039 - Operable Parts - Miscellaneous - See Additional Comments
Additional Comments: See Keynote 8 for corrective action.

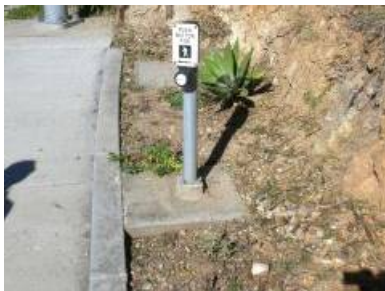
Keynote 10

Field Condition	
04.33A - Directional Information and Signs - Pedestrian signal device does not provides compliant tactile or visual signs on the face of the device or its housing or mounting to indicate crosswalk direction and the name of the street containing the crosswalk served by the pedestrian signal.	1991 ADAAG 4.30.4
Existing Condition:	2004 ADAAG 703.1
	2007 CBC 1117B.5.1 item 2; 1117B.5.6
	Other 2005 PROWAG-R306.4

Classification	
DOJ Location Type:	1
Use:	PV
Severity:	C
Level of Difficulty	Moderate

Corrective Action
039 - Operable Parts - Miscellaneous - See Additional Comments
Additional Comments: See Keynote 8 for corrective action.

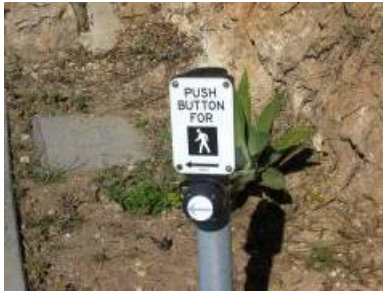
Keynote 11

Field Condition	
04.33B - Arrow - Pedestrian signal device does not includes a tactile arrow that contrasts with the background and is aligned parallel to the crosswalk direction.	1991 ADAAG -
Existing Condition: Arrow has faded.	2004 ADAAG -
	2007 CBC -
	Other 2005 PROWAG-R306.4.1

Classification	
DOJ Location Type:	1
Use:	PV
Severity:	C
Level of Difficulty	Moderate

Corrective Action
039 - Operable Parts - Miscellaneous - See Additional Comments
Additional Comments: See Keynote 8 for corrective action.

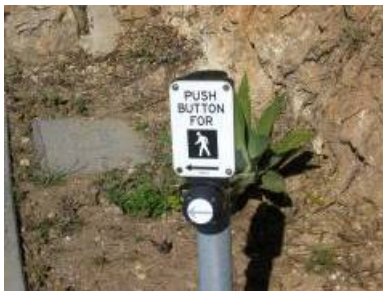
Keynote 12

Field Condition	
04.33C - Street Name - Pedestrian signal device does not includes street name information consisting of California Grade 2 Braille and aligned parallel to the crosswalk direction. OR Pedestrian signal device does not provide street name information in audible format. (Street name information in one format or the other is required to be compliant.)	1991 ADAAG -
Existing Condition:	2004 ADAAG -
	2007 CBC -
	Other 2005 PROWAG-R306.4.2

Classification	
DOJ Location Type:	1
Use:	PV
Severity:	C
Level of Difficulty	Moderate

Corrective Action
039 - Operable Parts - Miscellaneous - See Additional Comments
Additional Comments: See Keynote 8 for corrective action.

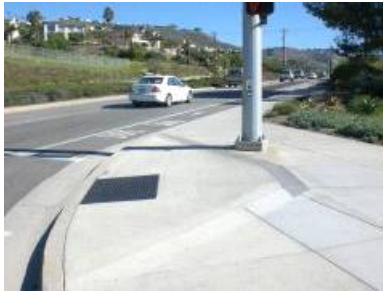
Keynote 13

Field Condition	
04.25 - Pedestrian Signal Device - Clear Floor Space - Location of pedestrian signal device does not accommodate a level 30" x 48" min.. clear space, centered and parallel to the pedestrian signal push button. (Accessible pedestrian signals shall be located so that the vibrotactile feature can be contacted from the level landing serving a curb ramp, if provided, or from a clear floor or ground space that is in line with the crosswalk line adjacent to the vehicle stop line.)	1991 ADAAG 4.2.4 2004 ADAAG 305.3; Fig. 305.3 2007 CBC 1118B.4 item 1 Other 2005 PROWAG-R306.2.1
Existing Condition: 5.9% CS and 23" wide clear floor space.

Classification	
DOJ Location Type:	1
Use:	PV
Severity:	C
Level of Difficulty	Moderate

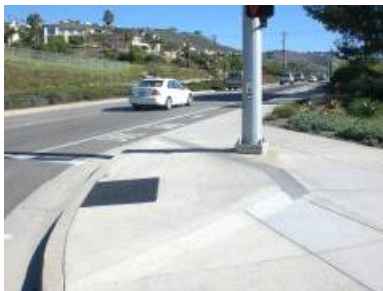
Keynote 14

Field Condition	
04.26B1 - Pedestrian Signal Device - Location versus Curbline - Location of pedestrian signal device is not within 5' of curb.	1991 ADAAG - 2004 ADAAG - 2007 CBC - Other 2005 PROWAG-R306.2.1.1
Existing Condition: 6'-8" from curb line.

Classification	
DOJ Location Type:	1
Use:	PV
Severity:	C
Level of Difficulty	Moderate

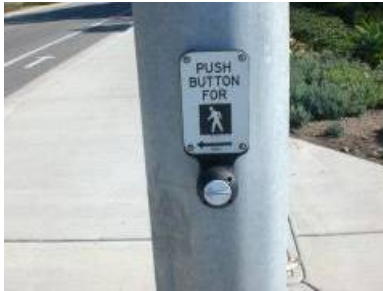
Keynote 15

Field Condition	
04.32A - Push Button Operating Effort - The force required to activate operable part(s) of pedestrian signal device exceeds 5 lbs.	1991 ADAAG 4.27.4
Existing Condition:	2004 ADAAG 309.4
	2007 CBC 1117B.6 item 4
	Other 2005 PROWAG-R306.3.1; R405.4

Classification	
DOJ Location Type:	1
Use:	PV
Severity:	C
Level of Difficulty	Moderate

Corrective Action
039 - Operable Parts - Miscellaneous - See Additional Comments
Additional Comments: Replace with compliant vibrotactile signal device at compliant location.

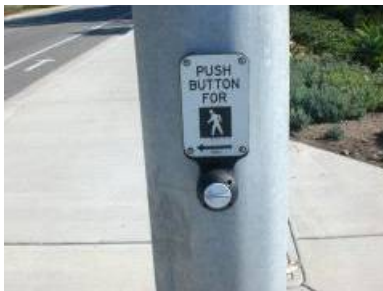
Keynote 16

Field Condition	
04.32B - Push Button Locator Tone - The pedestrian signal push button does not incorporate a locator tone at the push button.	1991 ADAAG -
Existing Condition:	2004 ADAAG -
	2007 CBC -
	Other 2005 PROWAG-R306.3.2

Classification	
DOJ Location Type:	1
Use:	PV
Severity:	C
Level of Difficulty	Moderate

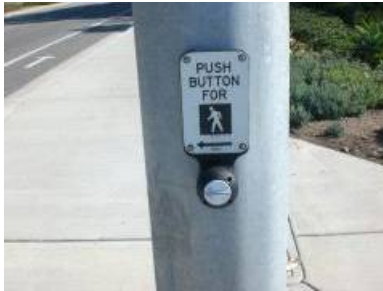
Keynote 17

Field Condition									
04.33A - Directional Information and Signs - Pedestrian signal device does not provides compliant tactile or visual signs on the face of the device or its housing or mounting to indicate crosswalk direction and the name of the street containing the crosswalk served by the pedestrian signal.

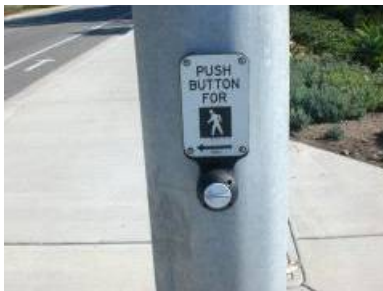
Keynote 18

Field Condition									
04.33B - Arrow - Pedestrian signal device does not includes a tactile arrow that contrasts with the background and is aligned parallel to the crosswalk direction.

1991 ADAAG	-	2004 ADAAG	-	2007 CBC	-	Other	2005 PROWAG-R306.4.1
1991 ADAAG	-								
2004 ADAAG	-								
2007 CBC	-								
Other	2005 PROWAG-R306.4.1								
Existing Condition: Arrow has faded.

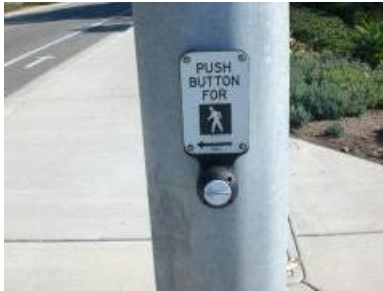
Keynote 19

04.33C - Street Name - Pedestrian signal device does not include street name information consisting of California Grade 2 Braille and aligned parallel to the crosswalk direction. OR Pedestrian signal device does not provide street name information in audible format. (Street name information in one format or the other is required to be compliant.)

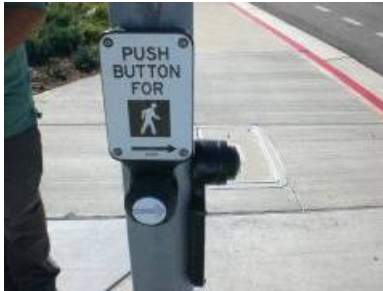
Keynote 20

04.34 - Signal Support or Controller - A hindrance to the passage of persons with physical disabilities, a signal support or controller cabinet, obstructs the sidewalk, or access from the sidewalk to the crosswalk. (Per CBC 1133B.7.1 walks & sidewalks shall have a minimum of 48" in width. Exception: When, because of right-of-way restrictions, natural barriers or other existing conditions, the enforcing agency determines that compliance with the 48-inch (1219 mm) clear sidewalk width would create an unreasonable hardship, the clear width may be reduced to 36 inches (914 mm).

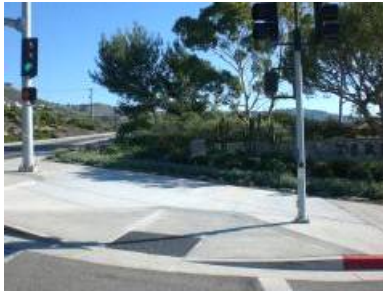
Keynote 21

Field Condition	
04.25 - Pedestrian Signal Device - Clear Floor Space - Location of pedestrian signal device does not accommodate a level 30" x 48" min.. clear space, centered and parallel to the pedestrian signal push button. (Accessible pedestrian signals shall be located so that the vibrotactile feature can be contacted from the level landing serving a curb ramp, if provided, or from a clear floor or ground space that is in line with the crosswalk line adjacent to the vehicle stop line.)	1991 ADAAG 4.2.4 2004 ADAAG 305.3; Fig. 305.3 2007 CBC 1118B.4 item 1 Other 2005 PROWAG-R306.2.1
Existing Condition: 4.6%.

Classification	
DOJ Location Type:	1
Use:	PV
Severity:	C
Level of Difficulty	High

Corrective Action	
008 - Concrete Landing - Remove non-compliant pavement and replace with new concrete. The landing slope shall not exceed 2% in any direction.	
Additional Comments:

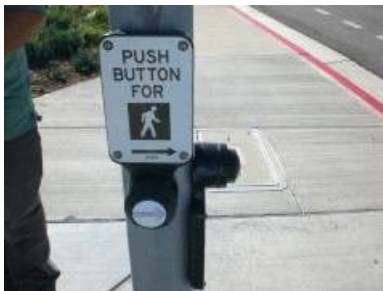
Keynote 22

Field Condition	
04.32A - Push Button Operating Effort - The force required to activate operable part(s) of pedestrian signal device exceeds 5 lbs.	1991 ADAAG 4.27.4 2004 ADAAG 309.4 2007 CBC 1117B.6 item 4 Other 2005 PROWAG-R306.3.1; R405.4
Existing Condition:

Classification	
DOJ Location Type:	1
Use:	PV
Severity:	C
Level of Difficulty	Moderate

Corrective Action	
039 - Operable Parts - Miscellaneous - See Additional Comments	
Additional Comments: Replace with compliant vibrotactile signal device.

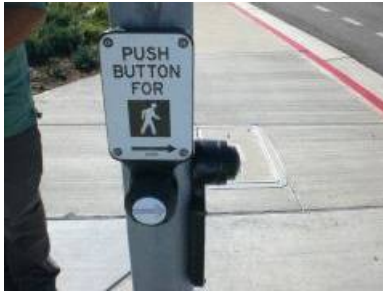
Keynote 23

Field Condition	
04.32B - Push Button Locator Tone - The pedestrian signal push button does not incorporate a locator tone at the push button.	1991 ADAAG -
Existing Condition:	2004 ADAAG -
	2007 CBC -
	Other 2005 PROWAG-R306.3.2

Classification	
DOJ Location Type:	1
Use:	PV
Severity:	C
Level of Difficulty	Moderate

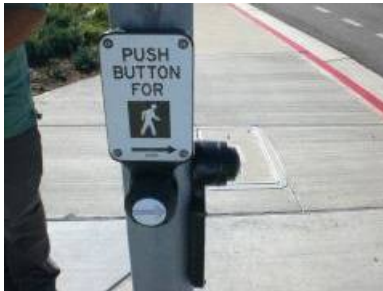
Keynote 24

Field Condition	
04.33A - Directional Information and Signs - Pedestrian signal device does not provides compliant tactile or visual signs on the face of the device or its housing or mounting to indicate crosswalk direction and the name of the street containing the crosswalk served by the pedestrian signal.	1991 ADAAG 4.30.4
Existing Condition:	2004 ADAAG 703.1
	2007 CBC 1117B.5.1 item 2; 1117B.5.6
	Other 2005 PROWAG-R306.4

Classification	
DOJ Location Type:	1
Use:	PV
Severity:	C
Level of Difficulty	Moderate

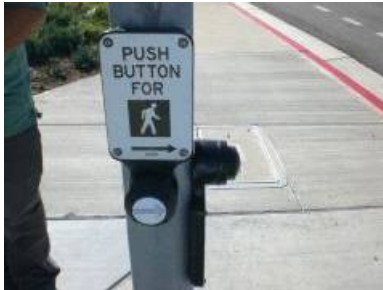
Keynote 25

Field Condition	
04.33B - Arrow - Pedestrian signal device does not includes a tactile arrow that contrasts with the background and is aligned parallel to the crosswalk direction.	1991 ADAAG -
Existing Condition: Arrow has faded.	2004 ADAAG -
	2007 CBC -
	Other 2005 PROWAG-R306.4.1

Classification	
DOJ Location Type:	1
Use:	PV
Severity:	C
Level of Difficulty	Moderate

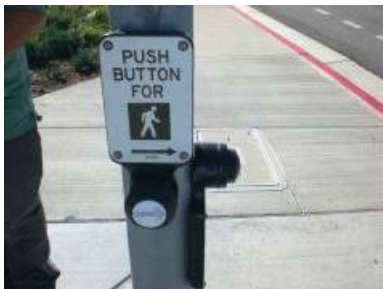
Keynote 26

Field Condition	
04.33C - Street Name - Pedestrian signal device does not includes street name information consisting of California Grade 2 Braille and aligned parallel to the crosswalk direction. OR Pedestrian signal device does not provide street name information in audible format. (Street name information in one format or the other is required to be compliant.)	1991 ADAAG -
Existing Condition:	2004 ADAAG -
	2007 CBC -
	Other 2005 PROWAG-R306.4.2

Classification	
DOJ Location Type:	1
Use:	PV
Severity:	C
Level of Difficulty	Moderate

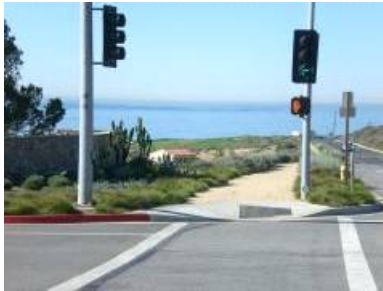
Keynote 27

Field Condition	
04.25 - Pedestrian Signal Device - Clear Floor Space - Location of pedestrian signal device does not accommodate a level 30" x 48" min.. clear space, centered and parallel to the pedestrian signal push button. (Accessible pedestrian signals shall be located so that the vibrotactile feature can be contacted from the level landing serving a curb ramp, if provided, or from a clear floor or ground space that is in line with the crosswalk line adjacent to the vehicle stop line.)	1991 ADAAG 4.2.4 2004 ADAAG 305.3; Fig. 305.3 2007 CBC 1118B.4 item 1 Other 2005 PROWAG-R306.2.1
Existing Condition:

Classification	
DOJ Location Type:	1
Use:	PV
Severity:	C
Level of Difficulty	High

Corrective Action	
008 - Concrete Landing - Remove non-compliant pavement and replace with new concrete. The landing slope shall not exceed 2% in any direction.	
Additional Comments:

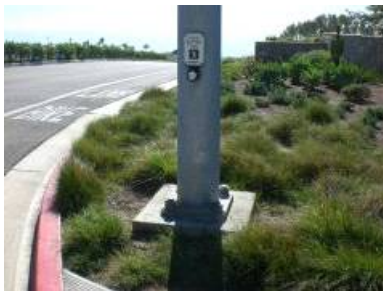
Keynote 28

Field Condition	
04.32A - Push Button Operating Effort - The force required to activate operable part(s) of pedestrian signal device exceeds 5 lbs.	1991 ADAAG 4.27.4 2004 ADAAG 309.4 2007 CBC 1117B.6 item 4 Other 2005 PROWAG-R306.3.1; R405.4
Existing Condition:

Classification	
DOJ Location Type:	1
Use:	PV
Severity:	C
Level of Difficulty	Moderate

Corrective Action	
039 - Operable Parts - Miscellaneous - See Additional Comments	
Additional Comments: Replace with compliant vibrotactile signal device.

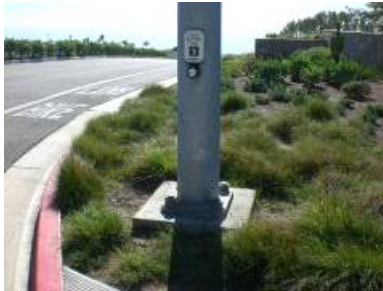
Keynote 29

Field Condition	
04.32B - Push Button Locator Tone - The pedestrian signal push button does not incorporate a locator tone at the push button.	1991 ADAAG -
Existing Condition:	2004 ADAAG -
	2007 CBC -
	Other 2005 PROWAG-R306.3.2

Classification	
DOJ Location Type:	1
Use:	PV
Severity:	C
Level of Difficulty	Moderate

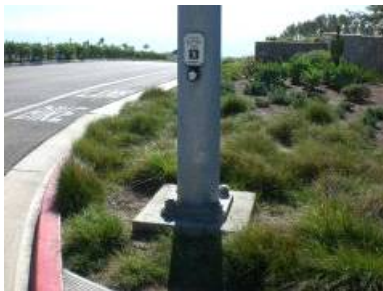
Keynote 30

Field Condition	
04.33A - Directional Information and Signs - Pedestrian signal device does not provides compliant tactile or visual signs on the face of the device or its housing or mounting to indicate crosswalk direction and the name of the street containing the crosswalk served by the pedestrian signal.	1991 ADAAG 4.30.4
Existing Condition:	2004 ADAAG 703.1
	2007 CBC 1117B.5.1 item 2; 1117B.5.6
	Other 2005 PROWAG-R306.4

Classification	
DOJ Location Type:	1
Use:	PV
Severity:	C
Level of Difficulty	Moderate

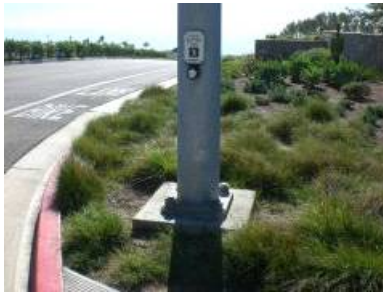
Keynote 31

Field Condition	
04.33B - Arrow - Pedestrian signal device does not includes a tactile arrow that contrasts with the background and is aligned parallel to the crosswalk direction.	1991 ADAAG -
Existing Condition: Arrow has faded.	2004 ADAAG -
	2007 CBC -
	Other 2005 PROWAG-R306.4.1

Classification	
DOJ Location Type:	1
Use:	PV
Severity:	C
Level of Difficulty	Moderate

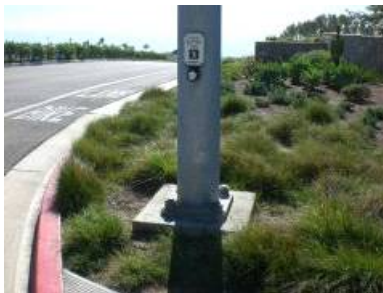
Keynote 32

Field Condition	
04.33C - Street Name - Pedestrian signal device does not includes street name information consisting of California Grade 2 Braille and aligned parallel to the crosswalk direction. OR Pedestrian signal device does not provide street name information in audible format. (Street name information in one format or the other is required to be compliant.)	1991 ADAAG -
Existing Condition:	2004 ADAAG -
	2007 CBC -
	Other 2005 PROWAG-R306.4.2

Classification	
DOJ Location Type:	1
Use:	PV
Severity:	C
Level of Difficulty	Moderate

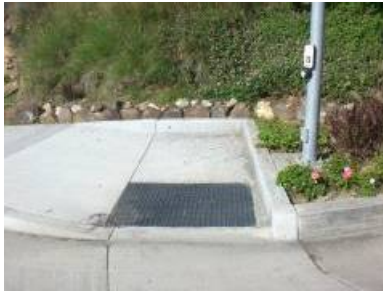
Keynote 33

Field Condition									
04.25 - Pedestrian Signal Device - Clear Floor Space - Location of pedestrian signal device does not accommodate a level 30" x 48" min.. clear space, centered and parallel to the pedestrian signal push button. (Accessible pedestrian signals shall be located so that the vibrotactile feature can be contacted from the level landing serving a curb ramp, if provided, or from a clear floor or ground space that is in line with the crosswalk line adjacent to the vehicle stop line.)

Corrective Action	
008 - Concrete Landing - Remove non-compliant pavement and replace with new concrete. The landing slope shall not exceed 2% in any direction.	
Additional Comments:

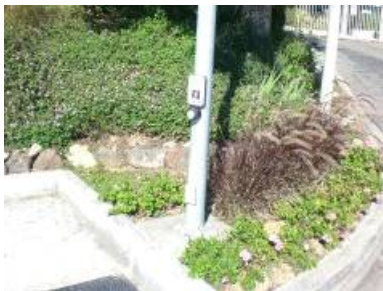
Keynote 34

Field Condition									
04.32A - Push Button Operating Effort - The force required to activate operable part(s) of pedestrian signal device exceeds 5 lbs.

Corrective Action	
039 - Operable Parts - Miscellaneous - See Additional Comments	
Additional Comments: Replace with compliant vibrotactile signal device.

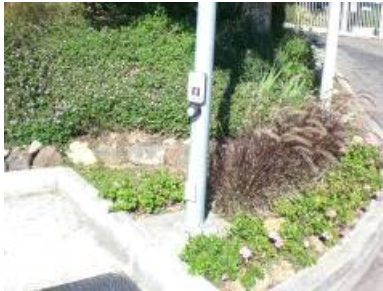
Keynote 35

Field Condition	
04.32B - Push Button Locator Tone - The pedestrian signal push button does not incorporate a locator tone at the push button.	1991 ADAAG -
Existing Condition:	2004 ADAAG -
	2007 CBC -
	Other 2005 PROWAG-R306.3.2

Classification	
DOJ Location Type:	1
Use:	PV
Severity:	C
Level of Difficulty	Moderate

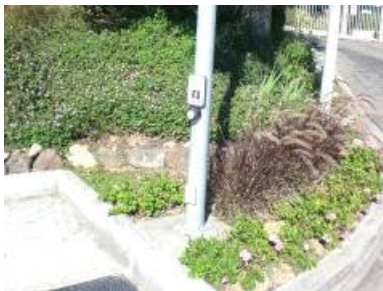
Keynote 36

Field Condition	
04.33A - Directional Information and Signs - Pedestrian signal device does not provides compliant tactile or visual signs on the face of the device or its housing or mounting to indicate crosswalk direction and the name of the street containing the crosswalk served by the pedestrian signal.	1991 ADAAG 4.30.4
Existing Condition:	2004 ADAAG 703.1
	2007 CBC 1117B.5.1 item 2; 1117B.5.6
	Other 2005 PROWAG-R306.4

Classification	
DOJ Location Type:	1
Use:	PV
Severity:	C
Level of Difficulty	Moderate

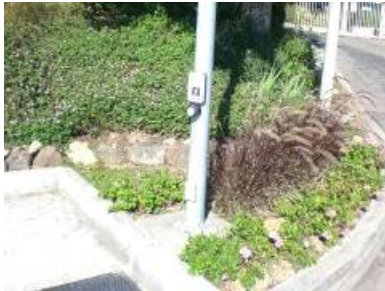
Keynote 37

Field Condition	
04.33B - Arrow - Pedestrian signal device does not includes a tactile arrow that contrasts with the background and is aligned parallel to the crosswalk direction.	1991 ADAAG -
Existing Condition: Arrow has faded.	2004 ADAAG -
	2007 CBC -
	Other 2005 PROWAG-R306.4.1

Classification	
DOJ Location Type:	1
Use:	PV
Severity:	C
Level of Difficulty	Moderate

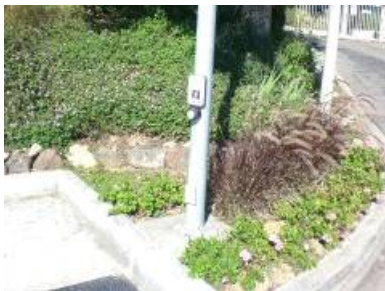
Keynote 38

Field Condition	
04.33C - Street Name - Pedestrian signal device does not includes street name information consisting of California Grade 2 Braille and aligned parallel to the crosswalk direction. OR Pedestrian signal device does not provide street name information in audible format. (Street name information in one format or the other is required to be compliant.)	1991 ADAAG -
Existing Condition:	2004 ADAAG -
	2007 CBC -
	Other 2005 PROWAG-R306.4.2
