LANDSLIDE INVESTIGATION

Portuguese Bend Club  
Rancho Palos Verdes, California

January 10, 1977

Job No. 2376-80

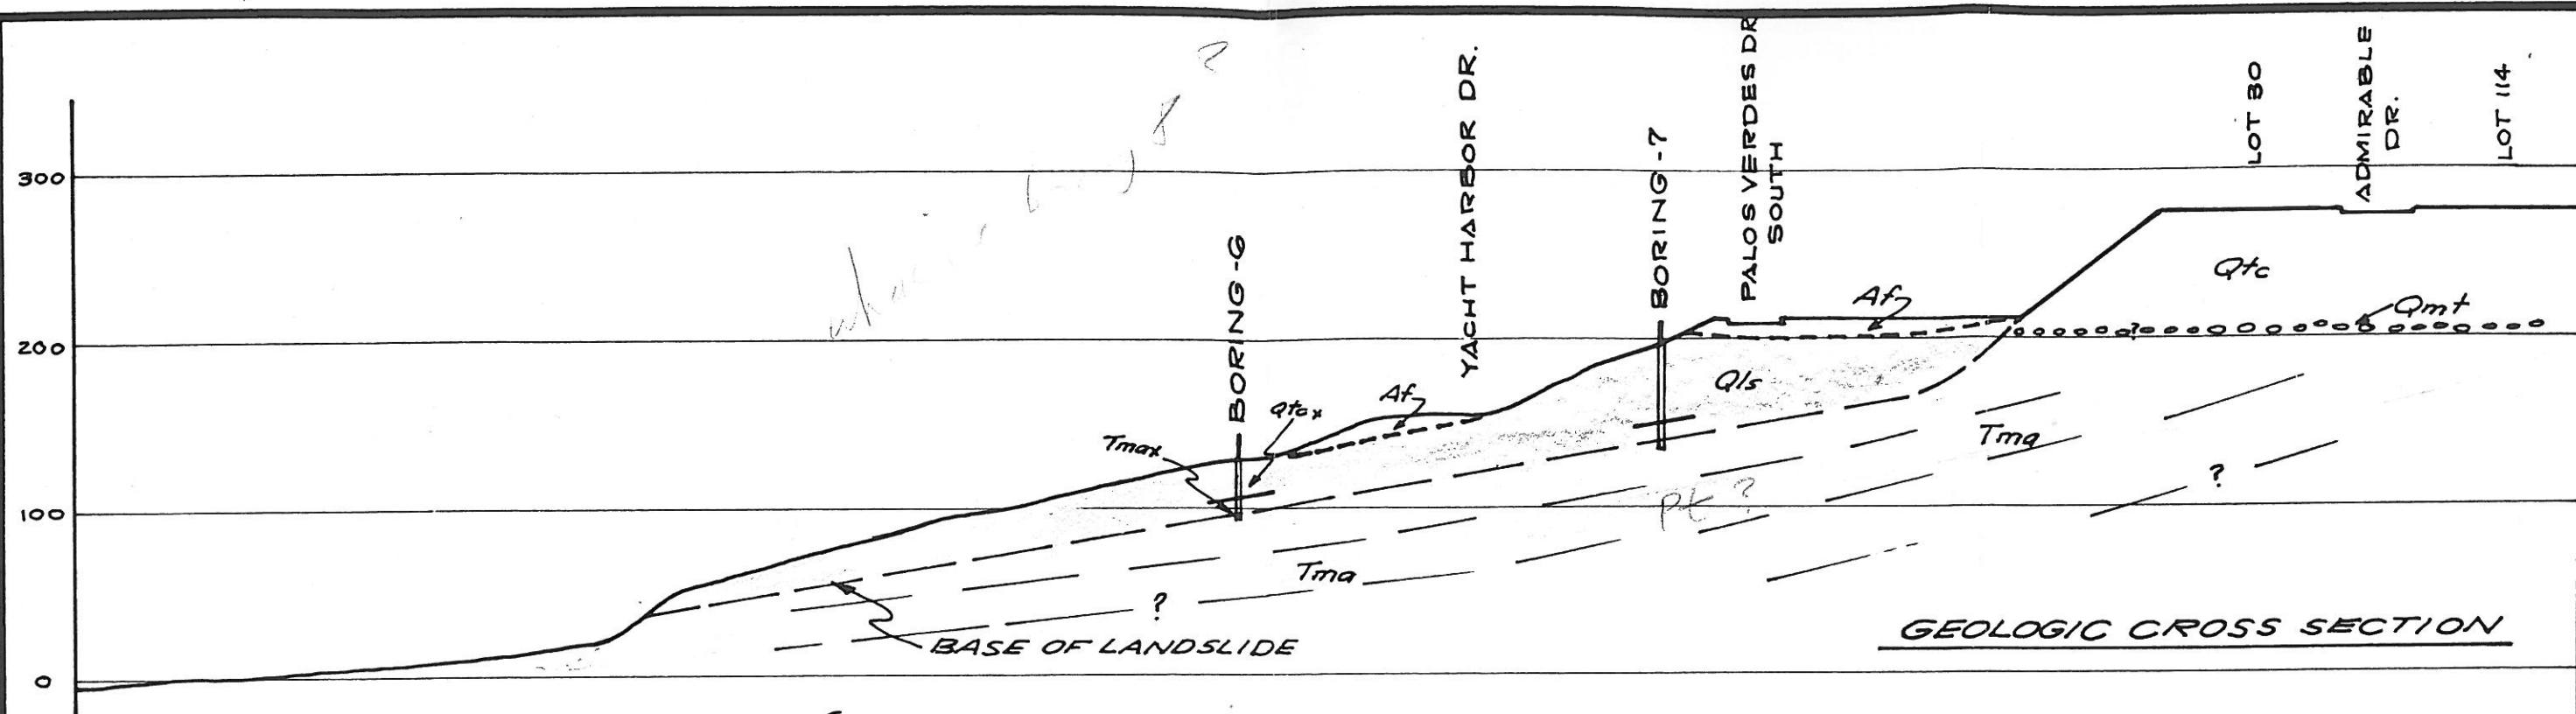
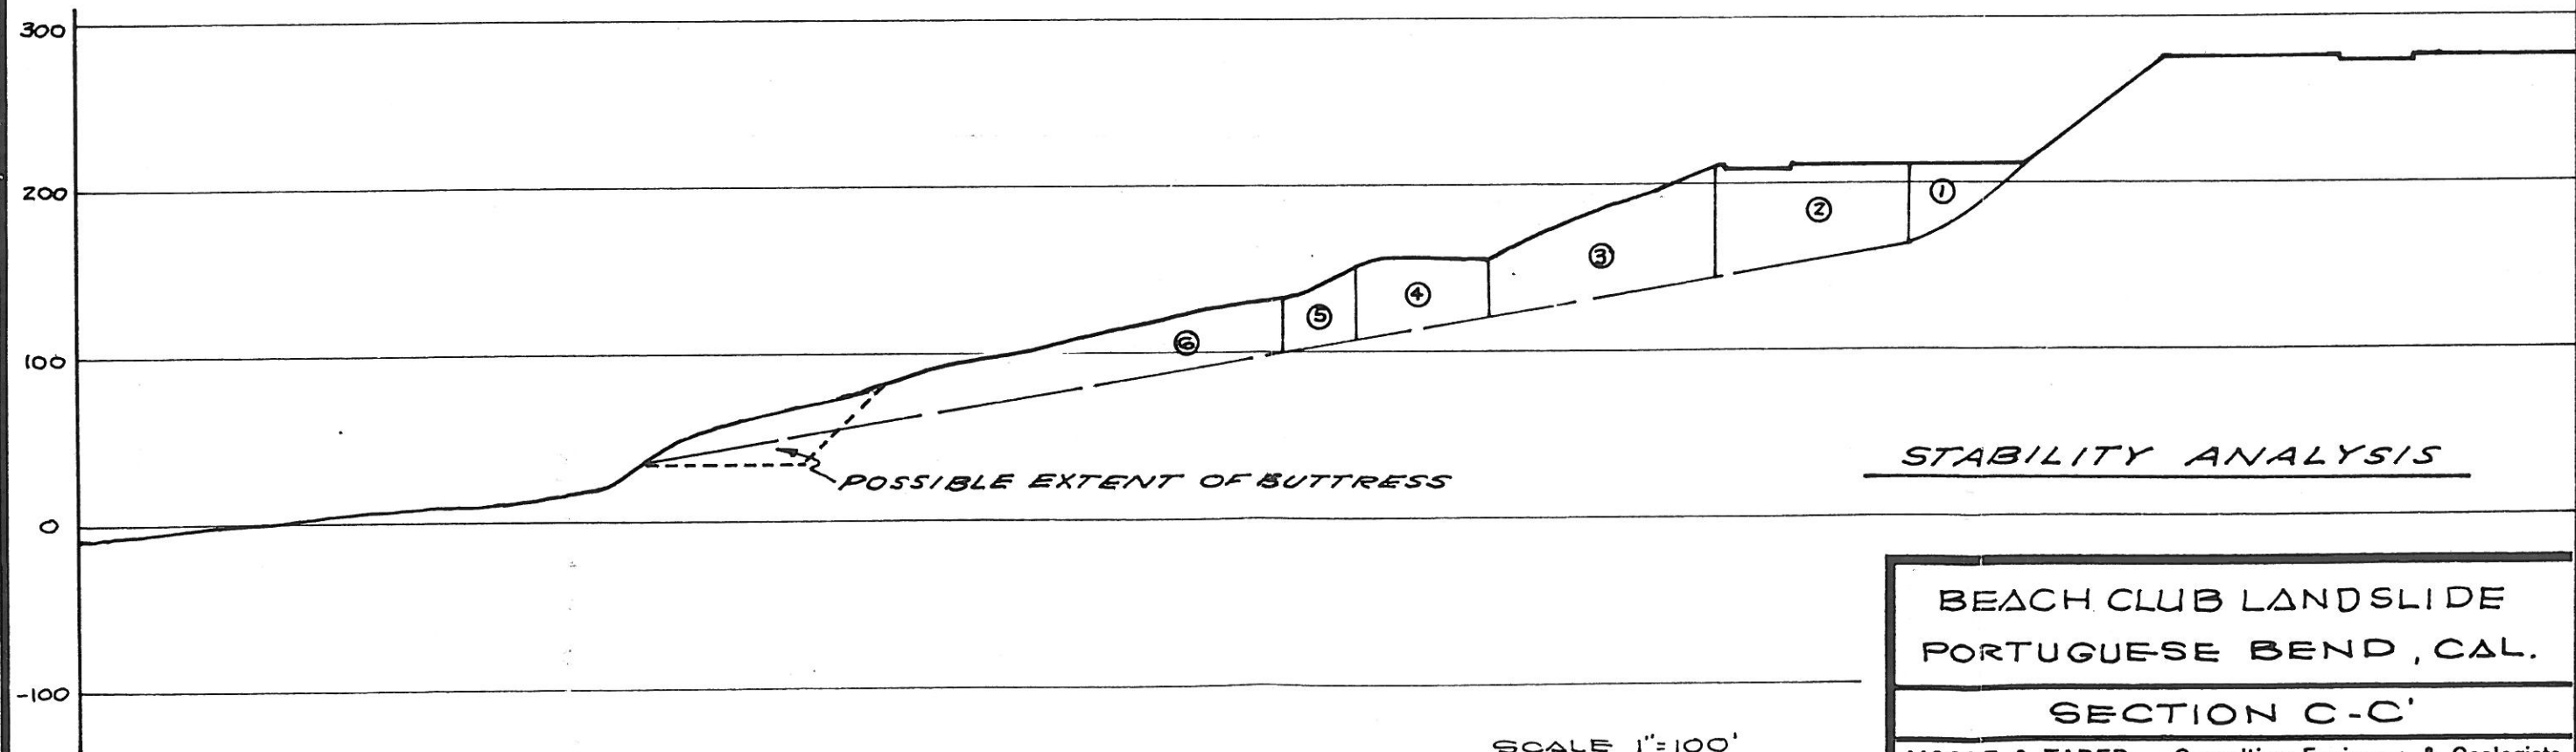
| SECTION C-C' | | | | |

A mass of Altamira shale, capped by Terrace deposits, slid along a section of adversely inclined, unsupported bentonitic clay probably in response to undercutting by past wave action. The siltstone and shale sections of the Monterey are relatively undisturbed, whereas the clay has been sheared and squeezed.

These relationships are illustrated in greater detail on the attached geologic map and cross-section C-C'. More complete stratigraphic information is contained in the boring logs.
