City of Rancho Palos Verdes
Rancho Palos Verdes ADA Assessment
Facility Report with Photos

Facility ID: # Curb Ramps

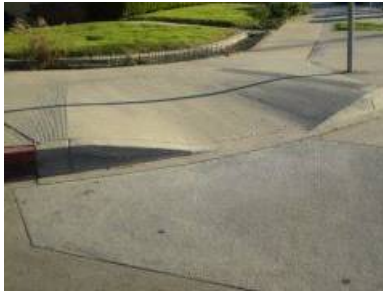
Keynote 1

Field Condition	
04.02 - Slope - Slope of the curb ramp exceeds 8.33% (or the least possible compliant slope).	1991 ADAAG 4.7.2; 4.8.2
Existing Condition: 11.3% RS.	2004 ADAAG 405.2; Advisory 405.2
	2007 CBC 1127B.5 item 3
	Other 2005 PROWAG-R303.2.1.1; R303.2.2.1

Corrective Action
120A - Curb Ramp - Provide compliant curb ramp.
Additional Comments:

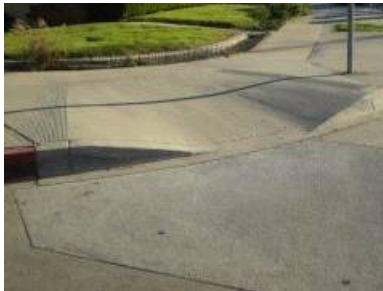
Keynote 2

Field Condition	
03A.07A - Cross Slope (PAR) - Cross slope of the pedestrian access route exceeds 1:50.	1991 ADAAG 4.3.7
Existing Condition: 4.9% CS at Curb Ramp	2004 ADAAG 403.3
	2007 CBC 1133B.7.1.3
	Other 2005 PROWAG-R301.4.1

Corrective Action
123 - Curb Ramps - Miscellaneous - See Additional Comments
Additional Comments: See Keynote 1 for corrective action.

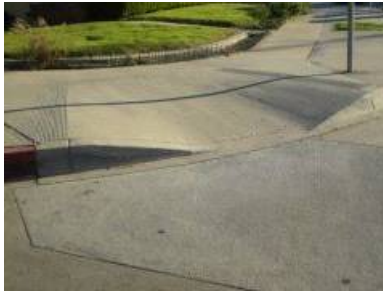
Keynote 3

Field Condition	
04.07B - Side Flare Slope (8.33% Max. Requirement) - Where the landing at the top of the ramp is less than 48" deep and wheelchair users must use the side flares for access, the flared sides have a slope greater than 8.33% (measured along the curb).	1991 ADAAG Fig. 12(a)
Existing Condition: 17.2% and 27.8% slope.	2004 ADAAG 406.3; Fig. 406.3
	2007 CBC 1127B.5 item 4
	Other -

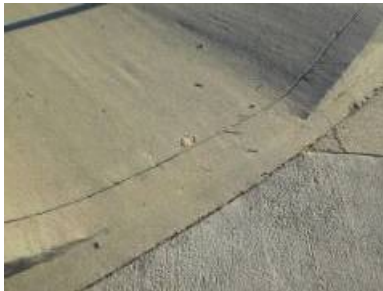
Keynote 4

Field Condition	
04.05 - Width - The width of the curb ramp, not including the flared sides, is less than 48".	1991 ADAAG 4.7.3
Existing Condition: 40" wide Curb Ramp.	2004 ADAAG 406.1; 405.5
	2007 CBC 1127B.5 item 2
	Other 2005 PROWAG-R303.3.1

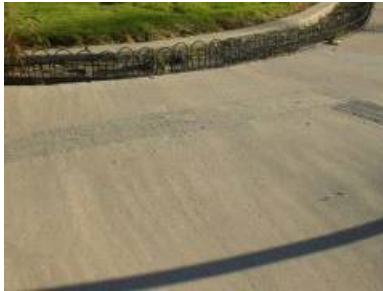
Keynote 5

Field Condition	
04.09A - Grooved Border Requirement - Curb ramp does not have a 12" wide grooved border around upper edges of curb ramp and flares to indicate transition from sidewalk to curb ramp.	1991 ADAAG -
Existing Condition: Grooved border @ 12 1/2" wide.	2004 ADAAG -
	2007 CBC 1127B.5 item 6
	Other -

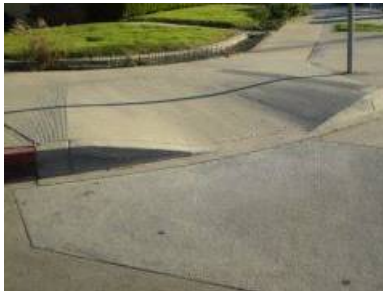
Field Condition	
04.10 - Detectable Warning Requirement - Regardless of slope, the curb ramp does not have a detectable warning.	1991 ADAAG 4.7.7; 4.29.2
Existing Condition: Not provided.	2004 ADAAG 705.1; Fig. 705.1
	2007 CBC 1127B.5 item 7
	Other 2005 PROWAG-R303.3.2

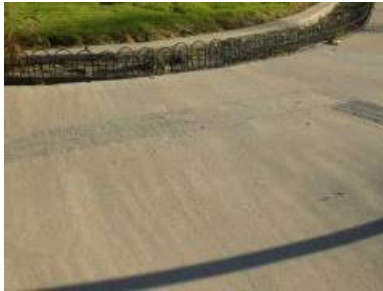
Field Condition									
03A.08 - Running Slope (PAR) - Slope of the pedestrian access route exceeds 1:20. Or slope of the pedestrian access route contained within a street or highway border exceeds the grade of the adjacent roadway. (1:20 requirement does not apply to compliant ramps or where slope of the pedestrian access route contained within a street or highway border does not exceed the grade of the adjacent roadway.)

1991 ADAAG	4.3.7	2004 ADAAG	403.3	2007 CBC	1133B.7.3	Other	2005 PROWAG-R301.4.2
1991 ADAAG	4.3.7								
2004 ADAAG	403.3								
2007 CBC	1133B.7.3								
Other	2005 PROWAG-R301.4.2								
Existing Condition: 6% slope.

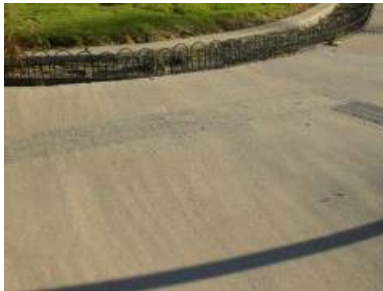
Field Condition									
03A.02A - Width - Accessible route of travel is less than 48" wide (note: 48" wide requirement does not apply to doorways or gates).

1991 ADAAG	4.3.3	2004 ADAAG	403.5.1	2007 CBC	1133B.7.1	Other	2005 PROWAG-R301.3.1
1991 ADAAG	4.3.3								
2004 ADAAG	403.5.1								
2007 CBC	1133B.7.1								
Other	2005 PROWAG-R301.3.1								
Existing Condition: 32"wide.

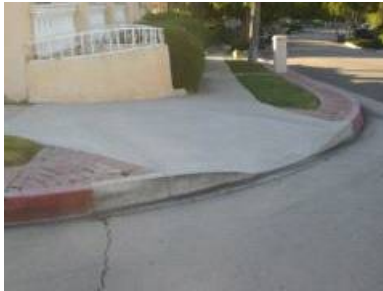
Field Condition	
03A.07A - Cross Slope (PAR) - Cross slope of the pedestrian access route exceeds 1:50.	1991 ADAAG 4.3.7
Existing Condition: 10.4% RS.	2004 ADAAG 403.3
	2007 CBC 1133B.7.1.3
	Other 2005 PROWAG-R301.4.1

Corrective Action
120D - Replace Curb Ramp - Remove existing curb ramp, provide new.
Additional Comments:

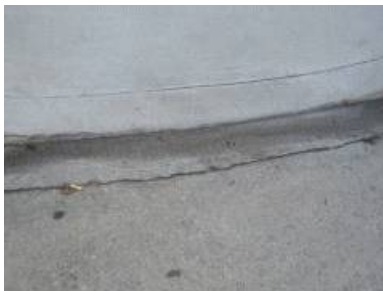
Field Condition	
04.03 - Transition - The transition from the curb ramp to the road or gutter is not flush or free of abrupt changes.	1991 ADAAG 4.7.2
Existing Condition: 1/2" transition.	2004 ADAAG 406.2; Fig. 406.2
	2007 CBC 1127B.5 item 3
	Other 2005 PROWAG-R301.5.1

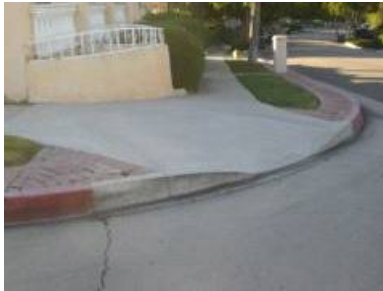
Field Condition	
04.07B - Side Flare Slope (8.33% Max. Requirement) - Where the landing at the top of the ramp is less than 48" deep and wheelchair users must use the side flares for access, the flared sides have a slope greater than 8.33% (measured along the curb). Existing Condition: 11.2% & 31.2%.	1991 ADAAG Fig. 12(a) 2004 ADAAG 406.3; Fig. 406.3 2007 CBC 1127B.5 item 4 Other -

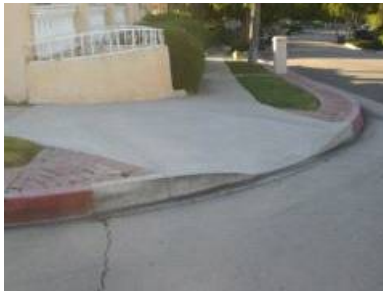
Field Condition	
04.10 - Detectable Warning Requirement - Regardless of slope, the curb ramp does not have a detectable warning. Existing Condition: Not provided.	1991 ADAAG 4.7.7; 4.29.2 2004 ADAAG 705.1; Fig. 705.1 2007 CBC 1127B.5 item 7 Other 2005 PROWAG-R303.3.2

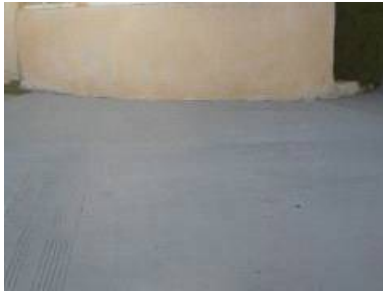
Field Condition	
03A.02A - Width - Accessible route of travel is less than 48" wide (note: 48" wide requirement does not apply to doorways or gates).	1991 ADAAG 4.3.3
Existing Condition: 36" wide.	2004 ADAAG 403.5.1
	2007 CBC 1133B.7.1
	Other 2005 PROWAG-R301.3.1

Corrective Action	
008 - Concrete Landing - Remove non-compliant pavement and replace with new concrete. The landing slope shall not exceed 2% in any direction.	
Additional Comments:

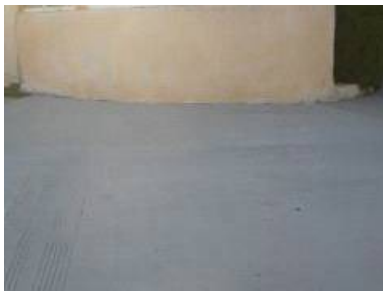
Field Condition	
03A.08 - Running Slope (PAR) - Slope of the pedestrian access route exceeds 1:20. Or slope of the pedestrian access route contained within a street or highway border exceeds the grade of the adjacent roadway. (1:20 requirement does not apply to compliant ramps or where slope of the pedestrian access route contained within a street or highway border does not exceed the grade of the adjacent roadway.)	1991 ADAAG 4.3.7
Existing Condition: 6.8% CS & 12.3% RS.	2004 ADAAG 403.3
	2007 CBC 1133B.7.3
	Other 2005 PROWAG-R301.4.2

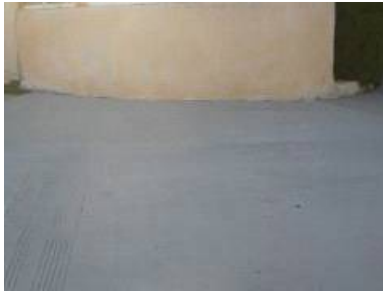
Field Condition	
04.09A - Grooved Border Requirement - Curb ramp does not have a 12" wide grooved border around upper edges of curb ramp and flares to indicate transition from sidewalk to curb ramp.	1991 ADAAG -
Existing Condition: 12 1/2" wide.	2004 ADAAG -
	2007 CBC 1127B.5 item 6
	Other -

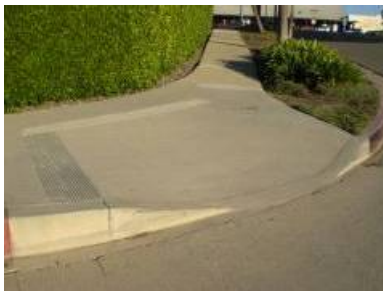
Field Condition	
04.07B - Side Flare Slope (8.33% Max. Requirement) - Where the landing at the top of the ramp is less than 48" deep and wheelchair users must use the side flares for access, the flared sides have a slope greater than 8.33% (measured along the curb).	1991 ADAAG Fig. 12(a)
Existing Condition: 16.6% & 31.1%.	2004 ADAAG 406.3; Fig. 406.3
	2007 CBC 1127B.5 item 4
	Other -

Corrective Action
120D - Replace Curb Ramp - Remove existing curb ramp, provide new.
Additional Comments:

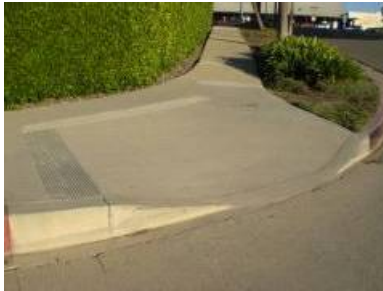
Field Condition	
04.10 - Detectable Warning Requirement - Regardless of slope, the curb ramp does not have a detectable warning.	1991 ADAAG 4.7.7; 4.29.2
Existing Condition: Not provided.	2004 ADAAG 705.1; Fig. 705.1
	2007 CBC 1127B.5 item 7
	Other 2005 PROWAG-R303.3.2

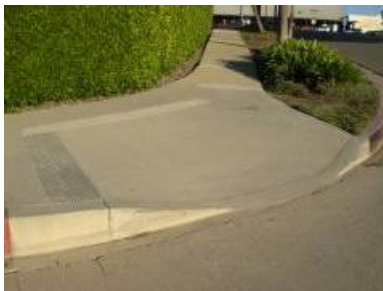
Field Condition	
03A.02A - Width - Accessible route of travel is less than 48" wide (note: 48" wide requirement does not apply to doorways or gates).	1991 ADAAG 4.3.3
Existing Condition: 34" wide.	2004 ADAAG 403.5.1
	2007 CBC 1133B.7.1
	Other 2005 PROWAG-R301.3.1

Corrective Action	
008 - Concrete Landing - Remove non-compliant pavement and replace with new concrete. The landing slope shall not exceed 2% in any direction.	
Additional Comments:

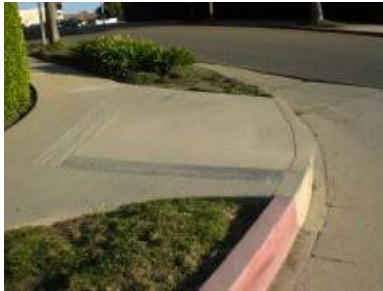
Field Condition	
03A.07A - Cross Slope (PAR) - Cross slope of the pedestrian access route exceeds 1:50.	1991 ADAAG 4.3.7
Existing Condition: 2.3% CS.	2004 ADAAG 403.3
	2007 CBC 1133B.7.1.3
	Other 2005 PROWAG-R301.4.1

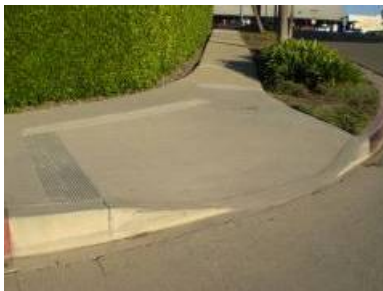
Field Condition	
03A.07A - Cross Slope (PAR) - Cross slope of the pedestrian access route exceeds 1:50.	1991 ADAAG 4.3.7
Existing Condition: 7.4% CS.	2004 ADAAG 403.3
	2007 CBC 1133B.7.1.3
	Other 2005 PROWAG-R301.4.1

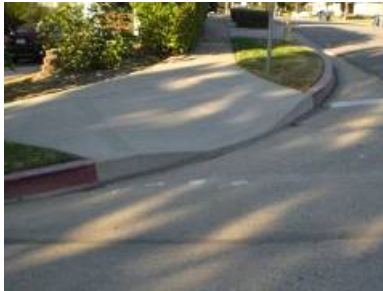
Field Condition	
04.02 - Slope - Slope of the curb ramp exceeds 8.33% (or the least possible compliant slope).	1991 ADAAG 4.7.2; 4.8.2
Existing Condition: 10.8% RS.	2004 ADAAG 405.2; Advisory 405.2
	2007 CBC 1127B.5 item 3
	Other 2005 PROWAG-R303.2.1.1; R303.2.2.1

Corrective Action
120D - Replace Curb Ramp - Remove existing curb ramp, provide new.
Additional Comments:

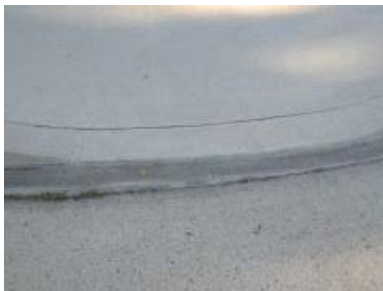
Field Condition	
04.03 - Transition - The transition from the curb ramp to the road or gutter is not flush or free of abrupt changes.	1991 ADAAG 4.7.2
Existing Condition: 1" transition.	2004 ADAAG 406.2; Fig. 406.2
	2007 CBC 1127B.5 item 3
	Other 2005 PROWAG-R301.5.1

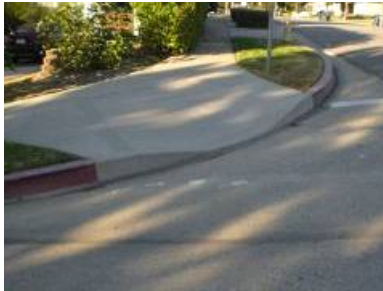
Field Condition	
04.05 - Width - The width of the curb ramp, not including the flared sides, is less than 48".	1991 ADAAG 4.7.3
Existing Condition: 40" wide.	2004 ADAAG 406.1; 405.5
	2007 CBC 1127B.5 item 2
	Other 2005 PROWAG-R303.3.1

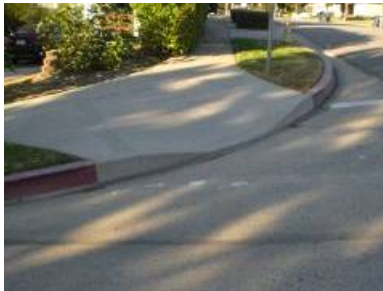
Field Condition	
04.07B - Side Flare Slope (8.33% Max. Requirement) - Where the landing at the top of the ramp is less than 48" deep and wheelchair users must use the side flares for access, the flared sides have a slope greater than 8.33% (measured along the curb).	1991 ADAAG Fig. 12(a)
Existing Condition: 11.1% & 27.4%.	2004 ADAAG 406.3; Fig. 406.3
	2007 CBC 1127B.5 item 4
	Other -

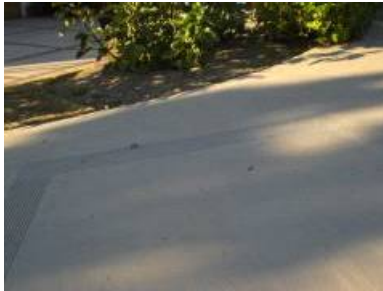
Field Condition	
04.09A - Grooved Border Requirement - Curb ramp does not have a 12" wide grooved border around upper edges of curb ramp and flares to indicate transition from sidewalk to curb ramp.	1991 ADAAG -
Existing Condition: 8 1/2" wide.	2004 ADAAG -
	2007 CBC 1127B.5 item 6
	Other -

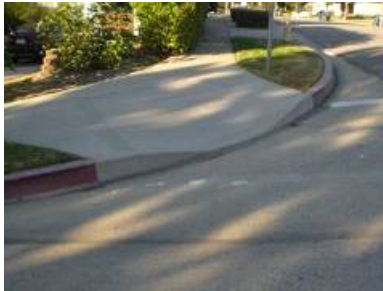
Field Condition	
03A.07A - Cross Slope (PAR) - Cross slope of the pedestrian access route exceeds 1:50.	1991 ADAAG 4.3.7
Existing Condition: 10.8% CS.	2004 ADAAG 403.3
	2007 CBC 1133B.7.1.3
	Other 2005 PROWAG-R301.4.1

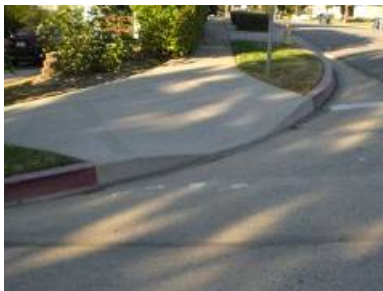
Field Condition	
03A.08 - Running Slope (PAR) - Slope of the pedestrian access route exceeds 1:20. Or slope of the pedestrian access route contained within a street or highway border exceeds the grade of the adjacent roadway. (1:20 requirement does not apply to compliant ramps or where slope of the pedestrian access route contained within a street or highway border does not exceed the grade of the adjacent roadway.)	1991 ADAAG 4.3.7
Existing Condition: 4.8% CS & 11.8% RS.	2004 ADAAG 403.3
	2007 CBC 1133B.7.3
	Other 2005 PROWAG-R301.4.2

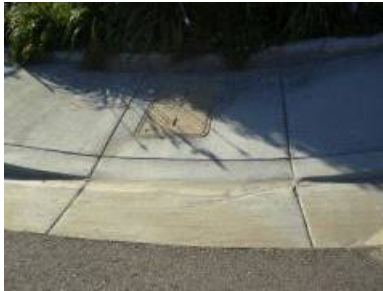
Field Condition	
04.04 - Counter Slope - The running slopes of the road, gutter or accessible route adjoining the ramp exceed 5%.	1991 ADAAG 4.7.2
Existing Condition: 13% counter slope.	2004 ADAAG 406.2
	2007 CBC 1127B.5 item 3
	Other 2005 PROWAG-R303.3.5

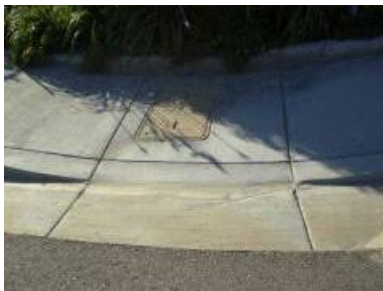
Field Condition	
04.05 - Width - The width of the curb ramp, not including the flared sides, is less than 48".	1991 ADAAG 4.7.3
Existing Condition: 45" wide.	2004 ADAAG 406.1; 405.5
	2007 CBC 1127B.5 item 2
	Other 2005 PROWAG-R303.3.1

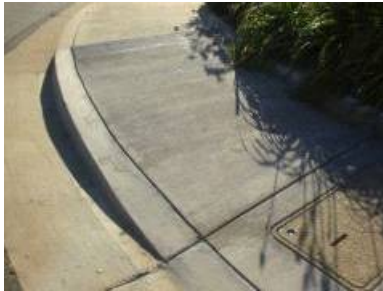
Existing Condition: 13" wide.

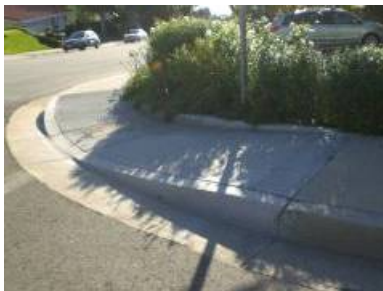
Existing Condition: Not provided.

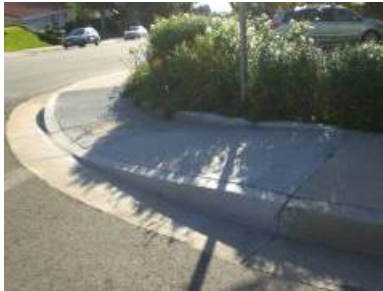
Field Condition	
03A.07A - Cross Slope (PAR) - Cross slope of the pedestrian access route exceeds 1:50.	1991 ADAAG 4.3.7
Existing Condition: 8.9% CS.	2004 ADAAG 403.3
	2007 CBC 1133B.7.1.3
	Other 2005 PROWAG-R301.4.1

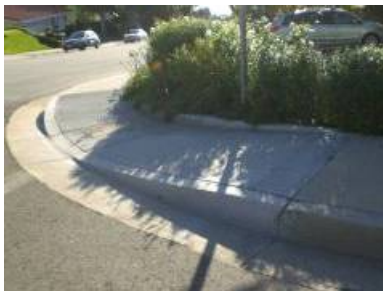
Field Condition	
03A.08 - Running Slope (PAR) - Slope of the pedestrian access route exceeds 1:20. Or slope of the pedestrian access route contained within a street or highway border exceeds the grade of the adjacent roadway. (1:20 requirement does not apply to compliant ramps or where slope of the pedestrian access route contained within a street or highway border does not exceed the grade of the adjacent roadway.)	1991 ADAAG 4.3.7
Existing Condition: 2.1% RS at turning area.	2004 ADAAG 403.3
	2007 CBC 1133B.7.3
	Other 2005 PROWAG-R301.4.2

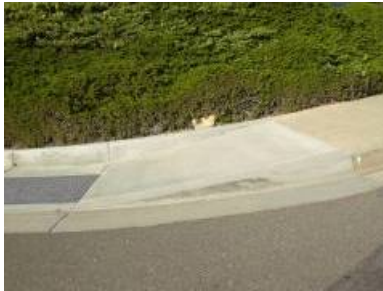
Field Condition	
04.02 - Slope - Slope of the curb ramp exceeds 8.33% (or the least possible compliant slope).	1991 ADAAG 4.7.2; 4.8.2
Existing Condition: 25.2% RS.	2004 ADAAG 405.2; Advisory 405.2
	2007 CBC 1127B.5 item 3
	Other 2005 PROWAG-R303.2.1.1; R303.2.2.1

Corrective Action
120D - Replace Curb Ramp - Remove existing curb ramp, provide new.
Additional Comments:

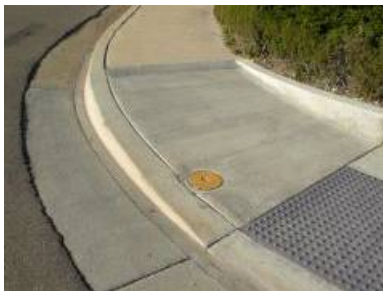
Field Condition	
04.09A - Grooved Border Requirement - Curb ramp does not have a 12" wide grooved border around upper edges of curb ramp and flares to indicate transition from sidewalk to curb ramp.	1991 ADAAG -
Existing Condition: 13" wide.	2004 ADAAG -
	2007 CBC 1127B.5 item 6
	Other -

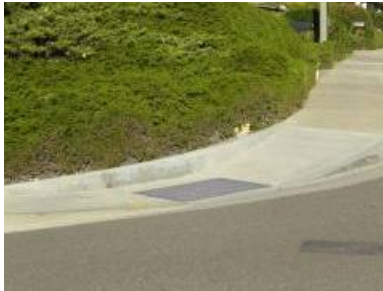
Field Condition	
03A.07A - Cross Slope (PAR) - Cross slope of the pedestrian access route exceeds 1:50.	1991 ADAAG 4.3.7
Existing Condition: 14.1% CS.	2004 ADAAG 403.3
	2007 CBC 1133B.7.1.3
	Other 2005 PROWAG-R301.4.1

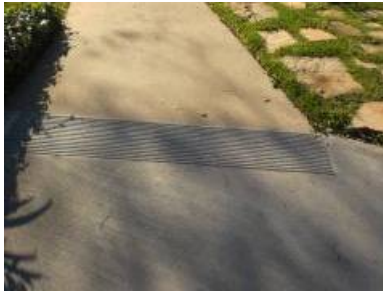
Field Condition	
04.09A - Grooved Border Requirement - Curb ramp does not have a 12" wide grooved border around upper edges of curb ramp and flares to indicate transition from sidewalk to curb ramp.	1991 ADAAG -
Existing Condition: 13" wide.	2004 ADAAG -
	2007 CBC 1127B.5 item 6
	Other -

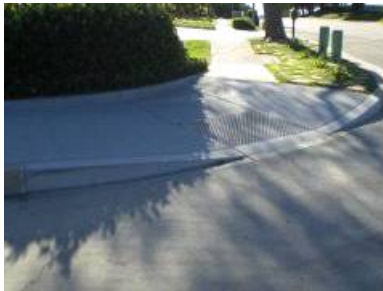
Field Condition	
03A.07A - Cross Slope (PAR) - Cross slope of the pedestrian access route exceeds 1:50.	1991 ADAAG 4.3.7
Existing Condition: 6.8% CS.	2004 ADAAG 403.3
	2007 CBC 1133B.7.1.3
	Other 2005 PROWAG-R301.4.1

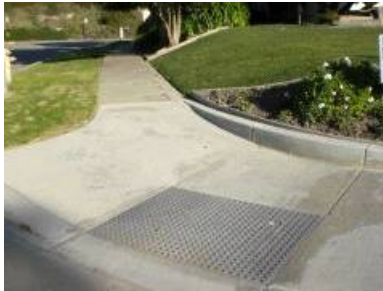
Field Condition	
04.02 - Slope - Slope of the curb ramp exceeds 8.33% (or the least possible compliant slope).	1991 ADAAG 4.7.2; 4.8.2
Existing Condition: 11.4% RS.	2004 ADAAG 405.2; Advisory 405.2
	2007 CBC 1127B.5 item 3
	Other 2005 PROWAG-R303.2.1.1; R303.2.2.1

Corrective Action
120D - Replace Curb Ramp - Remove existing curb ramp, provide new.
Additional Comments:

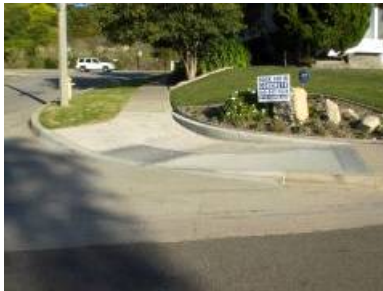
Field Condition	
04.07B - Side Flare Slope (8.33% Max. Requirement) - Where the landing at the top of the ramp is less than 48" deep and wheelchair users must use the side flares for access, the flared sides have a slope greater than 8.33% (measured along the curb).	1991 ADAAG Fig. 12(a)
Existing Condition: 10.4% RS.	2004 ADAAG 406.3; Fig. 406.3
	2007 CBC 1127B.5 item 4
	Other -

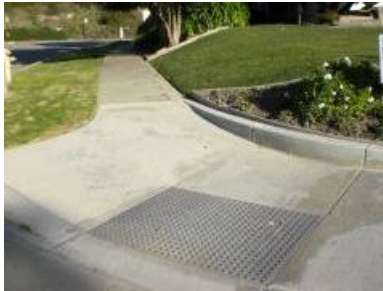
Field Condition	
04.09A - Grooved Border Requirement - Curb ramp does not have a 12" wide grooved border around upper edges of curb ramp and flares to indicate transition from sidewalk to curb ramp.	1991 ADAAG -
Existing Condition: 13" wide.	2004 ADAAG -
	2007 CBC 1127B.5 item 6
	Other -

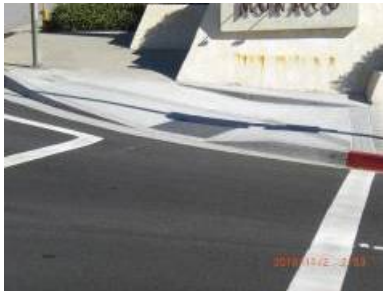
Field Condition	
04.04 - Counter Slope - The running slopes of the road, gutter or accessible route adjoining the ramp exceed 5%.	1991 ADAAG 4.7.2
Existing Condition: 6.6% counter slope.	2004 ADAAG 406.2
	2007 CBC 1127B.5 item 3
	Other 2005 PROWAG-R303.3.5

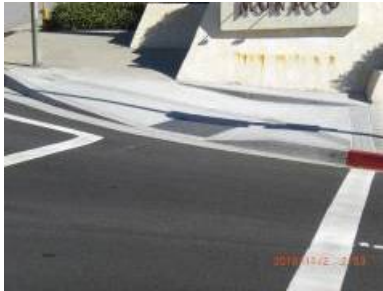
Field Condition	
04.07B - Side Flare Slope (8.33% Max. Requirement) - Where the landing at the top of the ramp is less than 48" deep and wheelchair users must use the side flares for access, the flared sides have a slope greater than 8.33% (measured along the curb). Existing Condition: 13.2% RS.	1991 ADAAG Fig. 12(a) 2004 ADAAG 406.3; Fig. 406.3 2007 CBC 1127B.5 item 4 Other -

Corrective Action	
120D - Replace Curb Ramp - Remove existing curb ramp, provide new.	
Additional Comments:

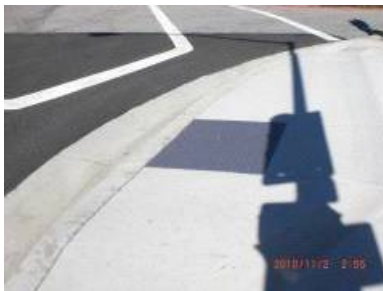
Field Condition	
03A.07A - Cross Slope (PAR) - Cross slope of the pedestrian access route exceeds 1:50. Existing Condition: 6.4% RS.	1991 ADAAG 4.3.7 2004 ADAAG 403.3 2007 CBC 1133B.7.1.3 Other 2005 PROWAG-R301.4.1

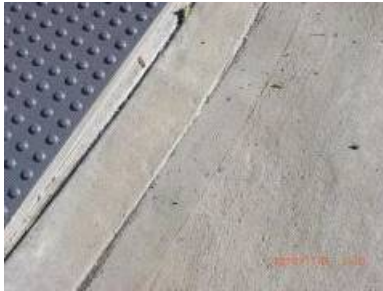
Field Condition	
04.03 - Transition - The transition from the curb ramp to the road or gutter is not flush or free of abrupt changes.	1991 ADAAG 4.7.2
Existing Condition: 1/4" transition.	2004 ADAAG 406.2; Fig. 406.2
	2007 CBC 1127B.5 item 3
	Other 2005 PROWAG-R301.5.1

Corrective Action	
120D - Replace Curb Ramp - Remove existing curb ramp, provide new.	
Additional Comments:

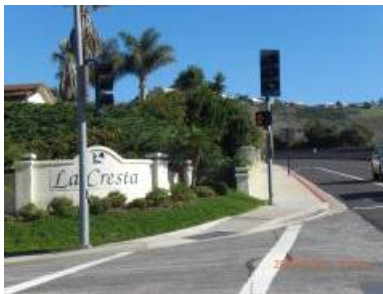
Field Condition	
04.04 - Counter Slope - The running slopes of the road, gutter or accessible route adjoining the ramp exceed 5%.	1991 ADAAG 4.7.2
Existing Condition: 12.2% counter slope.	2004 ADAAG 406.2
	2007 CBC 1127B.5 item 3
	Other 2005 PROWAG-R303.3.5

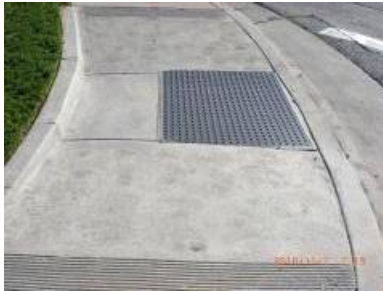
Field Condition	
04.05 - Width - The width of the curb ramp, not including the flared sides, is less than 48".	1991 ADAAG 4.7.3
Existing Condition: 41" wide.	2004 ADAAG 406.1; 405.5
	2007 CBC 1127B.5 item 2
	Other 2005 PROWAG-R303.3.1

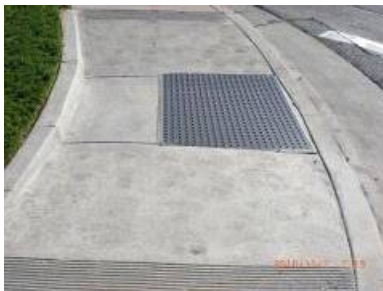
Field Condition	
04.09A - Grooved Border Requirement - Curb ramp does not have a 12" wide grooved border around upper edges of curb ramp and flares to indicate transition from sidewalk to curb ramp.	1991 ADAAG -
Existing Condition: 11" & 11 1/2" wide.	2004 ADAAG -
	2007 CBC 1127B.5 item 6
	Other -

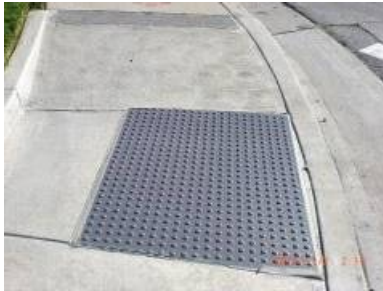
Field Condition	
04.07B - Side Flare Slope (8.33% Max. Requirement) - Where the landing at the top of the ramp is less than 48" deep and wheelchair users must use the side flares for access, the flared sides have a slope greater than 8.33% (measured along the curb). Existing Condition: 27.3% RS.	1991 ADAAG Fig. 12(a) 2004 ADAAG 406.3; Fig. 406.3 2007 CBC 1127B.5 item 4 Other -

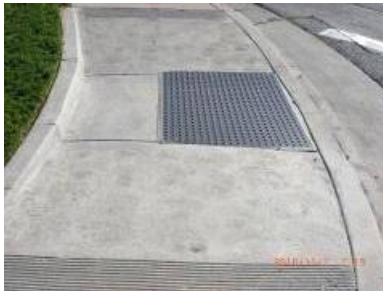
Field Condition	
03A.07A - Cross Slope (PAR) - Cross slope of the pedestrian access route exceeds 1:50. Existing Condition: 12.1% CS.	1991 ADAAG 4.3.7 2004 ADAAG 403.3 2007 CBC 1133B.7.1.3 Other 2005 PROWAG-R301.4.1

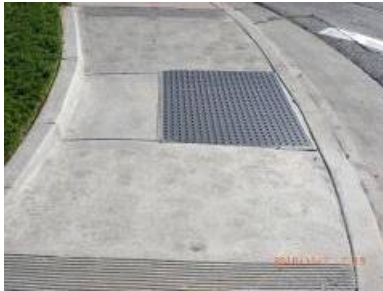
Field Condition	
03A.08 - Running Slope (PAR) - Slope of the pedestrian access route exceeds 1:20. Or slope of the pedestrian access route contained within a street or highway border exceeds the grade of the adjacent roadway. (1:20 requirement does not apply to compliant ramps or where slope of the pedestrian access route contained within a street or highway border does not exceed the grade of the adjacent roadway.)	1991 ADAAG 4.3.7 2004 ADAAG 403.3 2007 CBC 1133B.7.3 Other 2005 PROWAG-R301.4.2
Existing Condition: 8.9% RS.

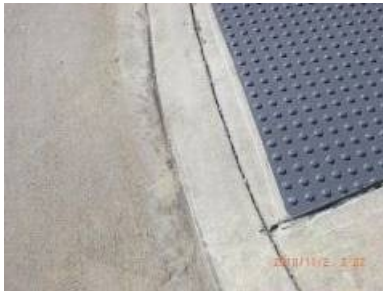
Field Condition	
04.03 - Transition - The transition from the curb ramp to the road or gutter is not flush or free of abrupt changes.	1991 ADAAG 4.7.2 2004 ADAAG 406.2; Fig. 406.2 2007 CBC 1127B.5 item 3 Other 2005 PROWAG-R301.5.1
Existing Condition: 1/4" transition.

Corrective Action
120D - Replace Curb Ramp - Remove existing curb ramp, provide new.
Additional Comments:

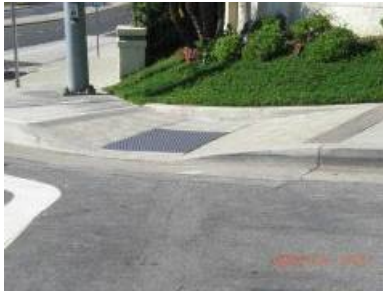
Field Condition	
04.04 - Counter Slope - The running slopes of the road, gutter or accessible route adjoining the ramp exceed 5%.	1991 ADAAG 4.7.2
Existing Condition: 11.2% CS.	2004 ADAAG 406.2
	2007 CBC 1127B.5 item 3
	Other 2005 PROWAG-R303.3.5

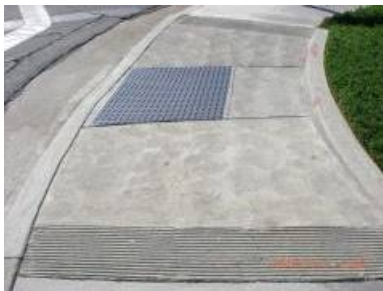
Field Condition	
04.05 - Width - The width of the curb ramp, not including the flared sides, is less than 48".	1991 ADAAG 4.7.3
Existing Condition: 41" wide.	2004 ADAAG 406.1; 405.5
	2007 CBC 1127B.5 item 2
	Other 2005 PROWAG-R303.3.1

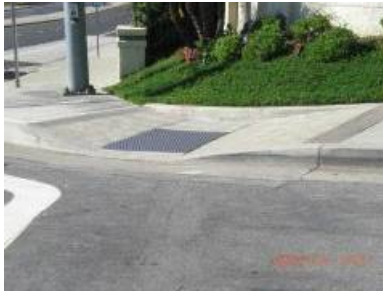
Field Condition	
04.07B - Side Flare Slope (8.33% Max. Requirement) - Where the landing at the top of the ramp is less than 48" deep and wheelchair users must use the side flares for access, the flared sides have a slope greater than 8.33% (measured along the curb). Existing Condition: 22.3% RS.	1991 ADAAG Fig. 12(a) 2004 ADAAG 406.3; Fig. 406.3 2007 CBC 1127B.5 item 4 Other -

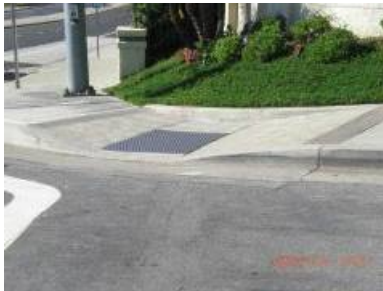
Field Condition	
03A.07A - Cross Slope (PAR) - Cross slope of the pedestrian access route exceeds 1:50. Existing Condition: 13.7% CS.	1991 ADAAG 4.3.7 2004 ADAAG 403.3 2007 CBC 1133B.7.1.3 Other 2005 PROWAG-R301.4.1

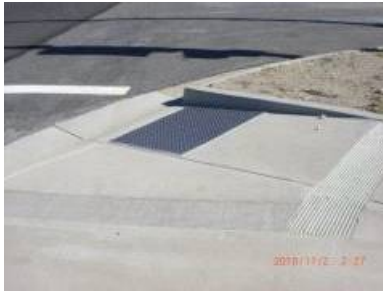
Field Condition	
04.04 - Counter Slope - The running slopes of the road, gutter or accessible route adjoining the ramp exceed 5%.	1991 ADAAG 4.7.2
Existing Condition: 9.7% counter slope.	2004 ADAAG 406.2
	2007 CBC 1127B.5 item 3
	Other 2005 PROWAG-R303.3.5

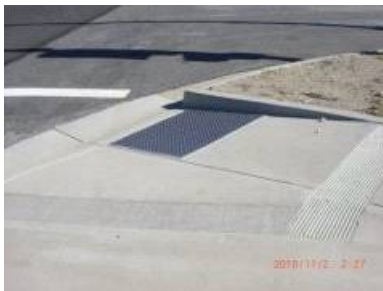
Field Condition	
04.09A - Grooved Border Requirement - Curb ramp does not have a 12" wide grooved border around upper edges of curb ramp and flares to indicate transition from sidewalk to curb ramp.	1991 ADAAG -
Existing Condition: 11" wide.	2004 ADAAG -
	2007 CBC 1127B.5 item 6
	Other -

Corrective Action	
120D - Replace Curb Ramp - Remove existing curb ramp, provide new.	
Additional Comments:

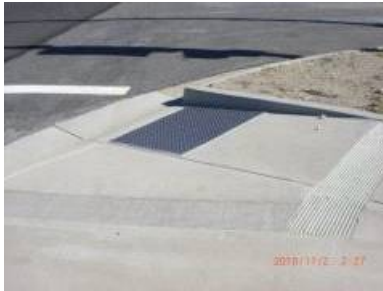
Field Condition	
03A.07A - Cross Slope (PAR) - Cross slope of the pedestrian access route exceeds 1:50.	1991 ADAAG 4.3.7
Existing Condition: 8% CS.	2004 ADAAG 403.3
	2007 CBC 1133B.7.1.3
	Other 2005 PROWAG-R301.4.1

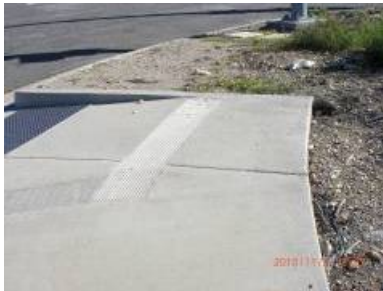
Field Condition	
04.40 - Other - Curb Ramps and Pedestrian Crossings - See Additional Comments	1991 ADAAG -
Existing Condition: 35" deep landing.	2004 ADAAG -
	2007 CBC -
	Other -

Corrective Action
008 - Concrete Landing - Remove non-compliant pavement and replace with new concrete. The landing slope shall not exceed 2% in any direction.
Additional Comments:

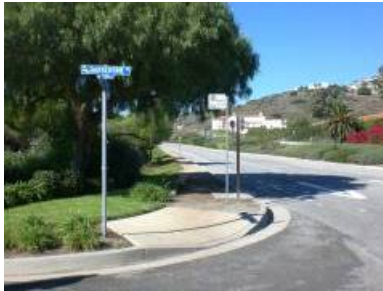
Field Condition	
04.03 - Transition - The transition from the curb ramp to the road or gutter is not flush or free of abrupt changes.	1991 ADAAG 4.7.2
Existing Condition: 1" transition.	2004 ADAAG 406.2; Fig. 406.2
	2007 CBC 1127B.5 item 3
	Other 2005 PROWAG-R301.5.1

Corrective Action	
120D - Replace Curb Ramp - Remove existing curb ramp, provide new.	
Additional Comments:

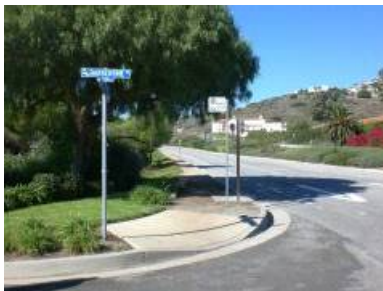
Field Condition	
04.05 - Width - The width of the curb ramp, not including the flared sides, is less than 48".	1991 ADAAG 4.7.3
Existing Condition: 32" wide.	2004 ADAAG 406.1; 405.5
	2007 CBC 1127B.5 item 2
	Other 2005 PROWAG-R303.3.1

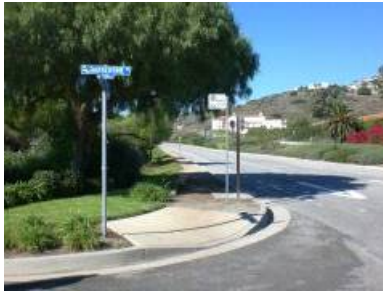
Existing Condition: Top landing not provided.

008 - Concrete Landing - Remove non-compliant pavement and replace with new concrete. The landing slope shall not exceed 2% in any direction.

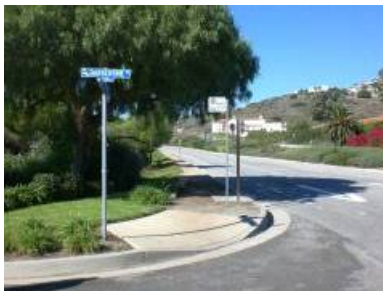
Existing Condition: Not provided.

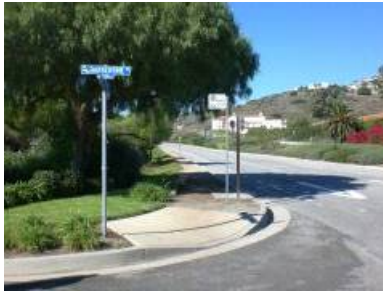
Field Condition	04.09A - Grooved Border Requirement - Curb ramp does not have a 12" wide grooved border around upper edges of curb ramp and flares to indicate transition from sidewalk to curb ramp.	1991 ADAAG -
	Existing Condition: Not provided.	2004 ADAAG -
		2007 CBC 1127B.5 item 6
		Other -

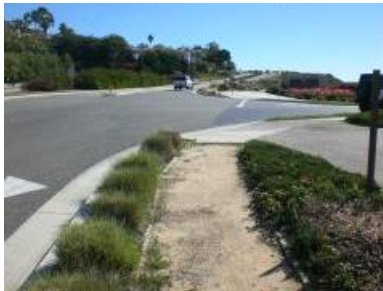
Field Condition	04.05 - Width - The width of the curb ramp, not including the flared sides, is less than 48".	1991 ADAAG 4.7.3
	Existing Condition: 45 1/2" wide.	2004 ADAAG 406.1; 405.5
		2007 CBC 1127B.5 item 2
		Other 2005 PROWAG-R303.3.1

Corrective Action	120D - Replace Curb Ramp - Remove existing curb ramp, provide new.
	Additional Comments:

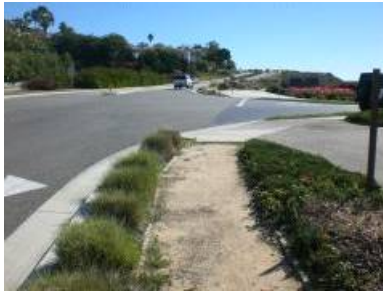
Field Condition	
04.09A - Grooved Border Requirement - Curb ramp does not have a 12" wide grooved border around upper edges of curb ramp and flares to indicate transition from sidewalk to curb ramp.	1991 ADAAG -
Existing Condition: Not provided.	2004 ADAAG -
	2007 CBC 1127B.5 item 6
	Other -

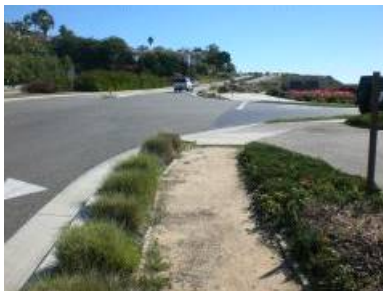
Field Condition	
04.10 - Detectable Warning Requirement - Regardless of slope, the curb ramp does not have a detectable warning.	1991 ADAAG 4.7.7; 4.29.2
Existing Condition: Not provided around entire curb ramp.	2004 ADAAG 705.1; Fig. 705.1
	2007 CBC 1127B.5 item 7
	Other 2005 PROWAG-R303.3.2

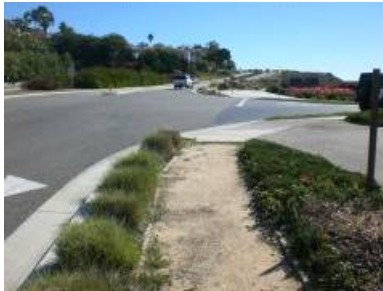
Field Condition	
04.40 - Other - Curb Ramps and Pedestrian Crossings - See Additional Comments	1991 ADAAG -
Existing Condition: 2" change in level at decomposed granite pathway.	2004 ADAAG -
	2007 CBC -
	Other -

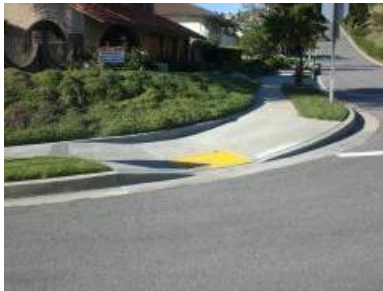
Field Condition	
04.02 - Slope - Slope of the curb ramp exceeds 8.33% (or the least possible compliant slope).	1991 ADAAG 4.7.2; 4.8.2
Existing Condition: 11.9% and 13% RS.	2004 ADAAG 405.2; Advisory 405.2
	2007 CBC 1127B.5 item 3
	Other 2005 PROWAG-R303.2.1.1; R303.2.2.1

Corrective Action
120D - Replace Curb Ramp - Remove existing curb ramp, provide new.
Additional Comments:
