June 14, 2016

F.N. 1-15-0591

**Subject:** Structural Evaluation No. 2 Pedestrian Bridge No. 10  
Trump National Golf Course, La Rotunda Canyon, Rancho Palos Verdes,  
California

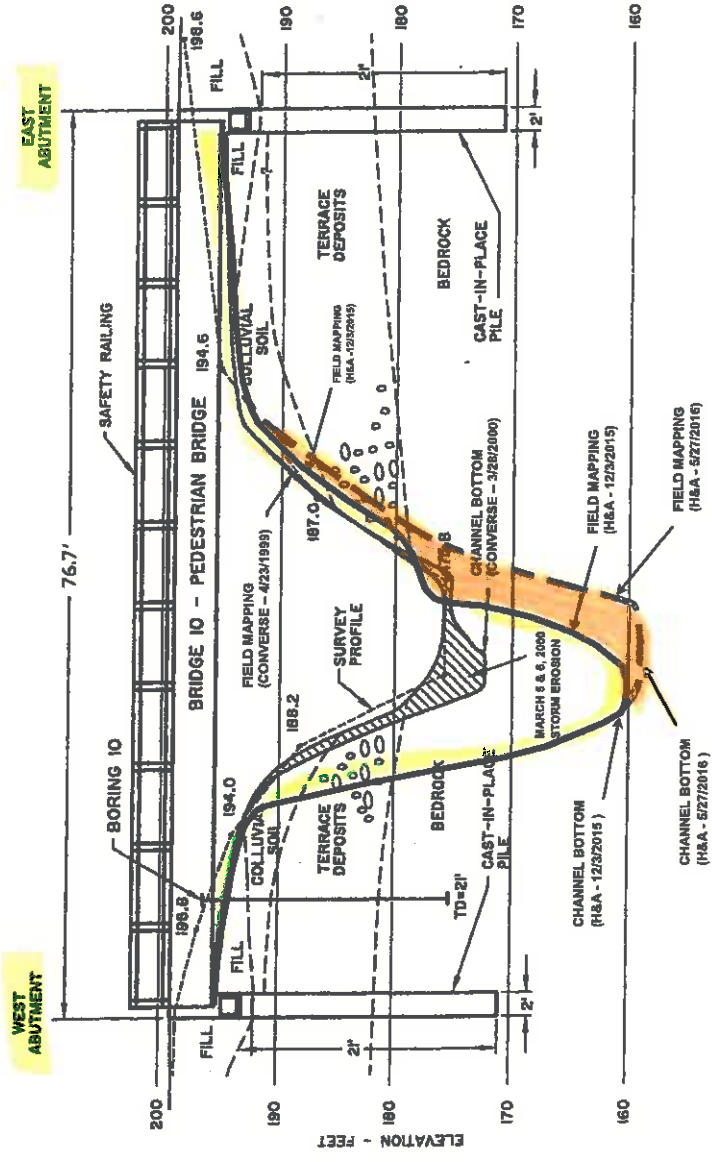
PLATE 1

From our review of the referenced Hamilton & Associates report, we noted that their Cross Section of Pedestrian Bridge No. 10 which was updated on May 2016 on Plate 1 indicates that the Channel Bottom has deepened approximately 1 foot and widened approximately 3 feet toward the East Abutment since their prior profile measurement. No changes in the Channel profile toward the closer West Abutment is illustrated in their report.

*It appears that the only change that has occurred at this bridge since our initial site visit on November 12, 2015 has been the profile of the exposed Canyon bottom directly beneath as recorded and measured by Hamilton & Associates.*

It is our recommendation that efforts be considered to reduce the amount of erosion which may cause future structural instability to the abutment foundations. This may involve collecting upstream runoff by installing a buried storm drain pipe to reduce the amount of water that can erode the Channel and/or to protect the Channel with reinforced concrete bottom and walls.

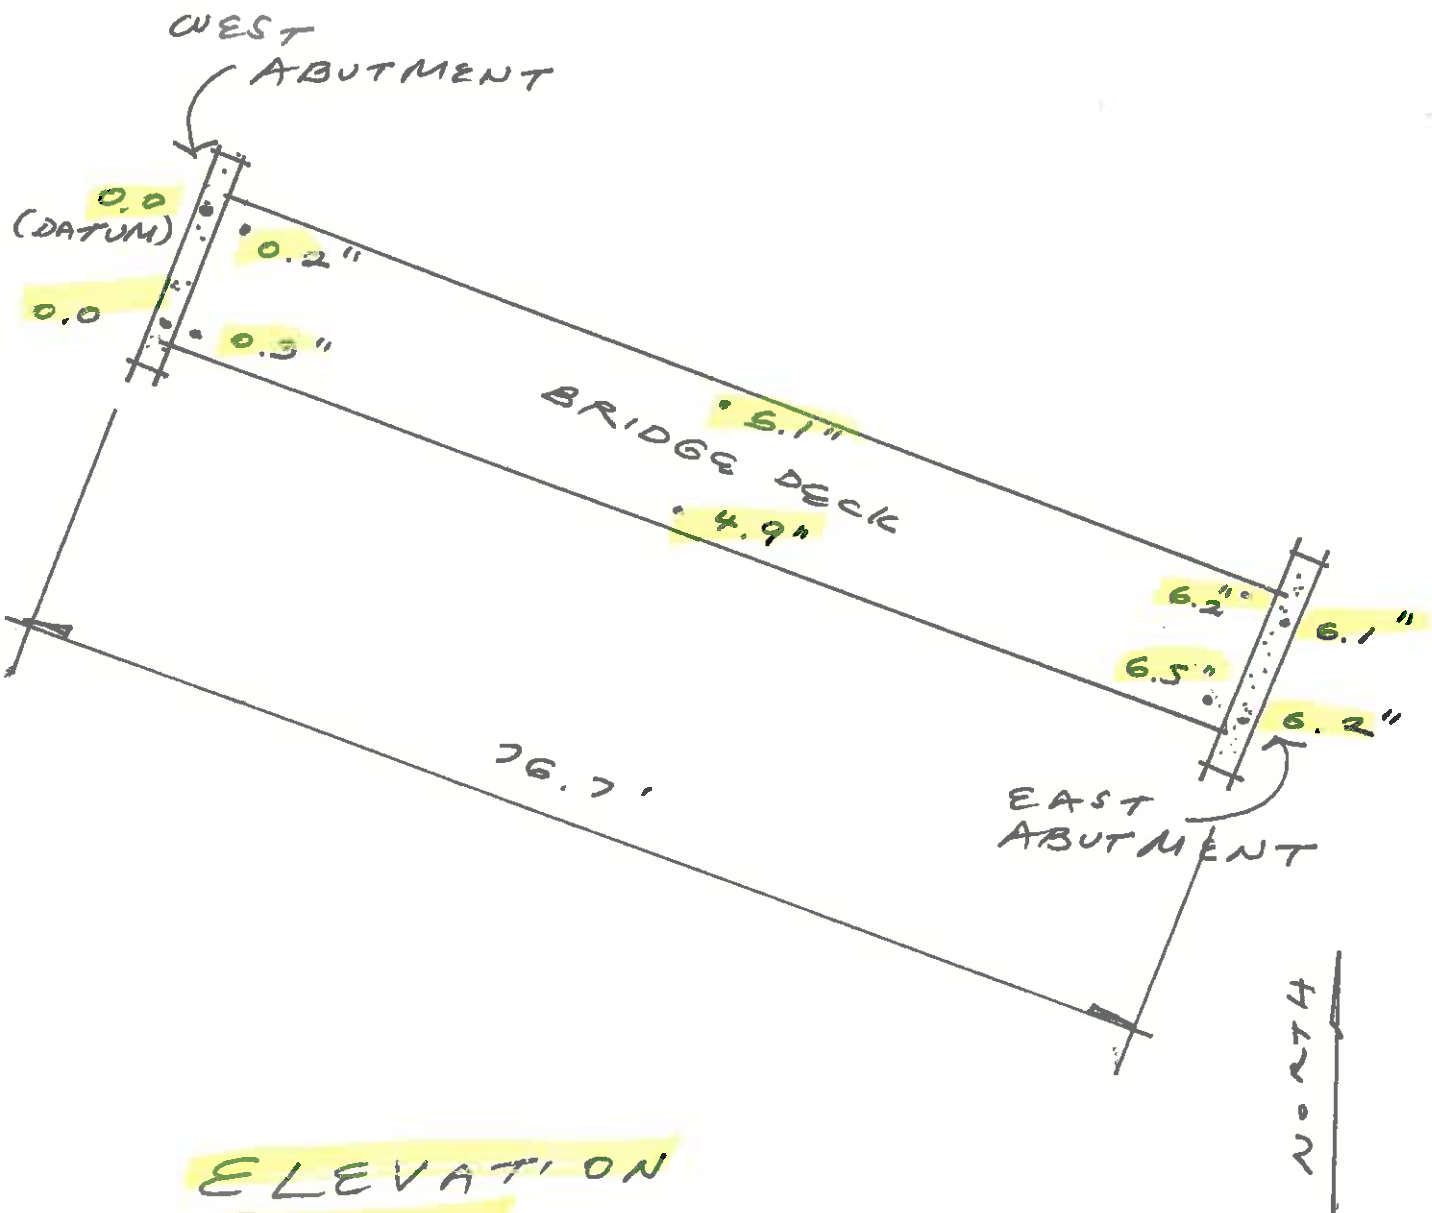
EXHIBIT B

We performed a second manometer survey of the Pedestrian Bridge No. 10 and found no deviations to the deck elevations from our initial survey performed on November 12, 2015 as depicted on Photographs 1 & 4, and Exhibit B.

It is our opinion that the structural condition of Pedestrian Bridge No. 10 has not changed since our initial inspection on November 12, 2015. Our second manometer survey revealed no noticeable changes in the bridge deck elevations as compared to our initial survey conducted on November 12, 2015.

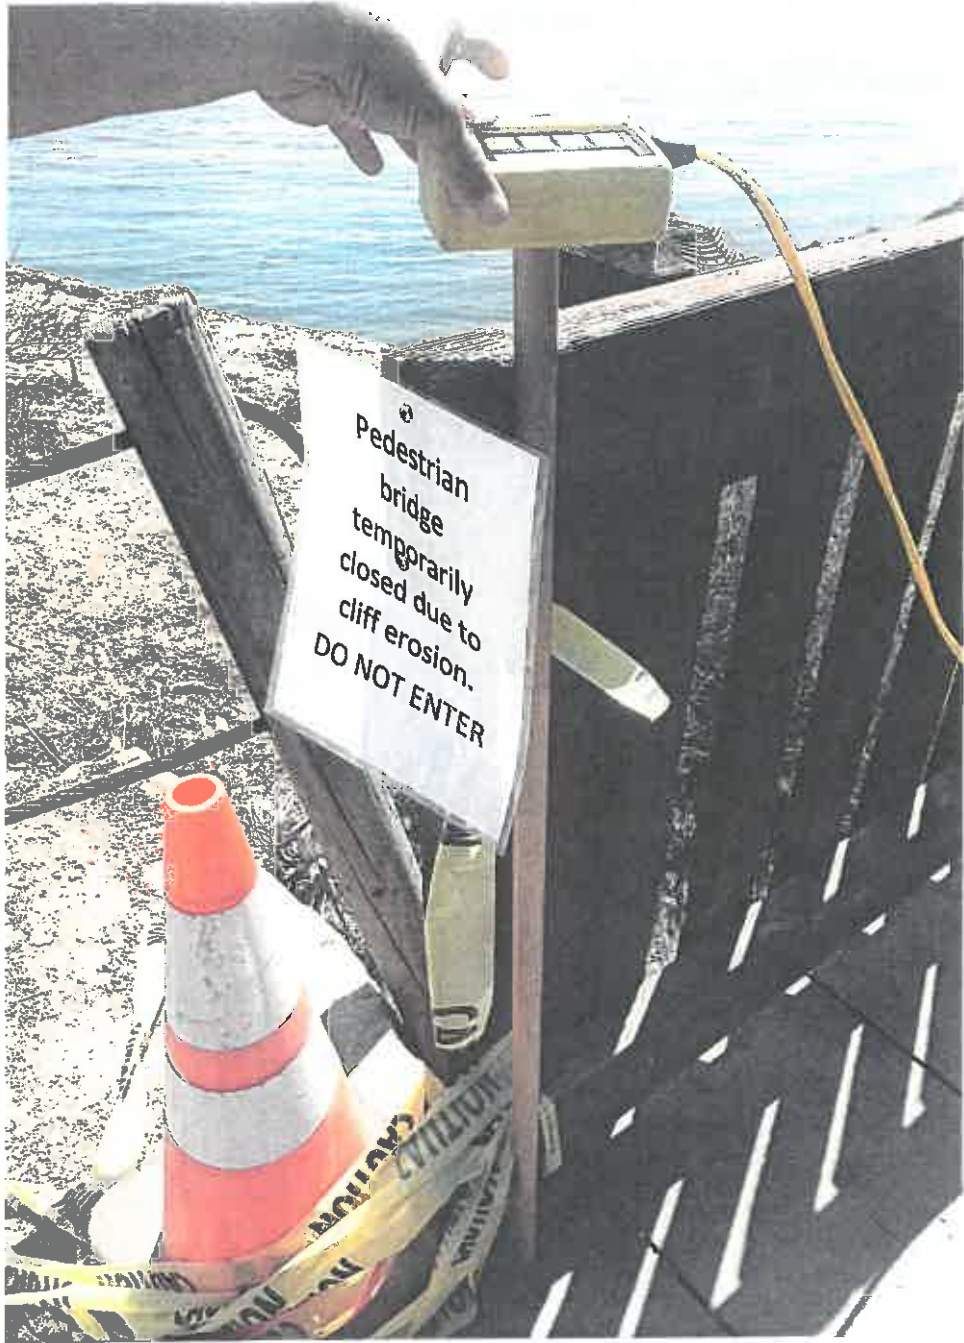
1 VIEW OF MANOMETER SURVEY TO VERIFY ELEVATION READINGS TAKEN FROM PRIOR SURVEY ON NOVEMBER 12, 2015

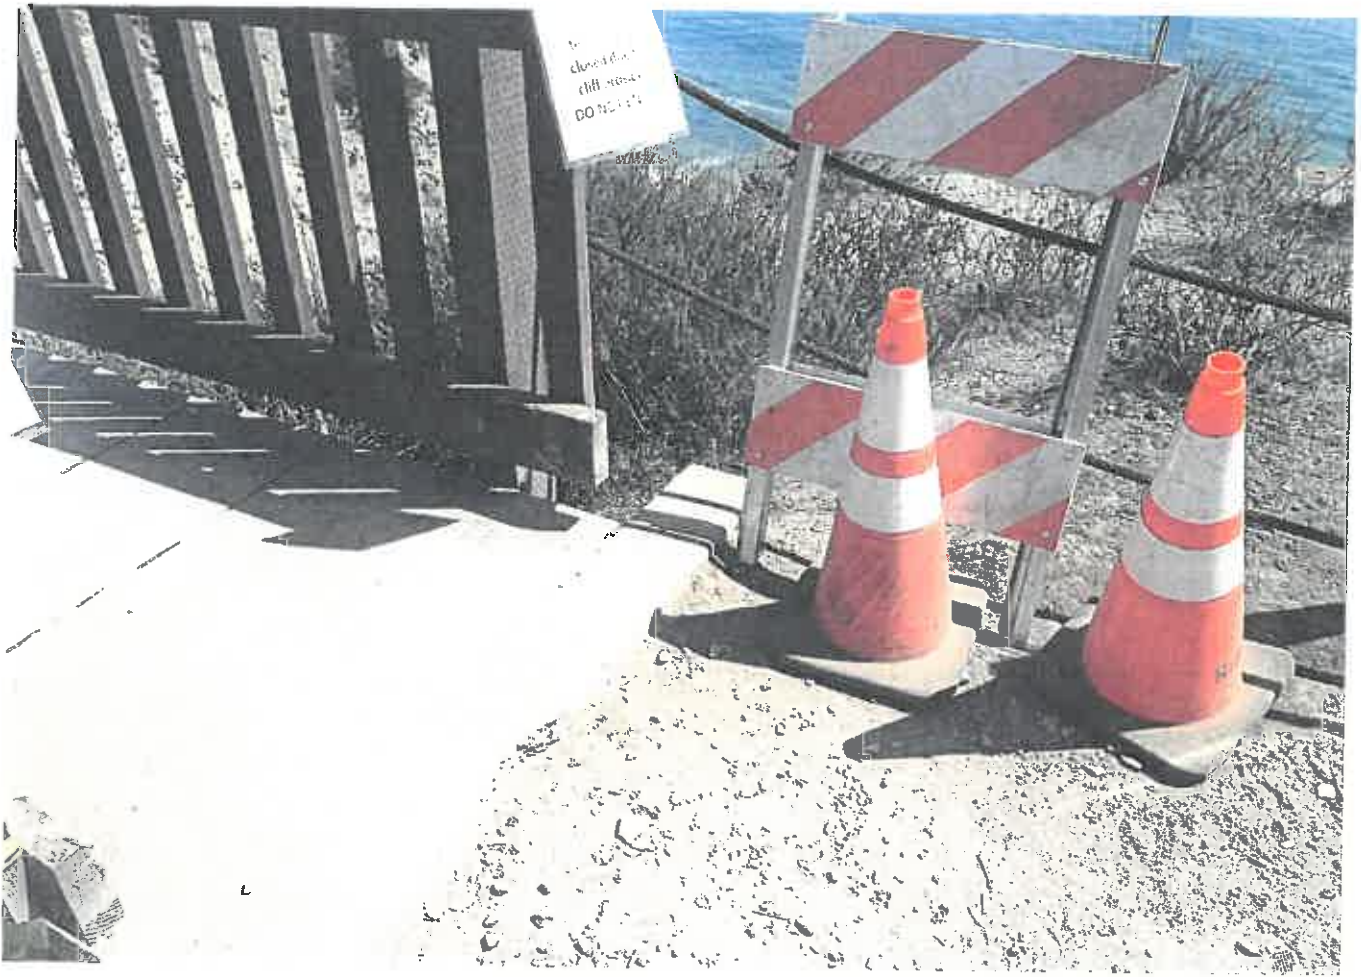
Both East and West concrete abutments were examined as shown on Photographs 2 & 3 and we detected no signs of cracking or separation from the adjoining two-primary glu-laminated girders as depicted on Photographs 5 & 6. From our visual examination of the structural elements that comprise the construction of Pedestrian Bridge No. 10, we observed no evidence of structural distress.

3 VIEW OF WEST ABUTMENT

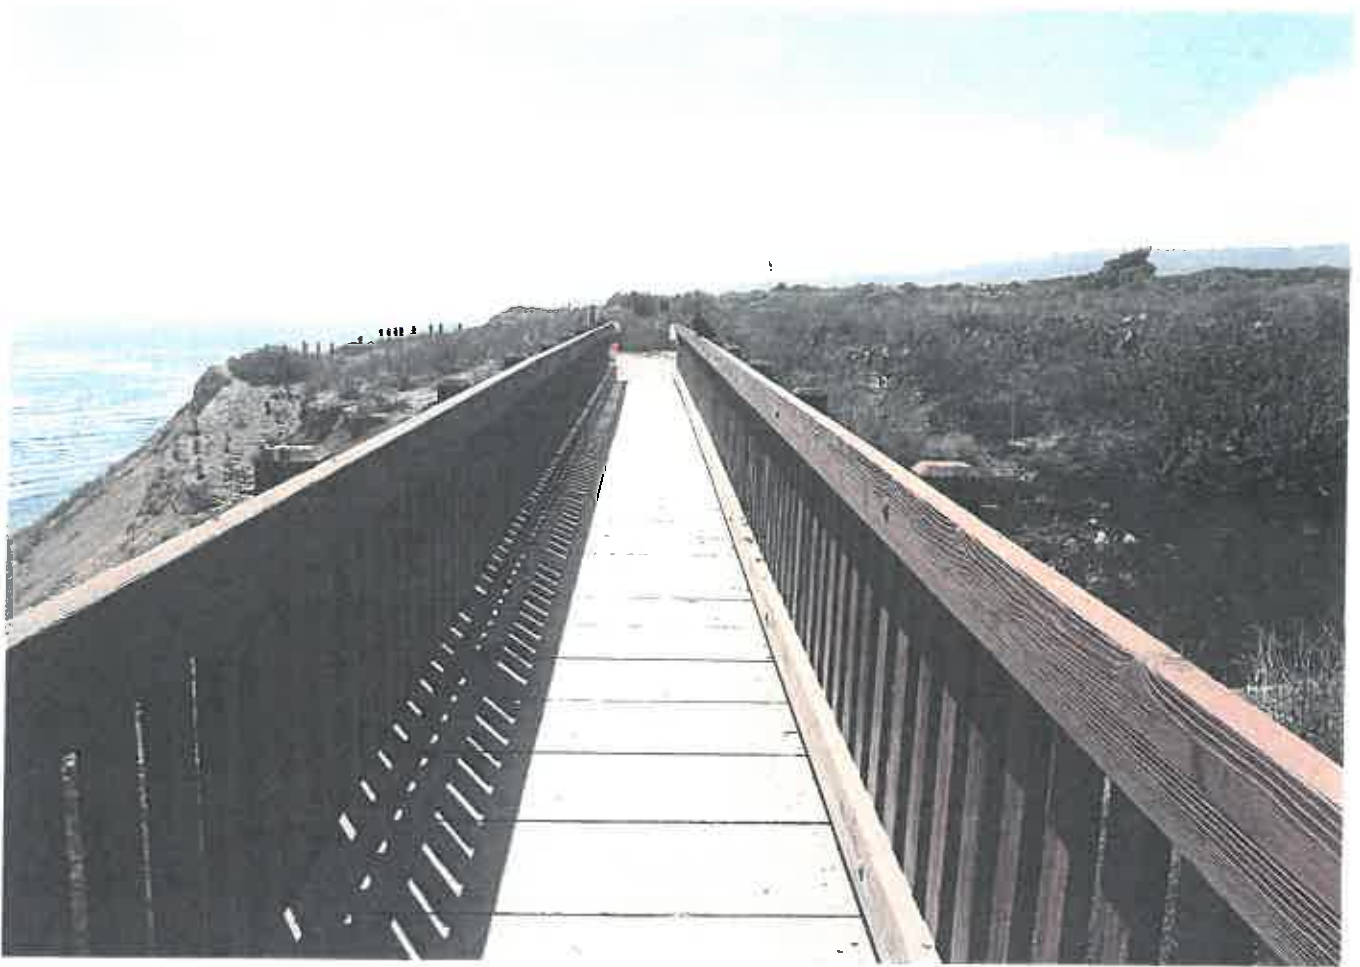
4 VIEW OF BRIDGE NO. 10  
DECK SURFACE TOWARD THE  
WEST ABUTMENT

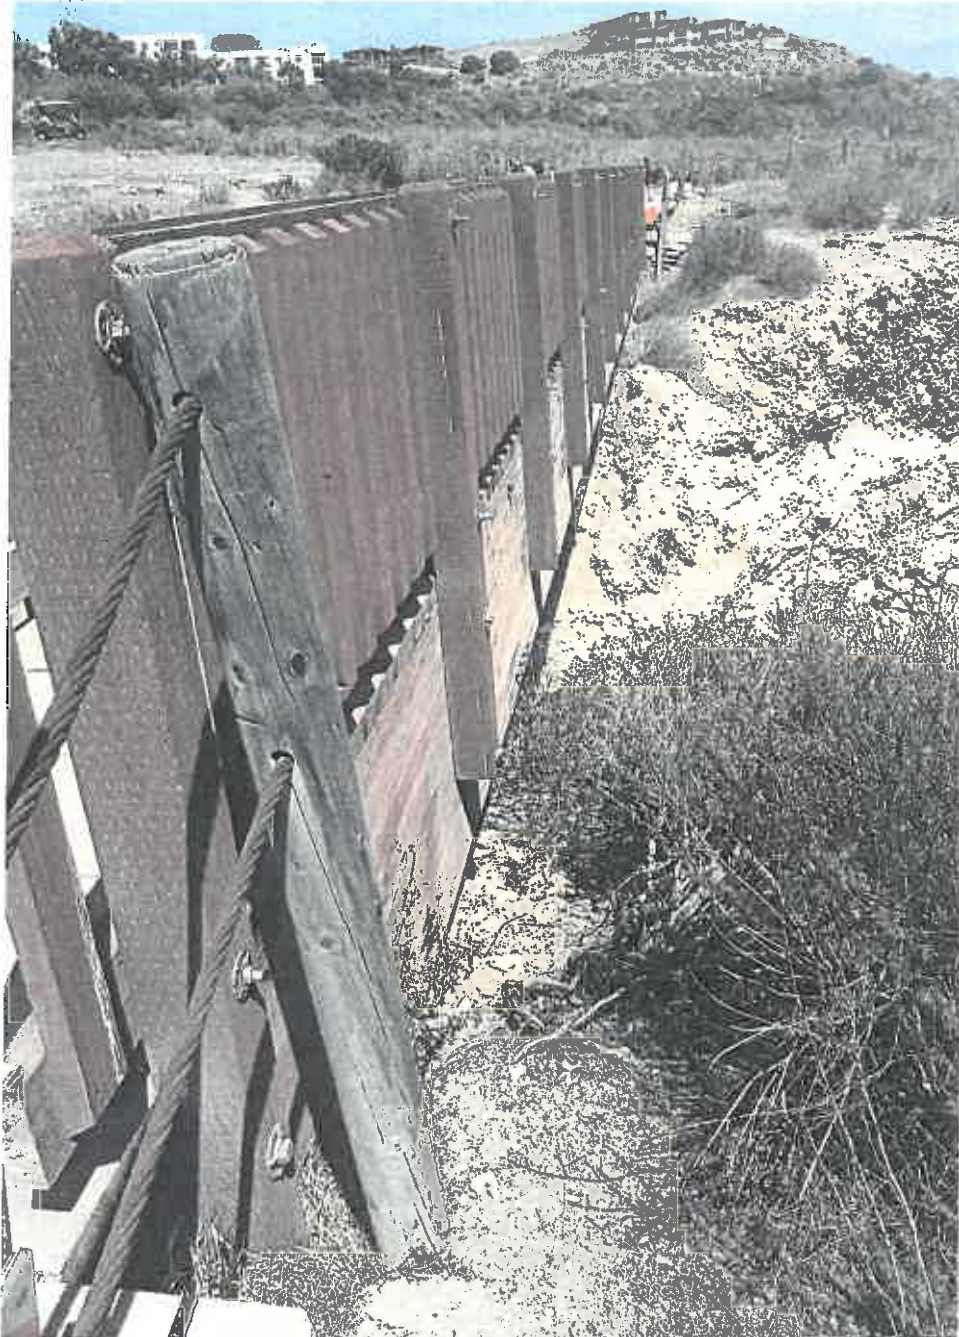
S VIEW OF BRIDGE NO. 10 GIRDER  
TOWARD THE EAST (SOUTH)  
ABUTMENT

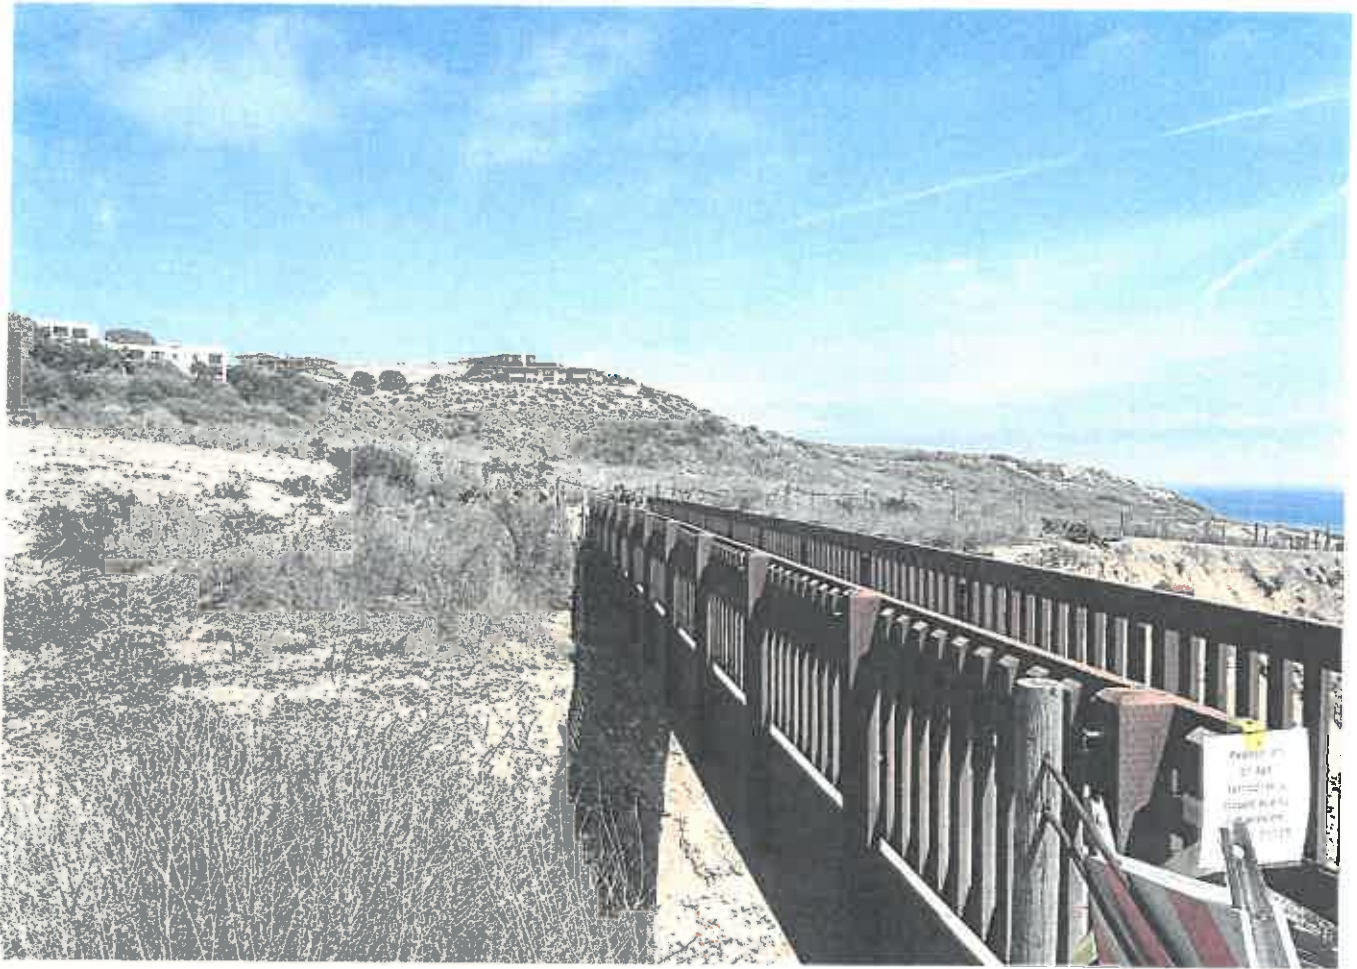
6 VIEW OF BRIDGE NO. 10 GIRDER  
TOWARD THE EAST ABUTMENT  
(NORTH)

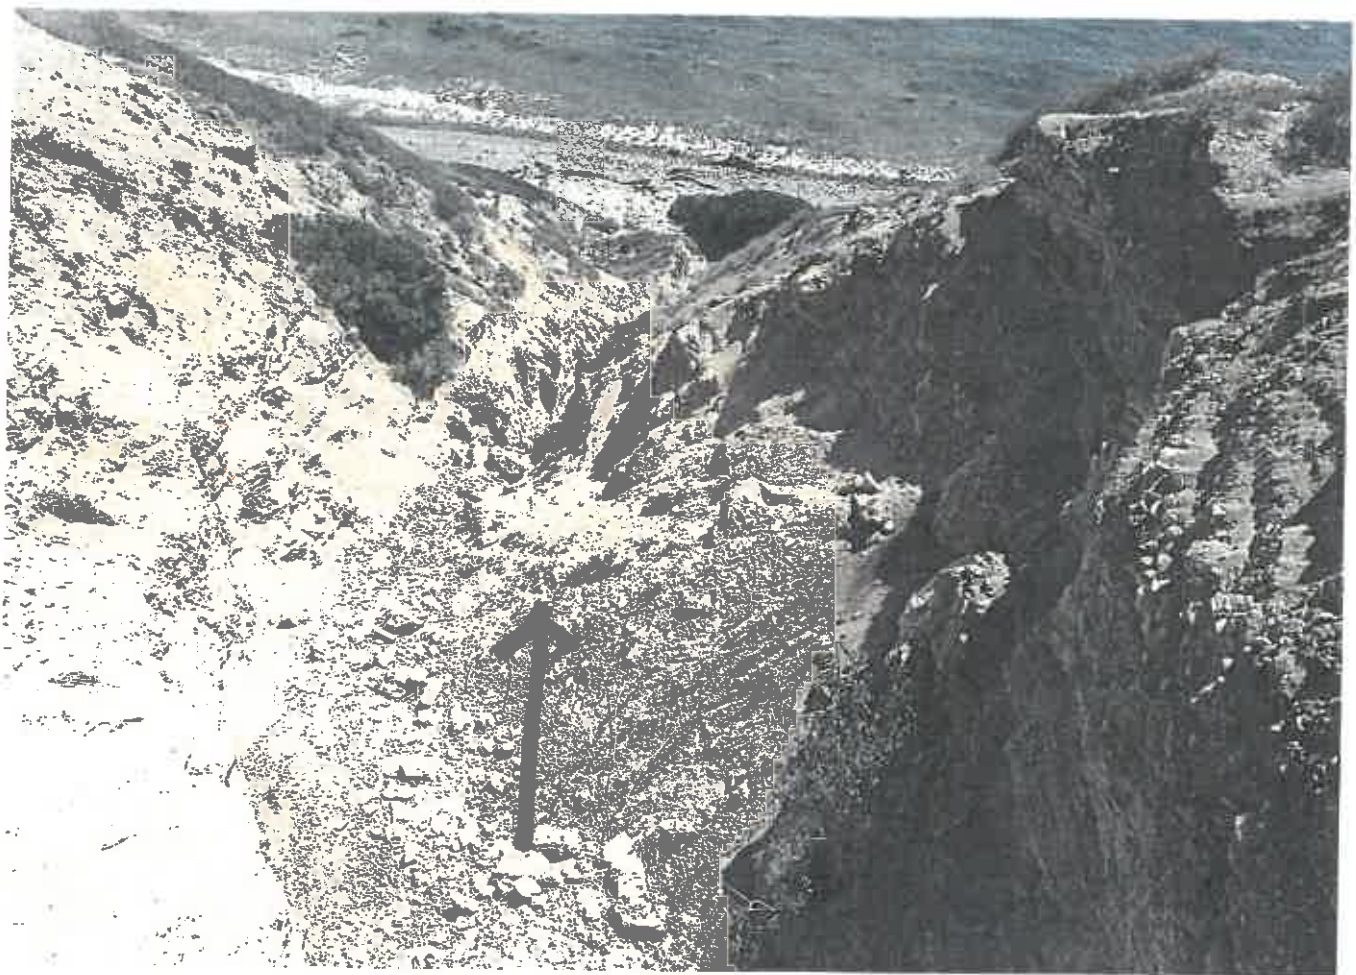
A view of the Channel directly south of the Pedestrian Bridge No. 10 is represented on Photograph 8 where we observed evidence of surficial erosion as surface runoff is directed toward the Ocean.

8 NOTICEABLE SURFICIAL  
EROSION OF CANYON SURFACE  
& WALLS SOUTH OF  
PEDESTRIAN BRIDGE NO. 10

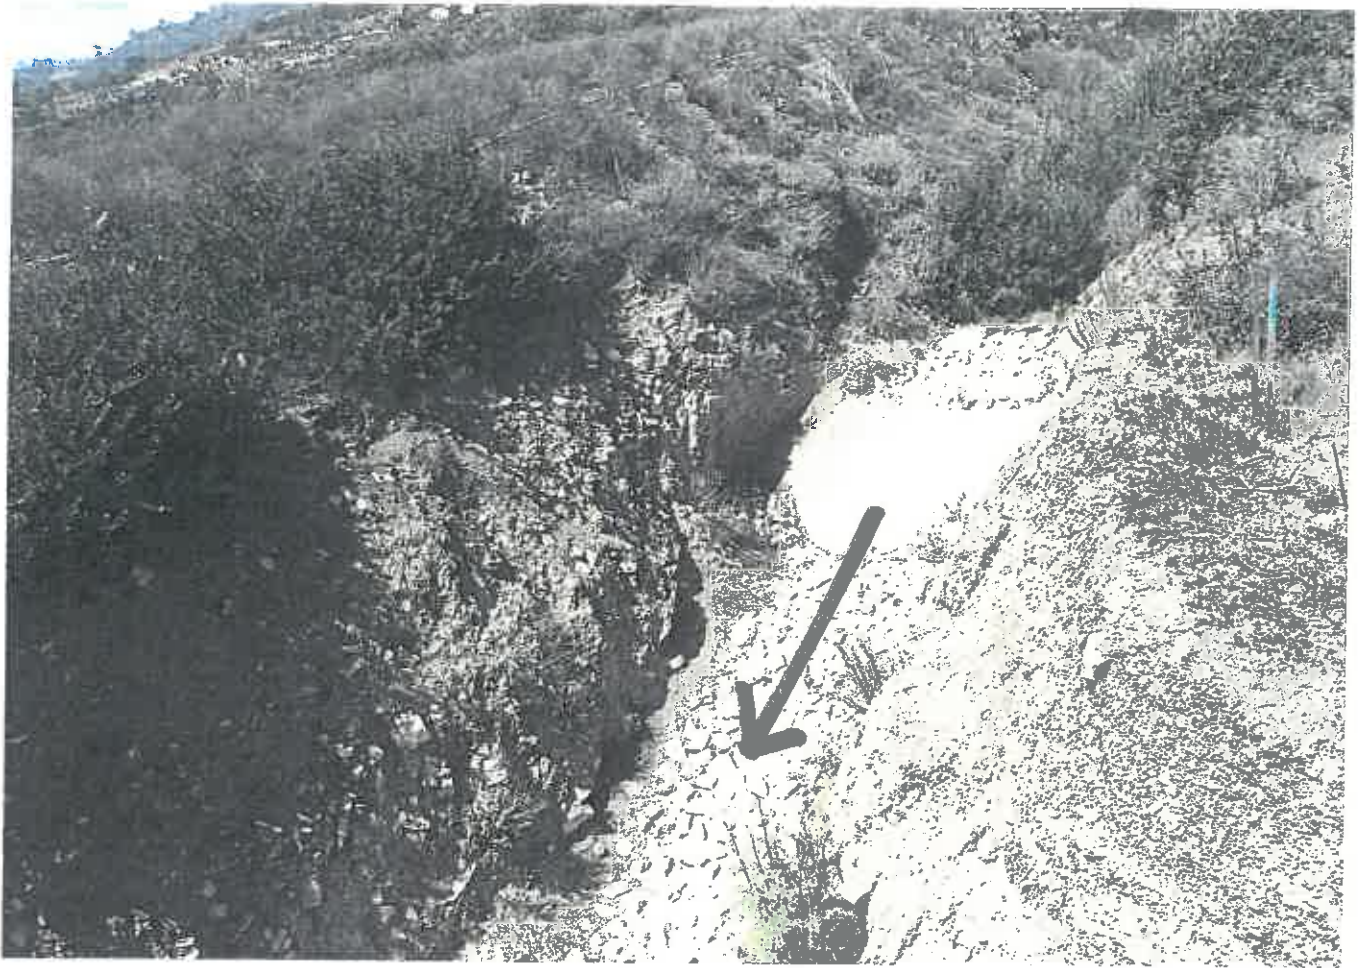
A view of the Channel directly north of Pedestrian Bridge No. 10 is represented on Photograph 7 where surface runoff is allowed to erode the soil walls on either side.

CANYON TO THE NORTH  
DIRECTS SURFACE RUNOFF  
TOWARDS & BENEATH  
PEDESTRIAN BRIDGE NO. 10
