THE CITY OF  
**RANCHO PALOS VERDES**

## Infrastructure Report Card

Revised May 14, 2014

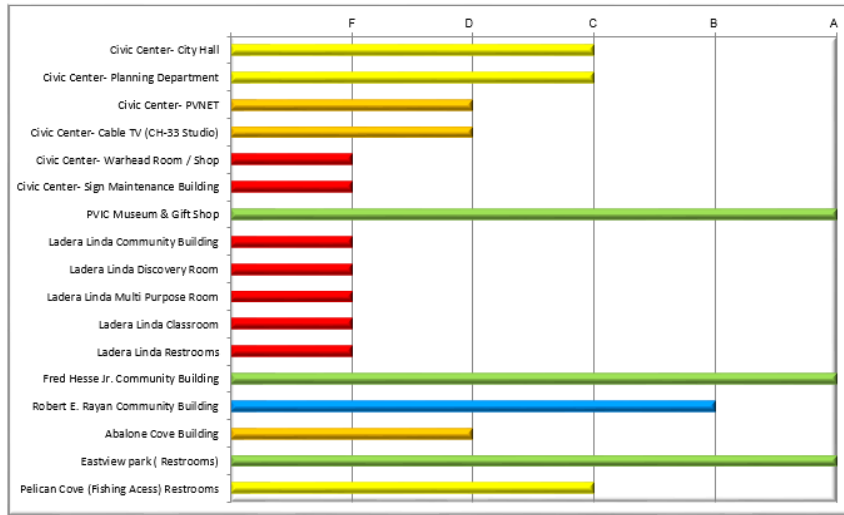
Figure 5.1: Grades of City-owned Buildings

The Overall Grade for the public buildings is D. The overall grade was calculated as the average of the individual grades of the 17 buildings. **Figure 5.2** below provides the grades of the individual buildings:

To upgrade the public buildings one grade up (from D to C), the city needs to perform retrofitting for some buildings and system replacement for others. This includes the replacement of the mechanical and electrical systems for the City Hall Buildings and Ladera Linda Community Center Buildings, and the retrofitting of Ryan Community Building and Abalone Cove Park Building. The upgrade also includes the necessary ADA Compliance improvements for items identified as the "Potential Safety Hazard" and "Severe" barriers (the most severe) in the City's ADA Assessment Compliance Report.

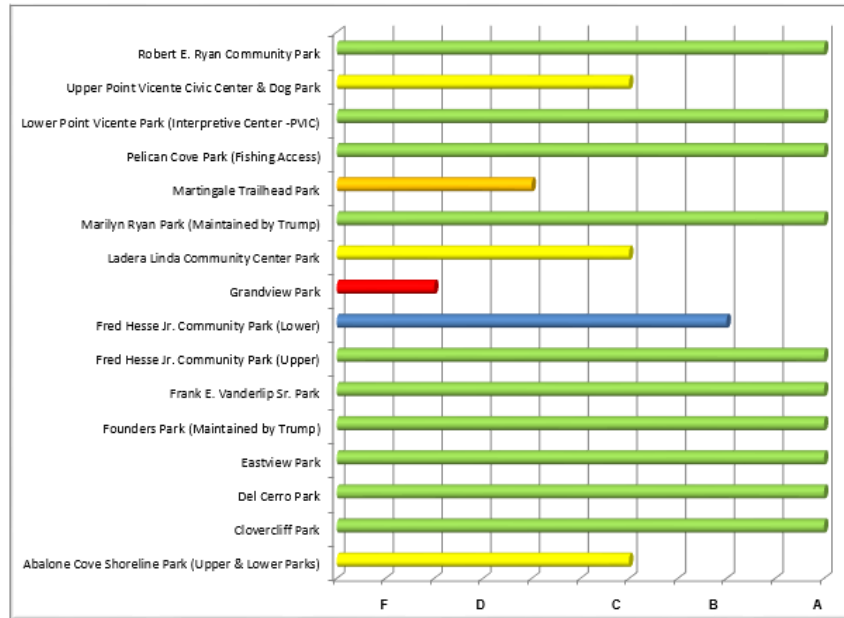
Figure 6.2: Park Grades

The Overall Grade for the parks is B. The overall grade was calculated as the average of the individual grades of the 15 Parks. **Figure 6.2** below provides the grades of the individual parks:

Investments will be needed to upgrade the parks system from B to A. This includes Abalone Cove Shoreline Park Parking Improvement; Abalone Cove Shoreline Parking Lot Improvements; Lower Hesse Park Improvement; Hesse Park parking lot resurfacing; Minor improvements to Civic Center park; Ryan Park Parking Lot Improvements; Ladera Linda Park site Improvement; Lower Point Vicente Park Improvements; Grandview Park Improvements; Gateway Park improvements; and all ADA compliance improvements for all parks. ADA Compliance improvements for the "Potential Safety Hazard" and "Severe" barriers (the most severe)

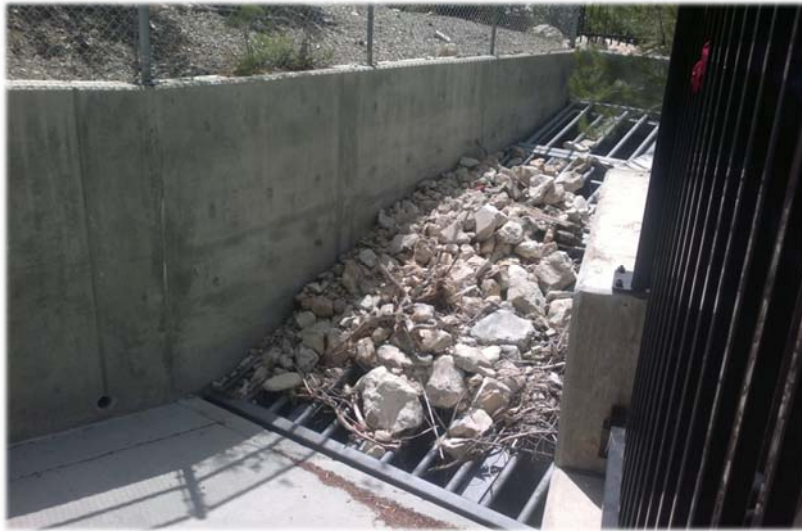
**Figure 8.1: McCarrell Canyon Storm Drain Inlet North of PVD South**

The City's landscape consists of a diverse topography that consists of undeveloped hilly terrain and canyons. As a result, the City is more vulnerable to flooding from nearby canyons that carry runoff during rainstorms. To protect property and loss of life, the City's storm drain system has been carefully designed to capture the maximum amount of storm water through numerous inlets, including the newly constructed McCarrell Canyon Storm Drain inlet shown below in **Figure 8.1**:

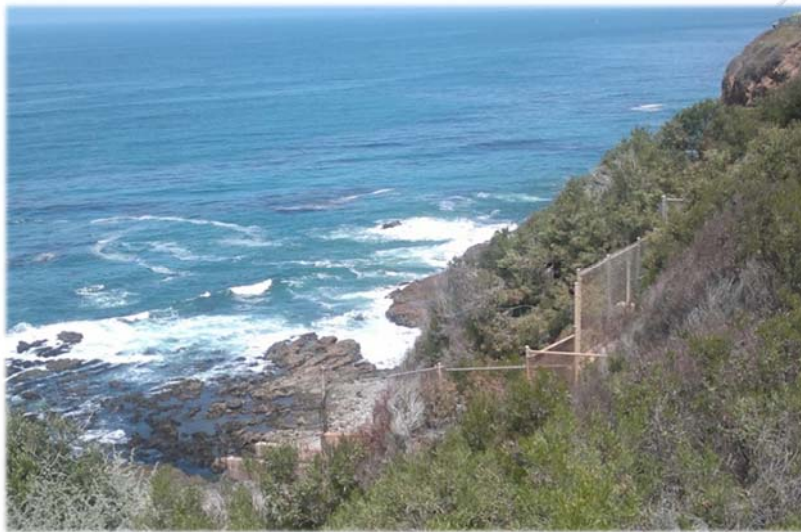
**Figure 8.2: Outlet Structure to Ocean in Ocean West Drainage Area**

With regard to man-made infrastructure, the City's storm drain system consists of inlets, pipes, manholes, and discharge structures. Storm drain pipes consist of reinforced concrete pipe (RCP), and corrugated metal pipe (CMP). Overall, the condition and capacity of the City's storm drain infrastructure is consistent throughout each drainage sub-basin. According to the City's records, there are over 4.6 miles of storm drain lines, 82 culverts, along with a multitude of inlets, catch basins, and manholes. A significant portion of the City's storm drain infrastructure lies within the Ocean South Drainage Area, including a number of culverts that cross PVDS. Since a number of these culverts are also located within the City's landslide area, the culverts are vulnerable to damage from severe landslides that result from heavy storms. The damage can also be compounded when the culverts become clogged with natural debris from the surrounding landscape which gets washed down during rainstorm periods. This could result in flooding which increases the potential for significant landslide activity to occur. To prevent flooding, the City's goal is to ensure that the storm drain pipe network drains stormwater away from developed areas and into one of eight outlets, as shown in **Figure 8.2** below:

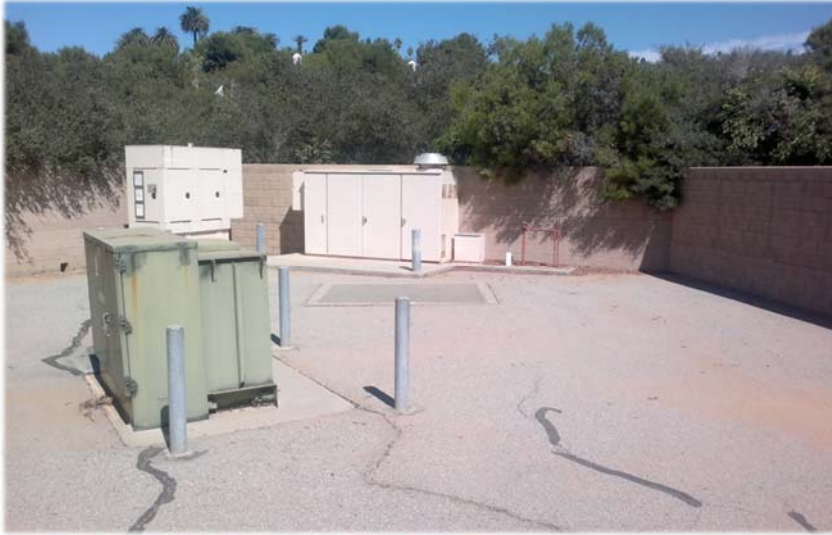
Figure 9.2: Calle Entradero Sewer Station

As mentioned previously, the City has a diverse, hilly terrain. The terrain varies from elevations at sea level to over 1,400 feet above sea level. As a result, the City has to utilize a combination of gravity pipes, lift stations, and pressurized force mains. With regard to its sanitary sewer infrastructure, there are over 150 miles of sewer pipelines, 17 lift stations, 44 grinder pumps, and 3,707 manholes. Sewer pipes consist primarily of vitrified clay pipe (VCP), with some plastic pipe, along with a few other materials. Due to the age of the City's sewer system, the majority of its pipe (VCP) was installed without gaskets, as the prevailing theory was that additional groundwater that flowed into the pipes was good for cleaning and flushing of the pipes.

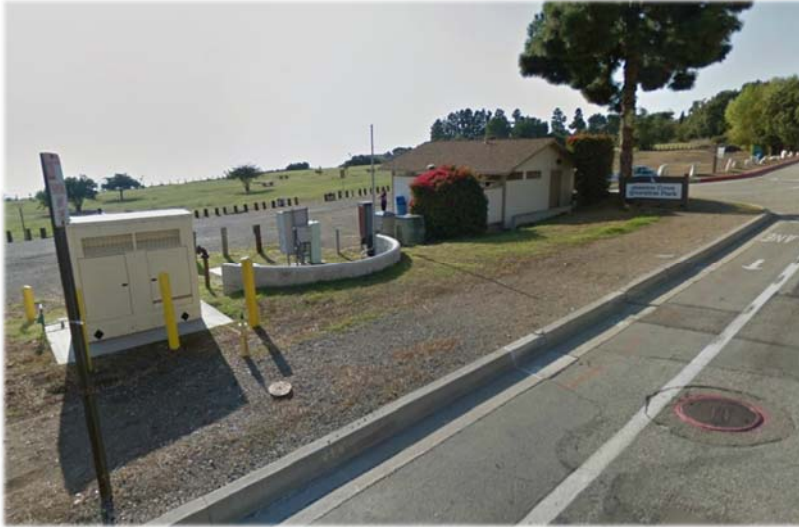
Figure 10.2: Abalone Cove Shoreline Park Sewer Lift Station

As mentioned previously, the District, as well as the City overall, has a diverse, hilly terrain. The terrain varies from elevations at sea level to over 1,400 feet above sea level. As a result, the District has to utilize a combination of gravity pipes, grinder pumps, low-pressure sewer mains, lift stations, and high pressurized force mains. According to the 2009 Master Plan, the District's system was installed in 2001 to replace septic systems in landslide areas. There are 130 manholes, 1 diversion structure, approximately 19,000 linear feet of gravity pipeline, 19,615 linear feet of low pressure pipe, and 2,505 linear feet of force main. Overall, there are 44 grinder pumps in the District, with 41 of them serving single family homes and 3 duplex grinder pumps serving two or more residences. There are 4 lift stations serving the District, one of which is the Abalone Cove Shoreline Park Lift Station shown in **Figure 10.2** below:

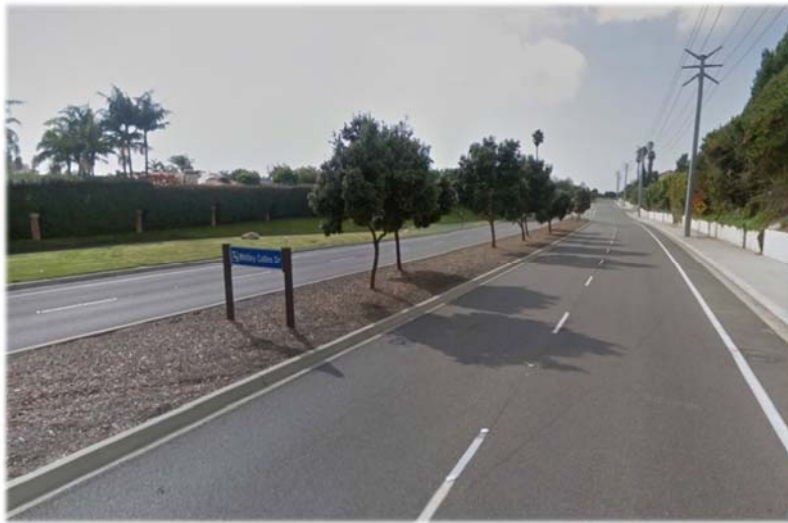
**Figure 11.1: Crest Rd west of Crenshaw Blvd looking southwest**

The City maintains a right of way network that consists of over 142 miles of local streets and major arterials. Due to the demographics of the City, local streets comprise the majority of the City's roadways at approximately 75% of the overall length or 106 miles. All of the City's roadways consist of asphalt-concrete (AC), with over 23 million square feet of AC pavement. In addition to the road network, the City also maintains traffic signals, safety lights, and flashers. The City's right of way network serves both motorists as well as bicyclists and pedestrians with nearly all major arterials consisting of a sidewalk and bike lanes. **Figure 11.1** below provides a sample of the condition of the City's streets.

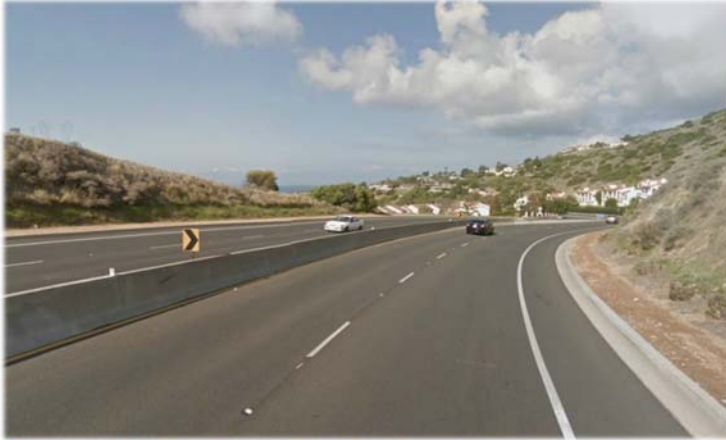
Figure 11.2: Hawthorne Blvd looking northwest

Due to the City's hilly terrain, major arterials are not arranged in a typical North/South grid-like manner, but rather change direction as they traverse the City's landscape. **Figure 11.2** below illustrates this.

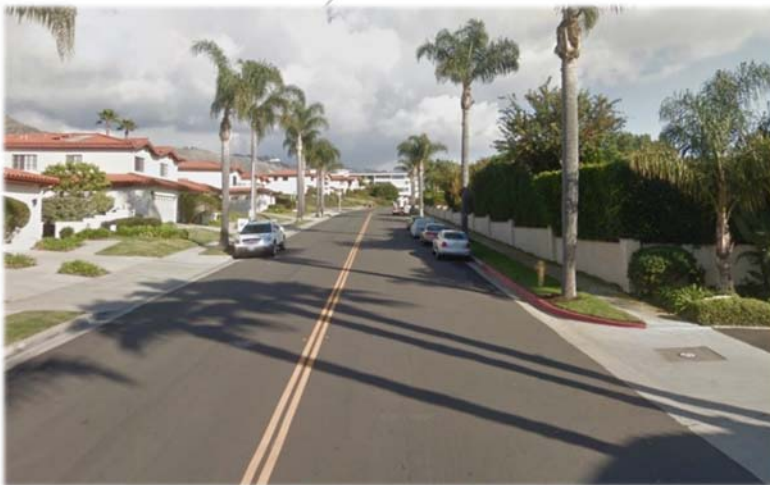
Figure 11.3: Beach View Drive Looking East

One major factor that makes the City's streets so appealing to both motorists and cyclists is the condition of the pavement, not only on major arterials but throughout the City's streets as whole. The 2009 Pavement Management System (PMS) revealed that the City's streets received an overall score of 84.5 on the Pavement Condition Index (PCI) and 95.3 on the Structural Index (SI), while arterials received a score of 76.8 on the PCI index and 90.8 on the SI index. The PCI and SI indexes focus on different aspects of pavement conditions. Residential streets received a score of 87.6 on the PCI Index and a score of 97.1 on the SI index. The 2013 PMS update revealed that the City's streets received an overall score of 82 on the PCI index. PCIs greater than 86 are considered to be "very good" and SIs greater than 90 are considered to be "good". Figure 11.2 below shows a sample condition of residential streets:

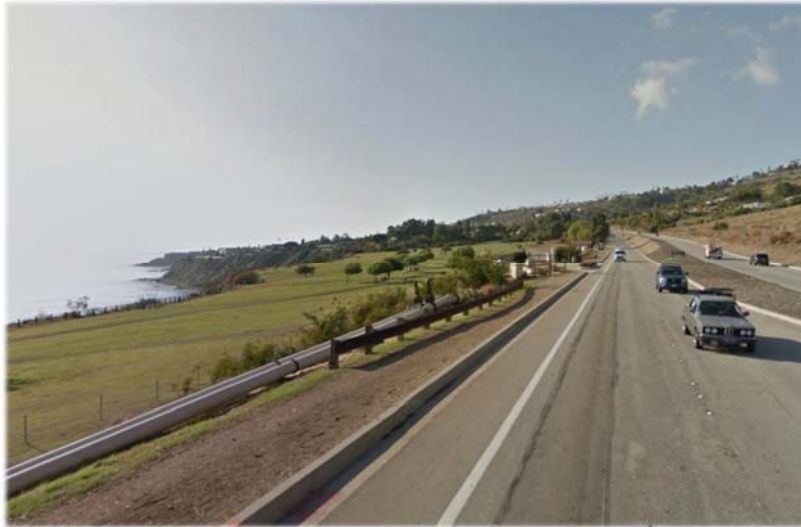
Figure 12.1: Palos Verdes Drive South along Landslide Area

A significant portion of the City lies within a natural landslide area that is composed of several component landslides. Overall, these landslides move southerly towards the ocean into the Abalone Cove, Sacred Cove, and Portuguese Bend shorelines. Approximately 1,000 acres, or 12% of the City's 13.6 square mile limits, are affected by landslide. The landslide affects not only surface streets and buildings, but also other infrastructure as well, including below grade utilities. **Figure 12.1** below shows part of the City's landscape that is located within the landslide region:

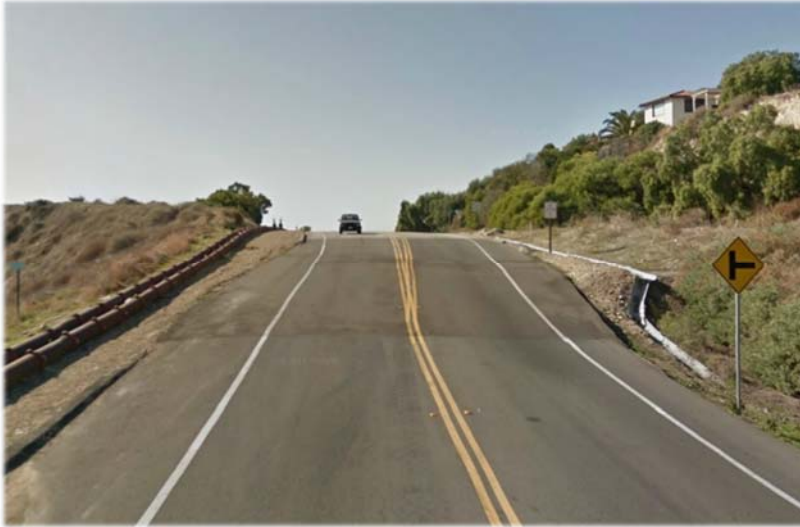
Figure 12.2: Landslide Damage to Palos Verdes Drive South

There are over a dozen landslides that make up what is known as the City's landslide area along Palos Verdes Drive South. The three main landslides in the City are the Abalone Cove, Portuguese Bend, and Klondike Canyon Landslides. The landslides are caused primarily by groundwater which decreases the strength of clays and adds additional weight to subsurface soils. Rainfall is the primary contributor to groundwater. The City has three main drainage basins within the landslide regions that collect rainwater and allow it to percolate to the soils below. These drainage basins include the Altamira Canyon Drainage Basin, the Portuguese Canyon/Paintbrush Canyon Drainage Basin, and the Klondike Canyon Drainage Basin. It is estimated that 50-75% of storm water infiltrates the canyons to become groundwater, primarily through fractures and expansive soils. Although the City has established drainage facilities within these canyons, the landslide movement causes damage to drainage facilities which enables more storm water to enter the surface below. **Figure 12.1** shows a damaged half corrugated pipe system along Palos Verdes Drive South resulting from continuous landslide movement:
