City of Rancho Palos Verdes
Rancho Palos Verdes ADA Assessment
Facility Report with Photos

Facility ID: # Area 7 Pedestrian Signals

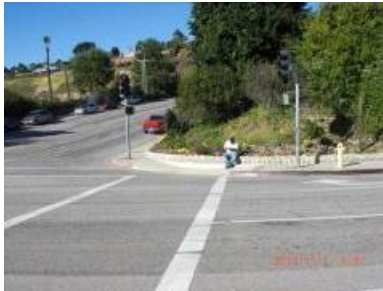
Keynote 1

Field Condition	
04.40 - Other - Curb Ramps and Pedestrian Crossings - See Additional Comments	1991 ADAAG -
Existing Condition:	2004 ADAAG -
	2007 CBC -
	Other -

Corrective Action
039 - Operable Parts - Miscellaneous - See Additional Comments
Additional Comments: Provide audible and vibrotactile signal devices.

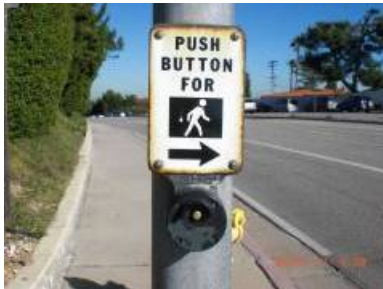
Keynote 2

Field Condition	
04.24A - Audible Signal Device - A crosswalk with pedestrian signal indication does not have an audible signal device to indicate the WALK interval.	1991 ADAAG -
Existing Condition:	2004 ADAAG -
	2007 CBC -
	Other 2005 PROWAG-R306.2

Corrective Action
039 - Operable Parts - Miscellaneous - See Additional Comments
Additional Comments: Provide audible signal device.

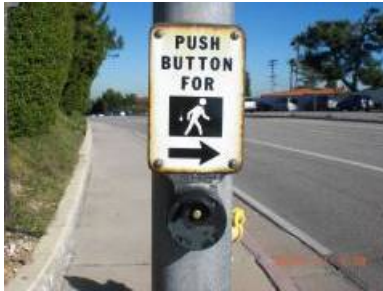
Keynote 3

04.24B - Vibrotactile Signal Device - A crosswalk with pedestrian signal indication does not have a vibrotactile signal device integrated into the signal device to indicate the WALK interval.

Additional Comments: Replace with compliant vibrotactile signal device at compliant location.

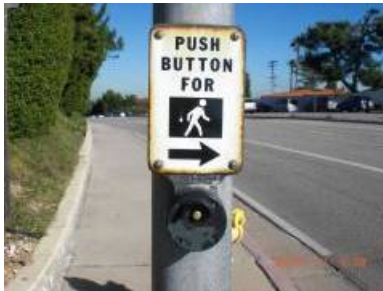
Keynote 4

04.32C - Push Button Size - The pedestrian signal push button is not a min.. 2" across in one dimension.

Existing Condition: 1/2" diameter.

Additional Comments: See Keynote 3 for corrective action.

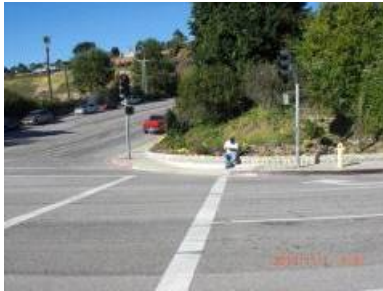
Keynote 5

Field Condition	
04.26A - Pedestrian Signal Device - Location versus Crosswalk Line - Location of pedestrian signal device is not within 5' of crosswalk line.	1991 ADAAG -
Existing Condition: 7'-10" from crosswalk line.	2004 ADAAG -
	2007 CBC -
	Other 2006 Cal MUTCD-Sec. 4E-09, Fig. 4E-2

Corrective Action
039 - Operable Parts - Miscellaneous - See Additional Comments
Additional Comments: See Keynote 3 for corrective action.

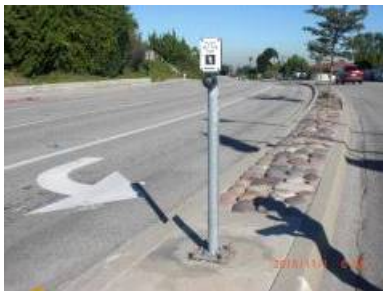
Keynote 6

Field Condition	
04.25 - Pedestrian Signal Device - Clear Floor Space - Location of pedestrian signal device does not accommodate a level 30" x 48" min.. clear space, centered and parallel to the pedestrian signal push button. (Accessible pedestrian signals shall be located so that the vibrotactile feature can be contacted from the level landing serving a curb ramp, if provided, or from a clear floor or ground space that is in line with the crosswalk line adjacent to the vehicle stop line.)	1991 ADAAG 4.2.4
Existing Condition: 8.4%. 33.735678,-118.333444	2004 ADAAG 305.3; Fig. 305.3
	2007 CBC 1118B.4 item 1
	Other 2005 PROWAG-R306.2.1

Corrective Action
027 - Site Work - Miscellaneous - See Additional Comments
Additional Comments: See Keynote 7 for corrective action.

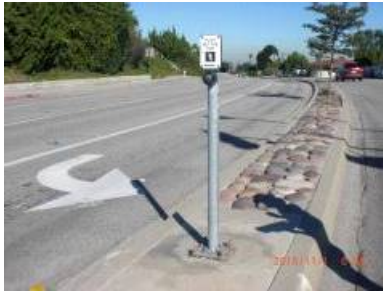
Keynote 7

Field Condition	
04.40 - Other - Curb Ramps and Pedestrian Crossings - See Additional Comments	1991 ADAAG -
Existing Condition: Path of travel to pedestrian signal device is not provided.	2004 ADAAG -
	2007 CBC -
	Other -

Corrective Action	
039 - Operable Parts - Miscellaneous - See Additional Comments	
Additional Comments: Recommendation: Remove pedestrian signal device.

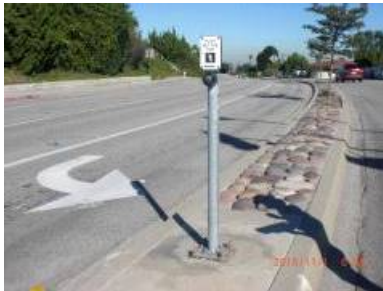
Keynote 8

Field Condition	
04.32D - Push Button Contrast - Color Coding - The pedestrian signal push button does not contrast visually with its housing or mounting. (i.e., pedestrian signal push button is not identified by color coding immediately above the control button and consisting of a textured horizontal yellow band 2" wide and encircling the pole, and a 1" wide dark border band above and below this yellow band.)	1991 ADAAG -
Existing Condition:	2004 ADAAG -
	2007 CBC 1117B.5.9
	Other 2005 PROWAG-R306.3.3

Corrective Action	
039 - Operable Parts - Miscellaneous - See Additional Comments	
Additional Comments: See Keynote 7 for corrective action.

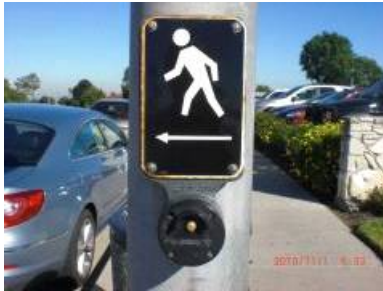
Keynote 9

Field Condition	04.24A - Audible Signal Device - A crosswalk with pedestrian signal indication does not have an audible signal device to indicate the WALK interval.	1991 ADAAG -
Existing Condition:		2004 ADAAG -
		2007 CBC -
		Other 2005 PROWAG-R306.2

Corrective Action	039 - Operable Parts - Miscellaneous - See Additional Comments
Additional Comments:	Provide audible signal device.

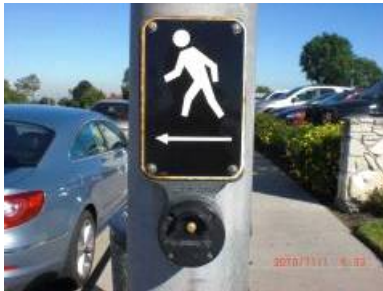
Keynote 10

Field Condition	04.24B - Vibrotactile Signal Device - A crosswalk with pedestrian signal indication does not have a vibrotactile signal device integrated into the signal device to indicate the WALK interval.	1991 ADAAG -
Existing Condition:		2004 ADAAG -
		2007 CBC -
		Other 2005 PROWAG-R306.2

Corrective Action	039 - Operable Parts - Miscellaneous - See Additional Comments
Additional Comments:	Replace with vibrotactile signal device.

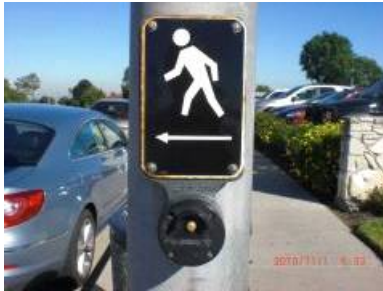
Keynote 11

Field Condition	
04.32C - Push Button Size - The pedestrian signal push button is not a min.. 2" across in one dimension.	1991 ADAAG -
Existing Condition: 1/2" diameter.	2004 ADAAG -
	2007 CBC -
	Other 2005 PROWAG-R306.3.3

Corrective Action
039 - Operable Parts - Miscellaneous - See Additional Comments
Additional Comments: See Keynote 10 for corrective action.

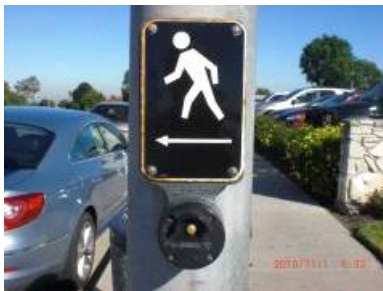
Keynote 12

Field Condition	
04.32A - Push Button Operating Effort - The force required to activate operable part(s) of pedestrian signal device exceeds 5 lbs.	1991 ADAAG 4.27.4
Existing Condition: 6 LBF.	2004 ADAAG 309.4
	2007 CBC 1117B.6 item 4
	Other 2005 PROWAG-R306.3.1; R405.4

Corrective Action
039 - Operable Parts - Miscellaneous - See Additional Comments
Additional Comments: See Keynote 10 for corrective action.

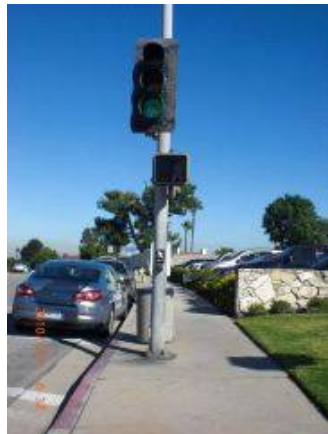
Keynote 13

Field Condition	
04.25 - Pedestrian Signal Device - Clear Floor Space - Location of pedestrian signal device does not accommodate a level 30" x 48" min.. clear space, centered and parallel to the pedestrian signal push button. (Accessible pedestrian signals shall be located so that the vibrotactile feature can be contacted from the level landing serving a curb ramp, if provided, or from a clear floor or ground space that is in line with the crosswalk line adjacent to the vehicle stop line.)	1991 ADAAG 4.2.4 2004 ADAAG 305.3; Fig. 305.3 2007 CBC 1118B.4 item 1 Other 2005 PROWAG-R306.2.1
Existing Condition: 2.5%.

Corrective Action	
008 - Concrete Landing - Remove non-compliant pavement and replace with new concrete. The landing slope shall not exceed 2% in any direction.	
Additional Comments:

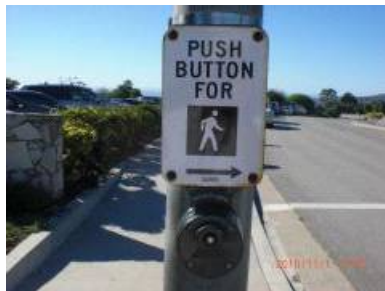
Keynote 14

Field Condition	
04.32C - Push Button Size - The pedestrian signal push button is not a min.. 2" across in one dimension.	1991 ADAAG - 2004 ADAAG - 2007 CBC - Other 2005 PROWAG-R306.3.3
Existing Condition: 1/2" diameter.

Corrective Action	
039 - Operable Parts - Miscellaneous - See Additional Comments	
Additional Comments: See Keynote 16 for corrective action.

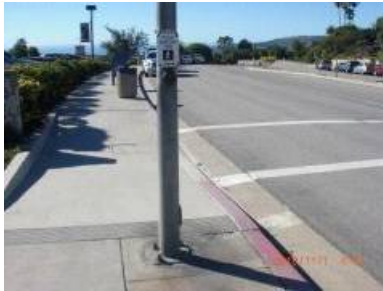
Keynote 15

Field Condition	
04.26A - Pedestrian Signal Device - Location versus Crosswalk Line - Location of pedestrian signal device is not within 5' of crosswalk line.	1991 ADAAG -
Existing Condition: 7'-4" from crosswalk line.	2004 ADAAG -
	2007 CBC -
	Other 2006 Cal MUTCD-Sec. 4E-09, Fig. 4E-2

Corrective Action
039 - Operable Parts - Miscellaneous - See Additional Comments
Additional Comments: See Keynote 16 for corrective action.

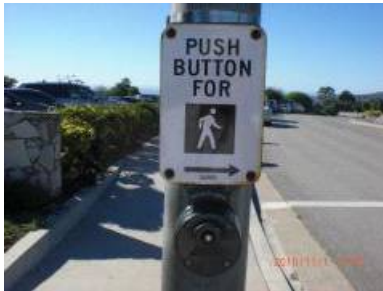
Keynote 16

Field Condition	
04.24B - Vibrotactile Signal Device - A crosswalk with pedestrian signal indication does not have a vibrotactile signal device integrated into the signal device to indicate the WALK interval.	1991 ADAAG -
Existing Condition:	2004 ADAAG -
	2007 CBC -
	Other 2005 PROWAG-R306.2

Corrective Action
039 - Operable Parts - Miscellaneous - See Additional Comments
Additional Comments: Replace with vibrotactile signal device.

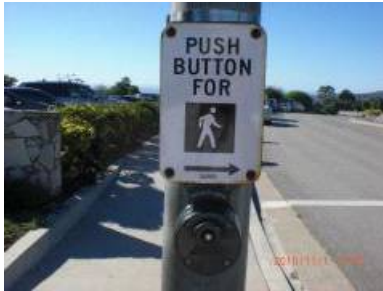
Keynote 17

Field Condition	
04.24A - Audible Signal Device - A crosswalk with pedestrian signal indication does not have an audible signal device to indicate the WALK interval.	1991 ADAAG -
Existing Condition:	2004 ADAAG -
	2007 CBC -
	Other 2005 PROWAG-R306.2

Corrective Action
039 - Operable Parts - Miscellaneous - See Additional Comments
Additional Comments: Provide audible signal device.

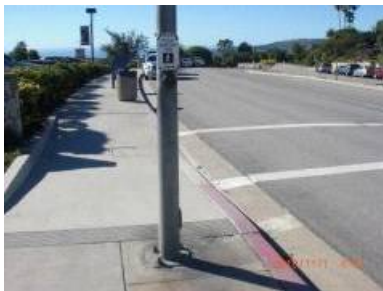
Keynote 18

Field Condition	
04.25 - Pedestrian Signal Device - Clear Floor Space - Location of pedestrian signal device does not accommodate a level 30" x 48" min.. clear space, centered and parallel to the pedestrian signal push button. (Accessible pedestrian signals shall be located so that the vibrotactile feature can be contacted from the level landing serving a curb ramp, if provided, or from a clear floor or ground space that is in line with the crosswalk line adjacent to the vehicle stop line.)	1991 ADAAG 4.2.4
Existing Condition: 2.2% & 2.6%.	2004 ADAAG 305.3; Fig. 305.3
	2007 CBC 1118B.4 item 1
	Other 2005 PROWAG-R306.2.1

Corrective Action
008 - Concrete Landing - Remove non-compliant pavement and replace with new concrete. The landing slope shall not exceed 2% in any direction.
Additional Comments:

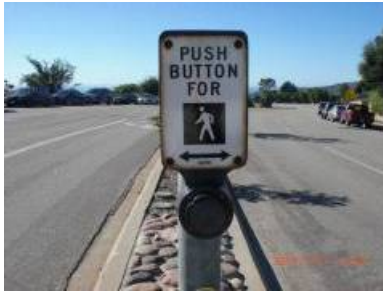
Keynote 19

Field Condition	04.32D - Push Button Contrast - Color Coding - The pedestrian signal push button does not contrast visually with its housing or mounting. (i.e., pedestrian signal push button is not identified by color coding immediately above the control button and consisting of a textured horizontal yellow band 2" wide and encircling the pole, and a 1" wide dark border band above and below this yellow band.)	1991 ADAAG -
		2004 ADAAG -
Existing Condition:		2007 CBC 1117B.5.9
		Other 2005 PROWAG-R306.3.3

Corrective Action	039 - Operable Parts - Miscellaneous - See Additional Comments
Additional Comments:	See Keynote 20 for corrective action.

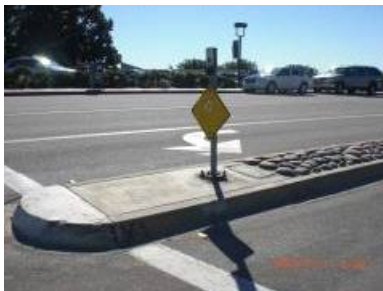
Keynote 20

Field Condition	04.40 - Other - Curb Ramps and Pedestrian Crossings - See Additional Comments	1991 ADAAG -
		2004 ADAAG -
Existing Condition:	Path of travel to pedestrian signal device is not provided.	2007 CBC -
		Other -

Corrective Action	039 - Operable Parts - Miscellaneous - See Additional Comments
Additional Comments:	Recommendation: Remove pedestrian signal device.

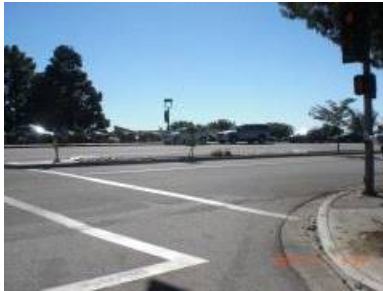
Keynote 21

Field Condition	
04.26A - Pedestrian Signal Device - Location versus Crosswalk Line - Location of pedestrian signal device is not within 5' of crosswalk line.	1991 ADAAG -
Existing Condition: 8'-8" from crosswalk line.	2004 ADAAG -
	2007 CBC -
	Other 2006 Cal MUTCD-Sec. 4E-09, Fig. 4E-2

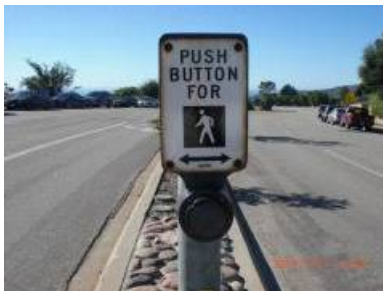
Keynote 22

Field Condition	
04.24A - Audible Signal Device - A crosswalk with pedestrian signal indication does not have an audible signal device to indicate the WALK interval.	1991 ADAAG -
Existing Condition:	2004 ADAAG -
	2007 CBC -
	Other 2005 PROWAG-R306.2

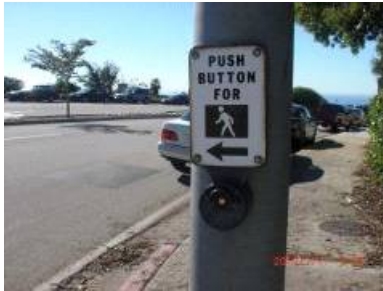
Keynote 23

Field Condition	
04.32A - Push Button Operating Effort - The force required to activate operable part(s) of pedestrian signal device exceeds 5 lbs.	1991 ADAAG 4.27.4
Existing Condition: 6 LBF.	2004 ADAAG 309.4
	2007 CBC 1117B.6 item 4
	Other 2005 PROWAG-R306.3.1; R405.4

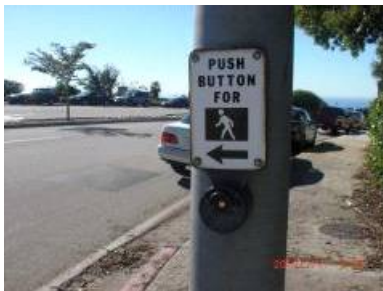
Keynote 24

Field Condition	
04.32C - Push Button Size - The pedestrian signal push button is not a min.. 2" across in one dimension.	1991 ADAAG -
Existing Condition: 1/2" diameter.	2004 ADAAG -
	2007 CBC -
	Other 2005 PROWAG-R306.3.3

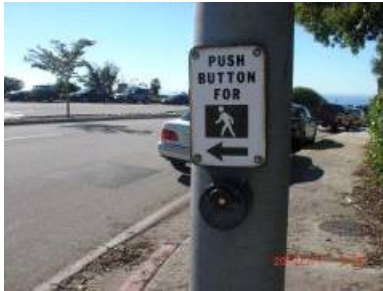
Keynote 25

04.24B - Vibrotactile Signal Device - A crosswalk with pedestrian signal indication does not have a vibrotactile signal device integrated into the signal device to indicate the WALK interval.

Additional Comments: Replace with vibrotactile signal device.

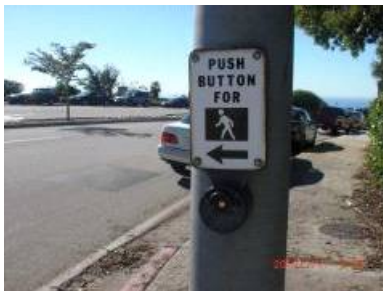
Keynote 26

04.24A - Audible Signal Device - A crosswalk with pedestrian signal indication does not have an audible signal device to indicate the WALK interval.

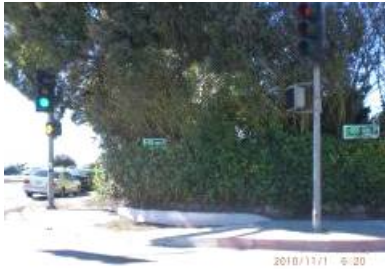
Keynote 27

Field Condition	
04.40 - Other - Curb Ramps and Pedestrian Crossings - See Additional Comments	1991 ADAAG -
Existing Condition:	2004 ADAAG -
	2007 CBC -
	Other -

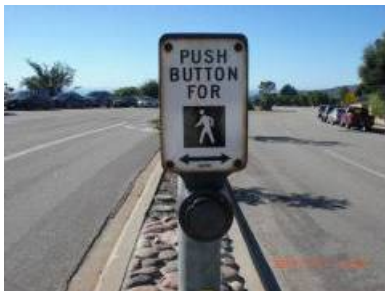
Keynote 28

Field Condition	
04.24B - Vibrotactile Signal Device - A crosswalk with pedestrian signal indication does not have a vibrotactile signal device integrated into the signal device to indicate the WALK interval.	1991 ADAAG -
Existing Condition:	2004 ADAAG -
	2007 CBC -
	Other 2005 PROWAG-R306.2

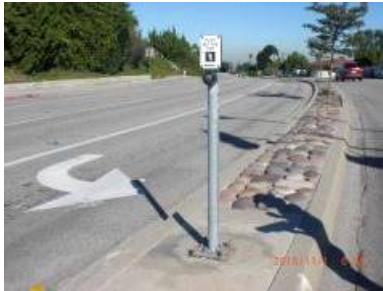
Keynote 29

Field Condition	
04.24A - Audible Signal Device - A crosswalk with pedestrian signal indication does not have an audible signal device to indicate the WALK interval.	1991 ADAAG -
Existing Condition:	2004 ADAAG -
	2007 CBC -
	Other 2005 PROWAG-R306.2

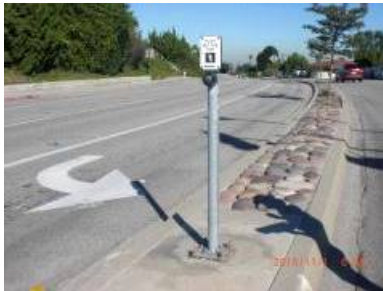
Keynote 30

Field Condition	
04.24B - Vibrotactile Signal Device - A crosswalk with pedestrian signal indication does not have a vibrotactile signal device integrated into the signal device to indicate the WALK interval.	1991 ADAAG -
Existing Condition:	2004 ADAAG -
	2007 CBC -
	Other 2005 PROWAG-R306.2
