City of Rancho Palos Verdes
Rancho Palos Verdes ADA Assessment
Facility Report with Photos

Facility ID: # 14 - Martingale Trailhead Park

Author: Vaish, B

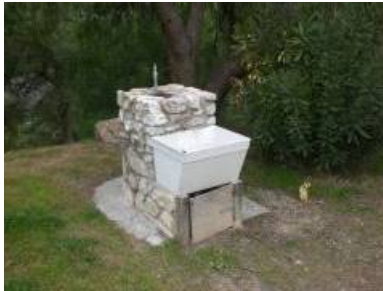
Location: Near the Road
Photo # 1

Field Condition	
05.03 - Accessible Route - The accessible drinking fountain is not located on an accessible route.	1991 ADAAG 4.1.3(10)(b)
Existing Condition: Drinking Fountain on Planting Area, provide safety rail.	2004 ADAAG 206.2.4
	2007 CBC 1115B.4.6 item 1
	Other -

Corrective Action
004A - Asphalt Paving - Remove non-compliant pavement and replace with new asphalt paving (area as shown on the drawings). The walkway slope shall not exceed 5% along the POT and cross slope shall not exceed 2%.
Additional Comments:

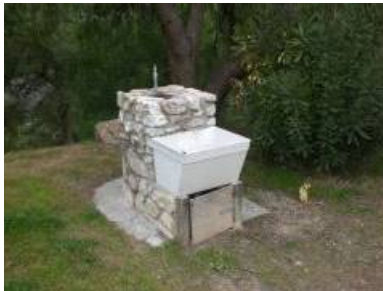
Location: Near the Road
Photo # 1

Field Condition	
05.04 - Depth - Drinking fountain is not 18" min.. to 19" max.. in depth.	1991 ADAAG 4.15.5(1); Figs. 27(a) and (b)
Existing Condition: 0"	2004 ADAAG -
	2007 CBC 1115B.4.6 item 2
	Other -

Corrective Action
273 - Replace Freestanding High/Low Drinking Fountain - Remove existing drinking fountain and replace with an accessible park-type hi-low drinking fountain. Reconnect plumbing and drain lines to existing piping. Provide a sand trap in the drain line.
Additional Comments:

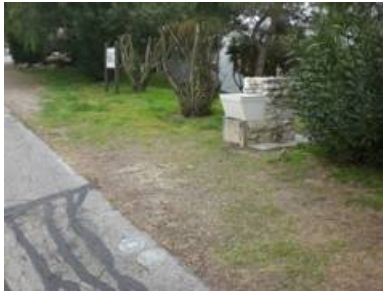
Location: Near the Road **Photo #** 3

05.07 - Clear Floor Space - Drinking fountain does not have a 30" x 48" clear floor space that adjoins or overlaps an accessible route of travel and that allows a forward approach by wheelchair users. (A side approach is not acceptable.)

Existing Condition: No Path of travel.

289 - Drinking Fountain - Miscellaneous - See Additional Comments

Additional Comments: See keynote 1 for corrective action.

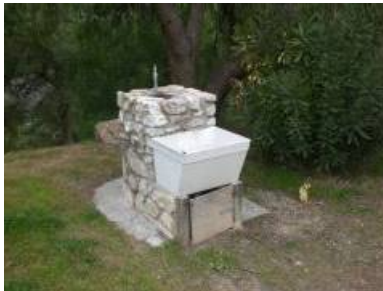
Location: Near the Road **Photo #** 1

05.01A - "HI" Drinking Fountain Requirement - Where there is only one drinking fountain area on a floor (e.g., an area with a drinking fountain or separate drinking fountains), it is accessible to wheelchair users and not to persons who have difficulty bending or stooping (i.e., the required accessibility for persons who have difficulty bending or stooping on each floor has not been provided).

289 - Drinking Fountain - Miscellaneous - See Additional Comments

Additional Comments: See keynote 2 for corrective action.

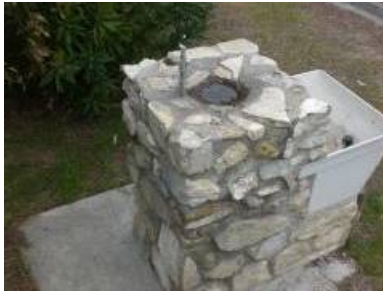
Location: Near the Road
Photo # 5

Field Condition	
05.09A - Spout Height for Wheelchair Users - The spout outlet is higher than 36" from the floor.	1991 ADAAG 4.15.2
Existing Condition: 47" high.	2004 ADAAG 602.4; 602.6; Advisory 602.6
	2007 CBC 1115B.4.6 item 4
	Other -

Corrective Action
289 - Drinking Fountain - Miscellaneous - See Additional Comments
Additional Comments: See keynote 2 for corrective action.

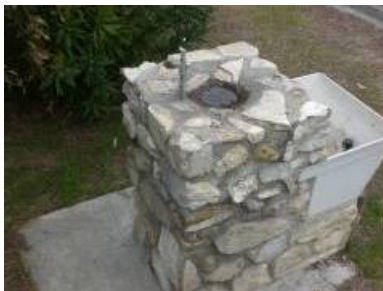
Location: Near the Road
Photo # 5

Field Condition	
05.10A - Bubbler Location - The bubbler outlet is not within 6" of the front edge of the unit.	1991 ADAAG 4.15.3
Existing Condition: 12" From front edge.	2004 ADAAG -
	2007 CBC 1115B.4.6 item 4
	Other -

Corrective Action
289 - Drinking Fountain - Miscellaneous - See Additional Comments
Additional Comments: See keynote 2 for corrective action.

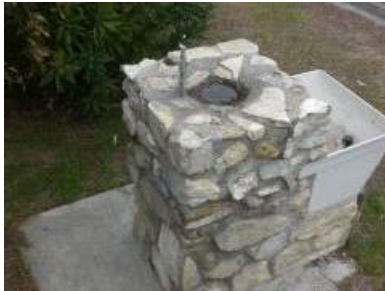
Location: Near the Road
Photo # 5

Field Condition	
05.13 - Operation - The controls are not compliant.(Accessible controls shall be operable with one hand, and without tight grasping, pinching, or twisting of the wrist, and the force to operate the controls shall be no greater than 5 lbs.)	1991 ADAAG 4.27.4
Existing Condition: Twist type faucet control.	2004 ADAAG 602.3; 309.4
	2007 CBC 1115B.4.6 item 4
	Other -

Corrective Action
289 - Drinking Fountain - Miscellaneous - See Additional Comments
Additional Comments: See keynote 2 for corrective action.

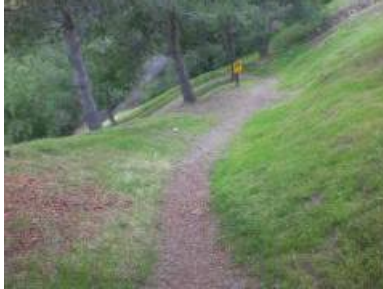
Location: Trail **Photo #** 8

Field Condition	
30.10A - Trail Segment - Running Slope - Running slope of trail segment in the direction of travel does not comply with the following: a. 5% or less for any distance. b. From 5.1% to 8.33% for 200' maximum. c. From 8.34% to 10% for 30' maximum. d. From 10% to 12% for 10' maximum.	1991 ADAAG -
Existing Condition: Approximate. 200 Ft. long trail on City property & variable slope, 34.2% RS, unstable & loose surface.	2004 ADAAG -
	2007 CBC -
	Other 1999 ADAAG-16.2.7.2.1; 16.2.7.2.2; 16.2.7.2.3; 16.2.7.2.4

Corrective Action
429 - Signs - Miscellaneous - See Additional Comments
Additional Comments: Provide Sign to include existing trail condition.
