Ancient Portuguese Bend Landslide Complex Town Hall

April 17, 2024

Mitigation of Portuguese Bend Landslide with Directional Drilling Rancho Palos Verdes, California

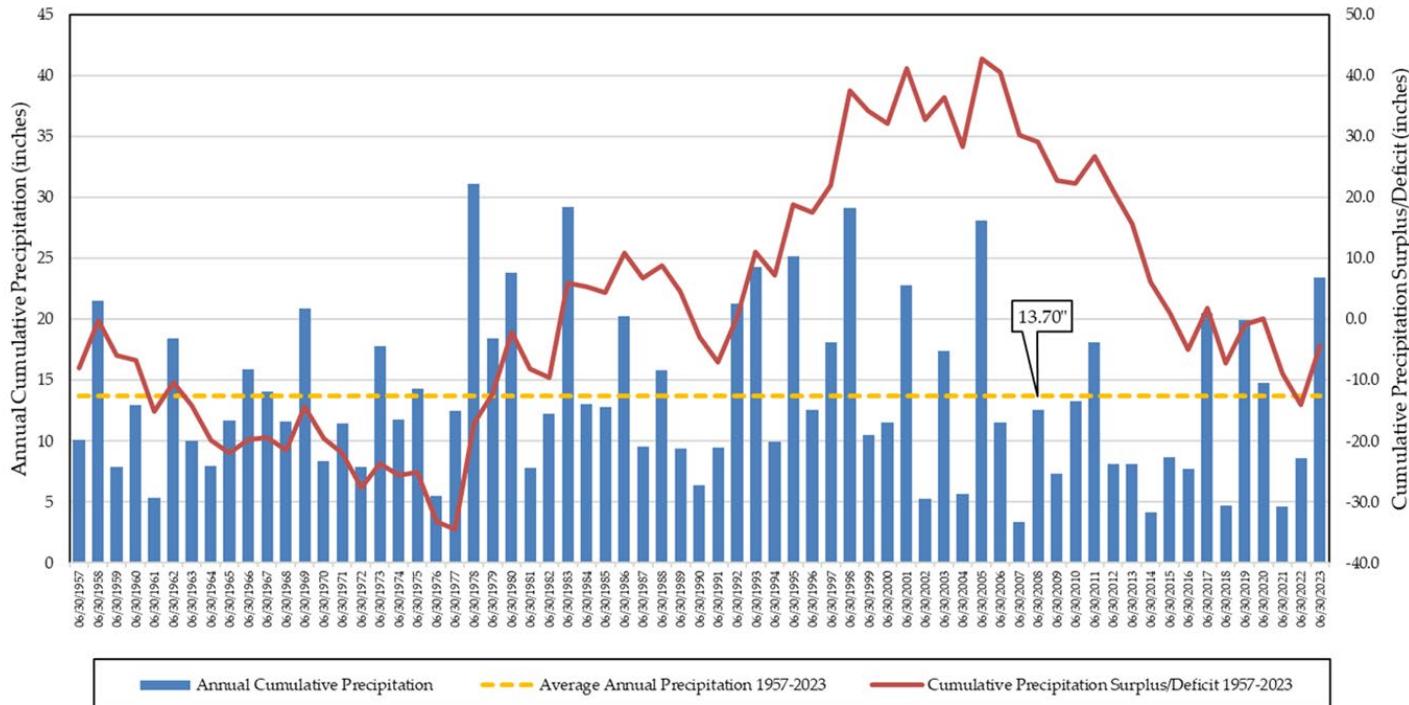
Annual Cumulative Precipitation and Cumulative Precipitation Surplus/Deficit 1957-2023 (Station 1011B)

- Two gauges – Point Vicente and Rolling Hills FS
- Rolling Hills FS is more representative of watersheds
- 67-year record
- Mean annual rainfall 13.70 inches
- 2022-23 Season: 26.33 inches (192% of hist. avg.)
- 2023-24 Season: 22.50 inches (164% of hist. avg.)
- 2011-2016: 5 year drought w/below avg rainfall
- 5 of the last 8 years wetter than average
- La Nina conditions forecast for 2024-25

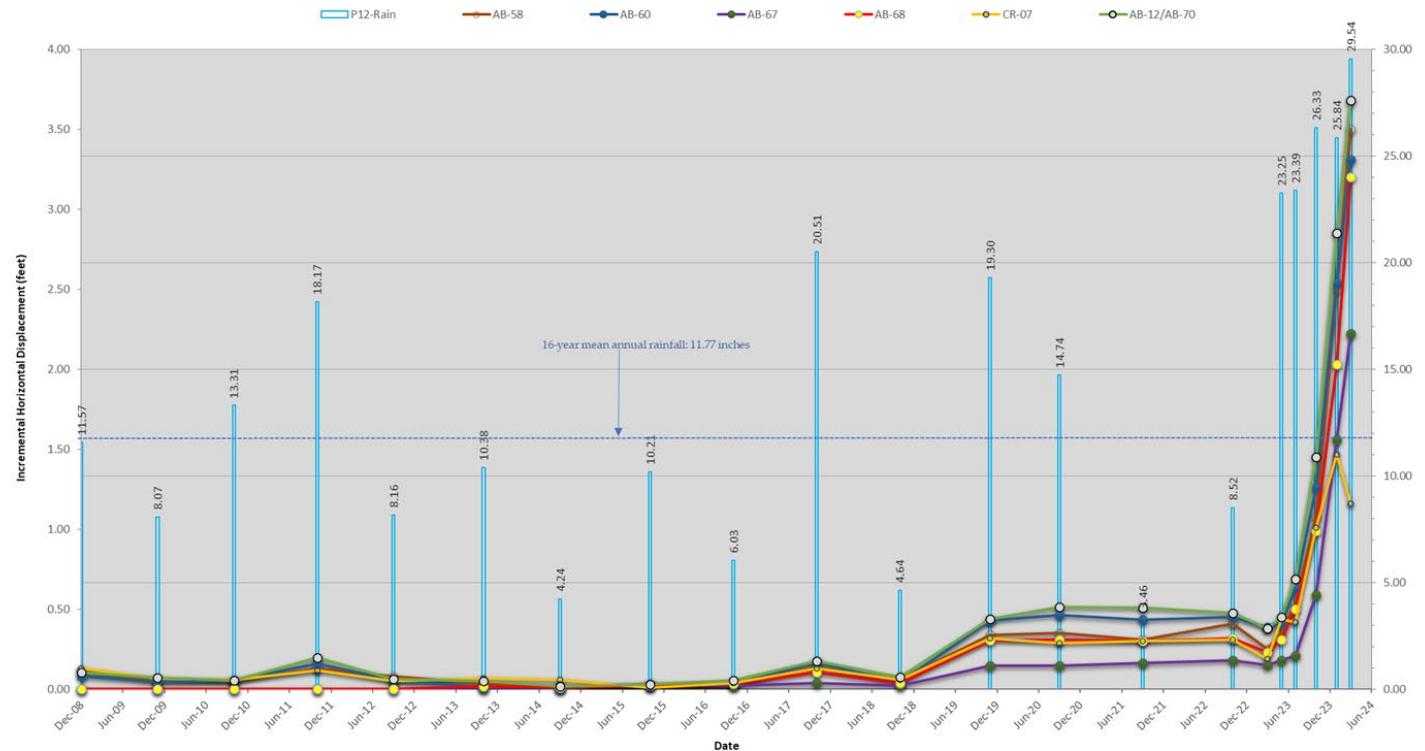
GPS Monitoring Data

Survey Monuments - ACL and Ancient PBL Areas Displacement Response to 12-month Antecedent Rainfall

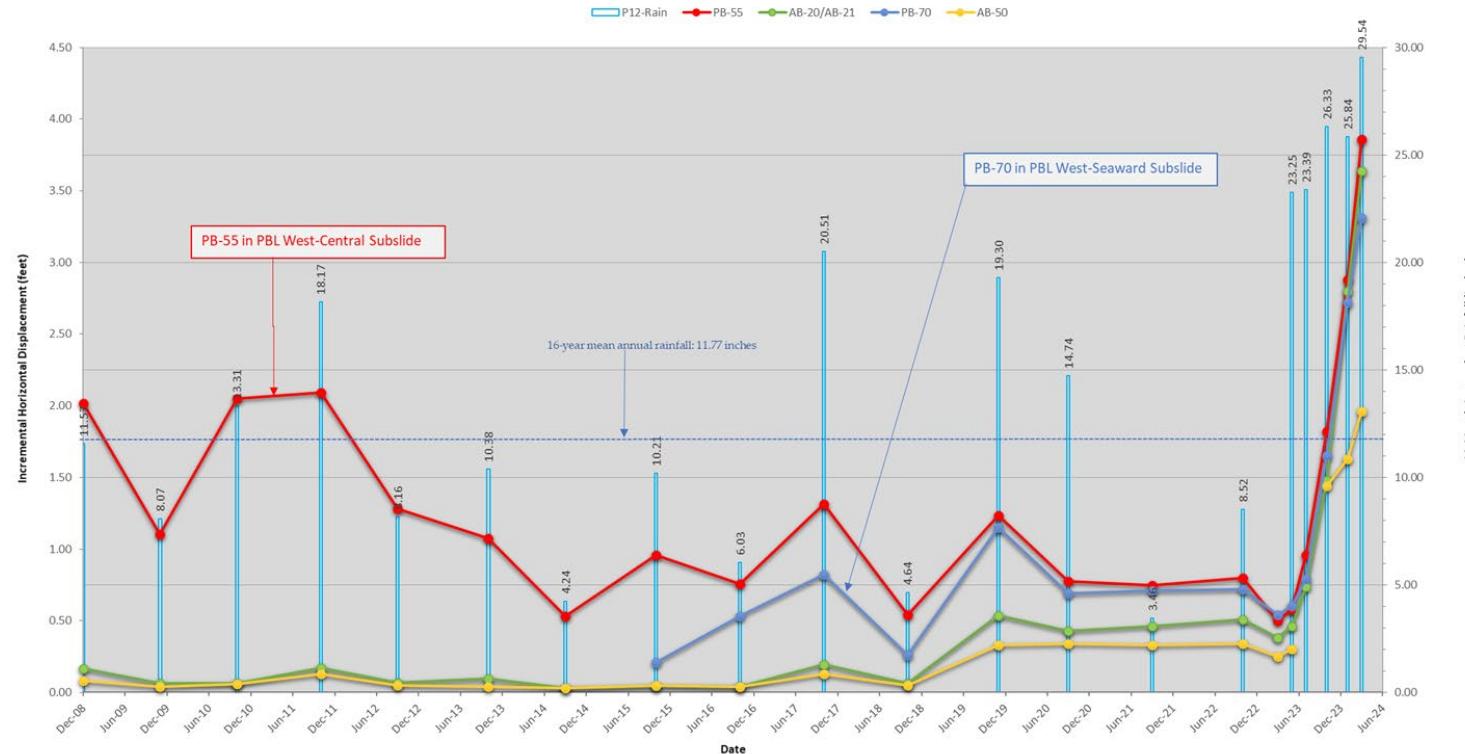
GPS Monitoring Data
Survey Monuments - ACL and PBL, PVDS "Ski Jump" Area
Displacement Response to 12-month Antecedent Rainfall

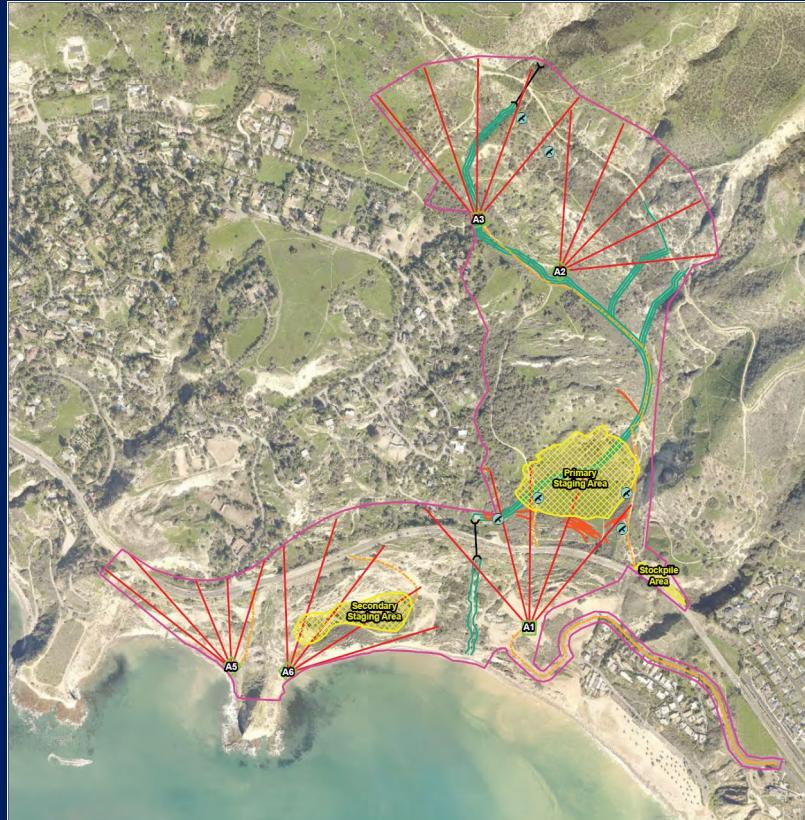
Portuguese Bend Landslide Remediation Project

- Proposed Project Limit
- Proposed Hydraulor Work Locations
- Staging Area/Work Location
- Proposed Hydraulor Arrays
- Approximate Surface Fracture Locations
- Proposed Access Route
- Proposed Culvert
- Proposed Swale

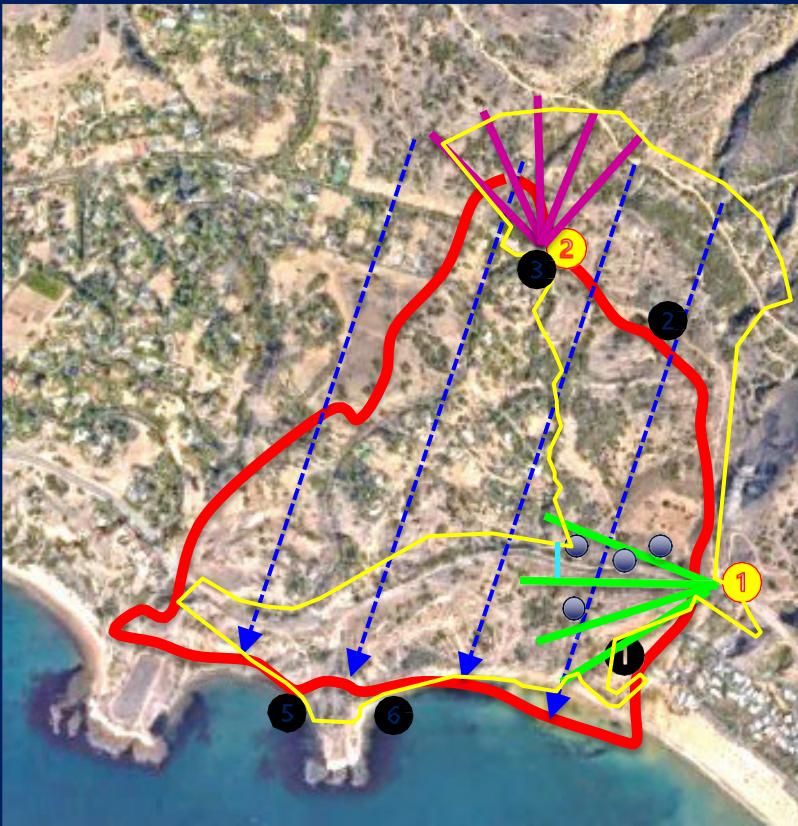
Emergency Stabilization Measures (① and ②)

- Approximate Portuguese Bend Landslide Limit
- Approximate BRIC Limit
- ←— Approximate Direction of Groundwater Flow
- 7-in. diameter Sacrificial Dual Boreholes
- ① Emergency Action Hydrauger Array E-1 (Relief of Artesian Pressure)
- ② Emergency Action Hydrauger Array E-2 (Groundwater Flow Interceptor)
- ① Originally Planned Hydrauger Arrays (Extent of Hydrauger Pipes Not Shown)
- | Approximate Location of 80-in. diameter Drainage Pipe under PVDS (Swale Below PVDS Not Shown)

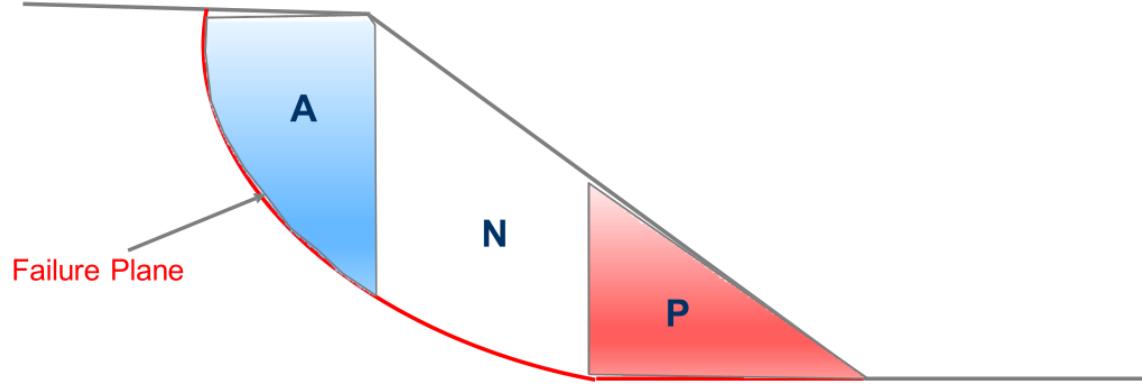
Schematic cross-section through a landslide

A = Active Zone (Pushing)

N = Neutral Zone (No Impact)

P = Passive Zone (Resisting)

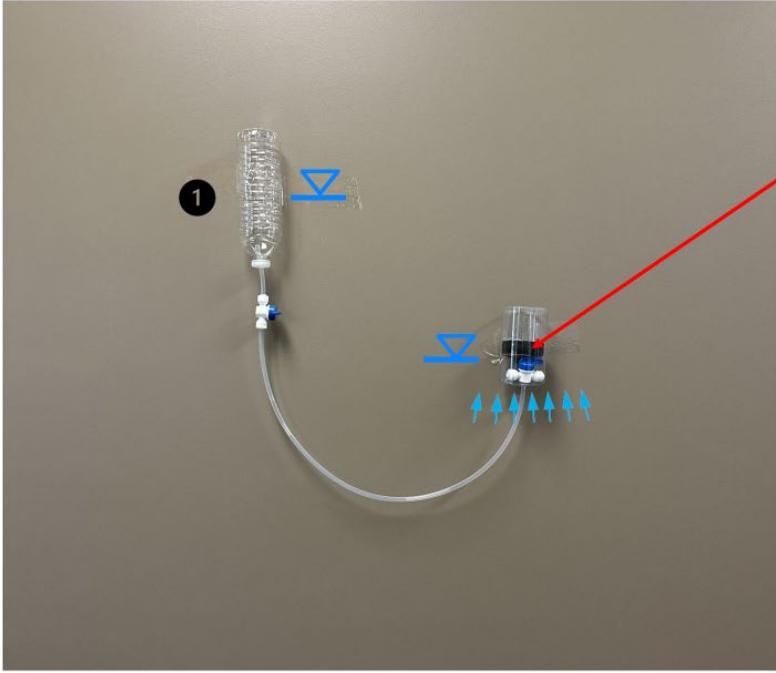
G. Primer – Friction & Artesian Pressure (hands-on demonstration of principles)

Sandpaper glued at
the base of a plastic
puck

Pressure on the puck
↑↑↑↑↑↑↑ is independent
of the size of the tube

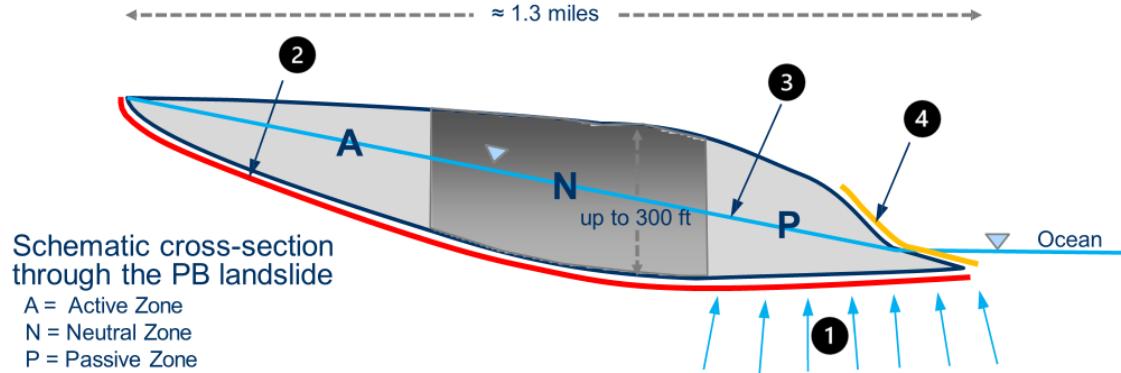
Schematic cross-section
through the PB landslide

A = Active Zone
N = Neutral Zone
P = Passive Zone

Given the site constraints, mitigation can address a subset of causal factors

- ① Confined water below basal surface (artesian pressure)
- ② Bentonite beds with adverse inclinations (incl. basal surf.)
- ③ Perched water above slip surface
- ④ Erosion at landslide toe
- ⑤ Other (adjacent landslides, Eq, load on A, ...)

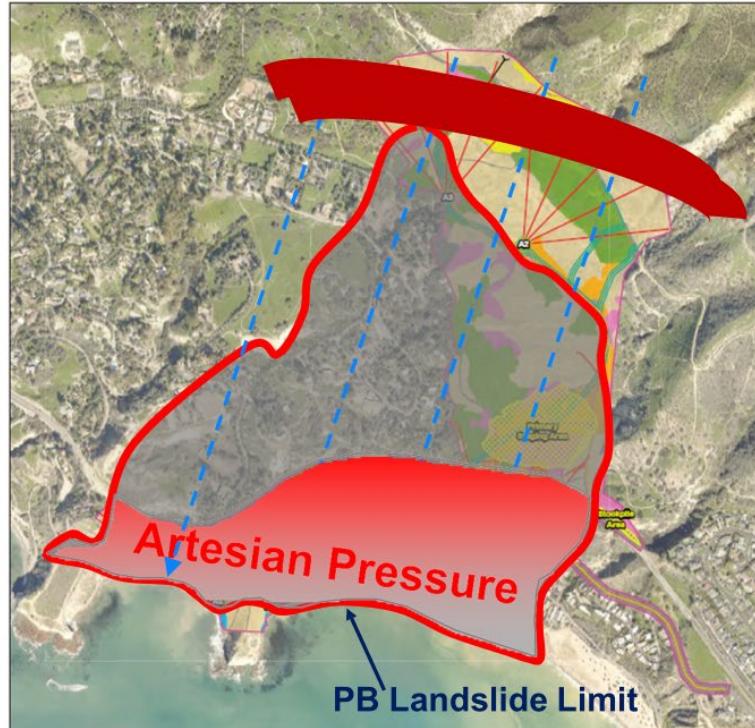
- Approximate PB Landslide limit
- Approximate BRIC limit
- ←— Approx. direction of groundwater flow
- Zone of significant artesian pressure
- Conceptual remedy – a hypothetical groundwater flow barrier

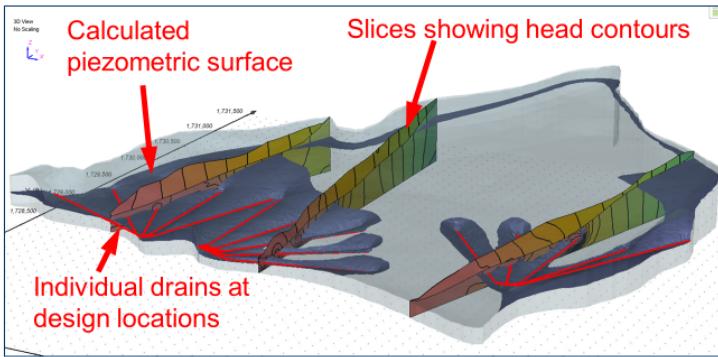
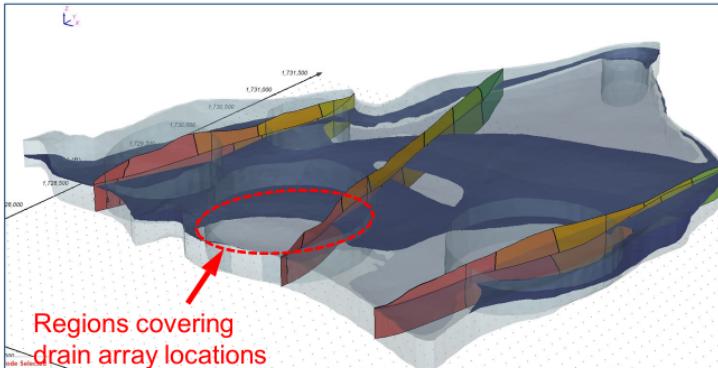
Positioning & Sizing of Hydraugers (3D Seepage Modeling)

Modeling considerations included:

- Individual drains (top) versus array-wide (bottom)
- Transient versus steady-state seepage
- “Accuracy,” computation time, and quality of input information
- “Other” (Public Comment)

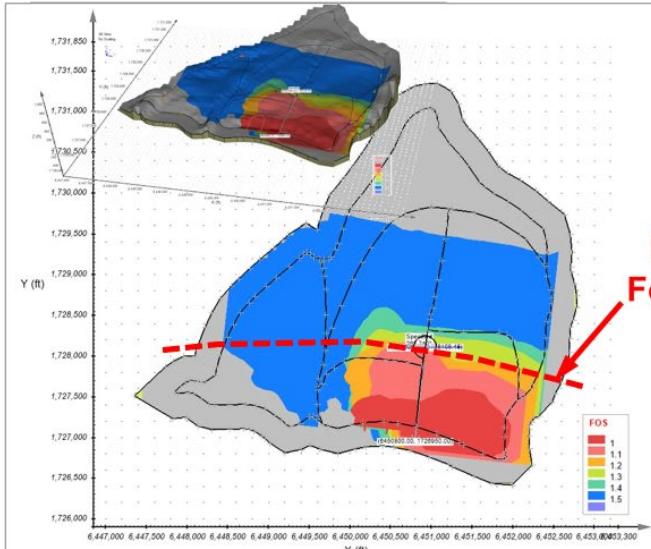
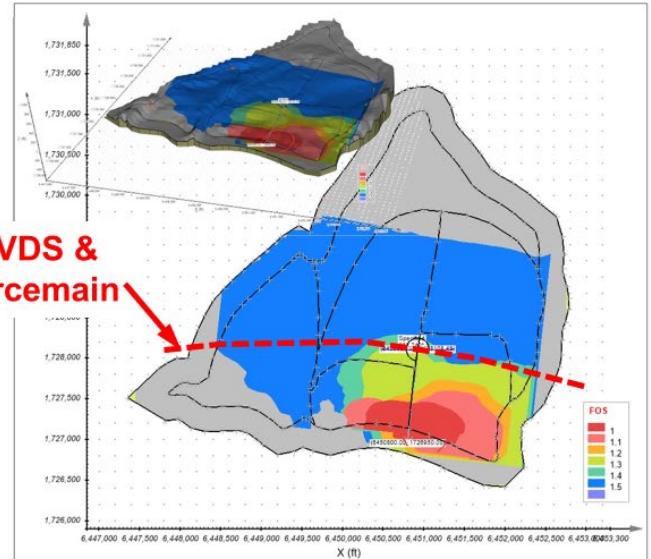
“existing”

with drains

- Reduced extents of fastest movement (red and pink)
- Reduced movement rate at road / forcemain location

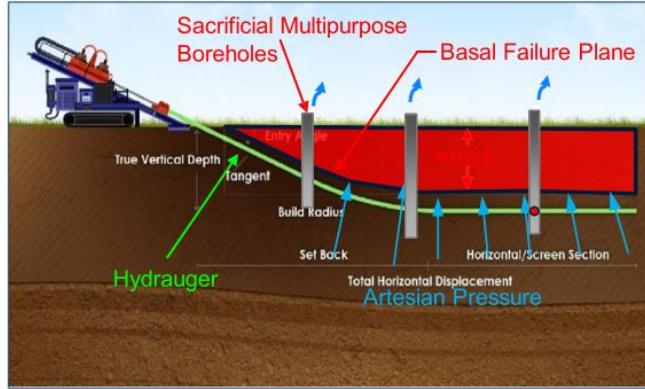
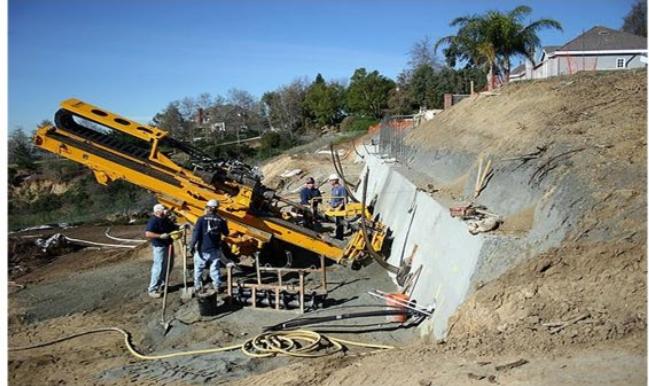
(Bottom Hydraugers)

- ≈150-ft deep dual pilot holes (2 holes next to each other to accommodate inclinometers and standpipe piezometers)
- Up to 1/4 mile-long artesian pressure relief hydraugers (directionally drilled; sequentially advanced)
- Possibly curved hydrauger alignment (curved in horiz. direction; directed with Gyroscopic Steering Tool, GST)
- Specialty equipment required; Wingwalls might be required at some locations
- Significant artesian pressure may not develop before May – June; may need to pump out
- Discharge to Klondike Canyon, LACSD Sewer Line, with some temporary storage on-site

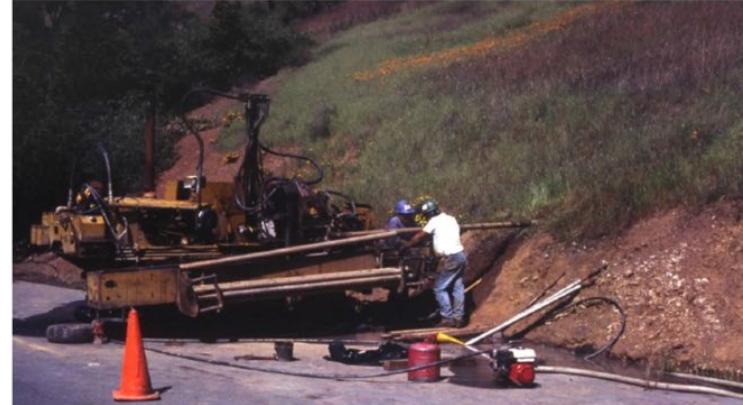
(Top Hydraugers)

- “Straight” interceptor hydrauger alignment - gravity-drained ($\approx 2\%$ out of slope)
- No artesian pressure expected
- Installed using “conventional” equipment
- Access is an issue; Can be repaired if sheared off
- Water discharged into canyons

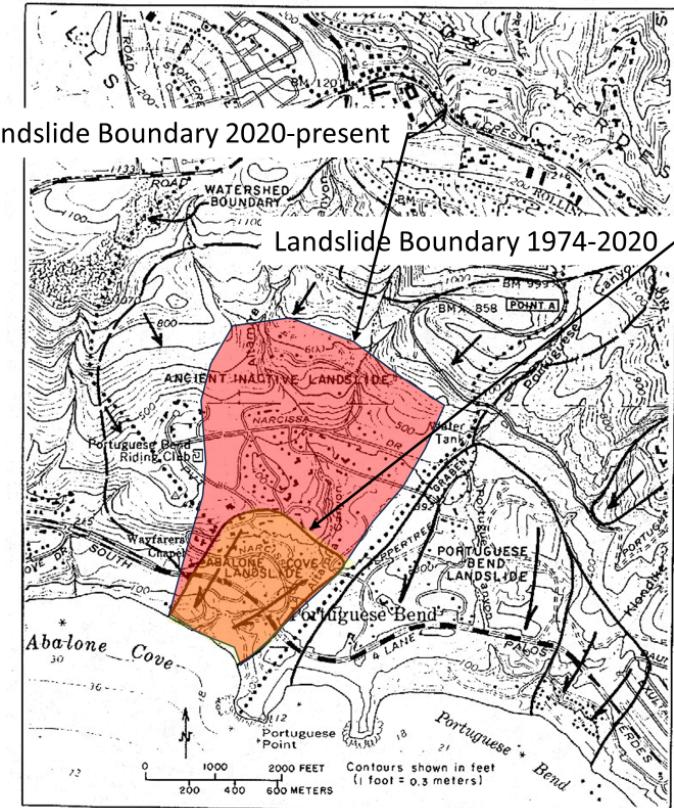
Figure 2
Site Map of the Portuguese Bend and Abalone Cove Landslides

- Surveys indicate increase in land movement
- Abalone Cove Landslide boundaries have more than double

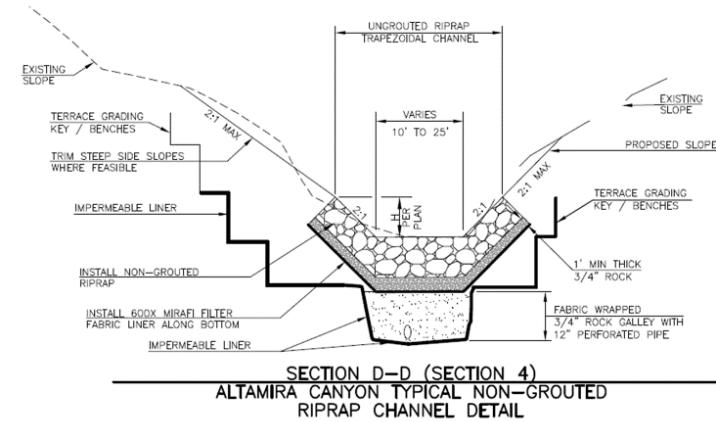
Altamira Canyon Lining

- Install Trapezoidal Channel
 - provides natural bedding to seasonal creek
 - Minimizes impact on wildlife in the Land Conservancy
- Stabilizes erosion of the canyon
- Protects the fissures from water intrusion

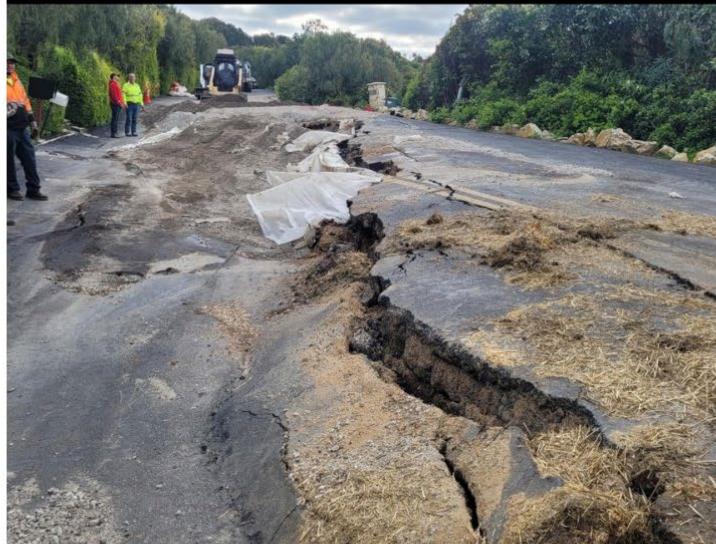
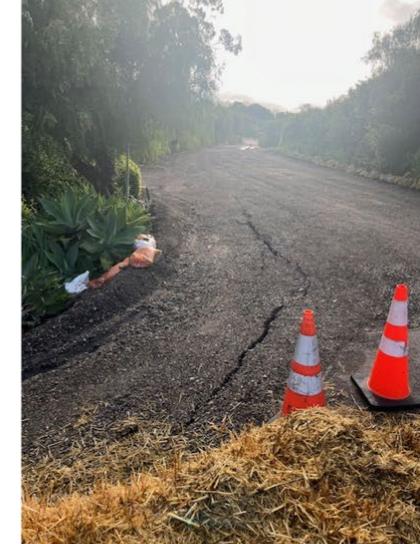
Road Damage – Lower Cinnamon

Before Repair

With CMB

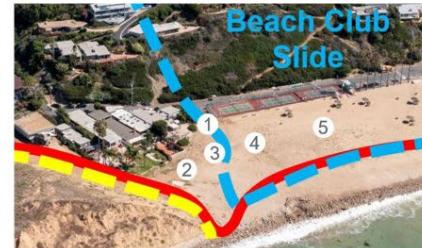
Step 2

5 active Wells ~ 400K Gal/day
210 days to remove 2023 rains (have 2-wells now)

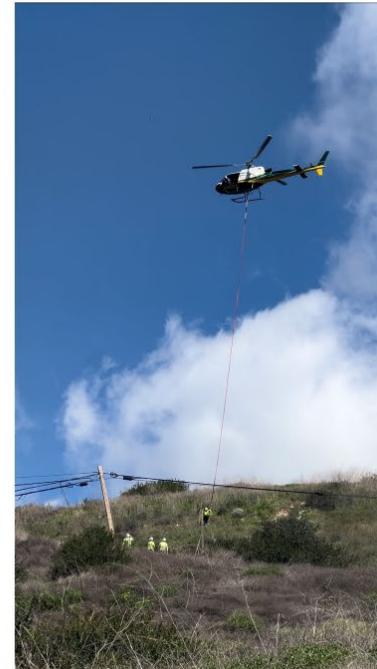
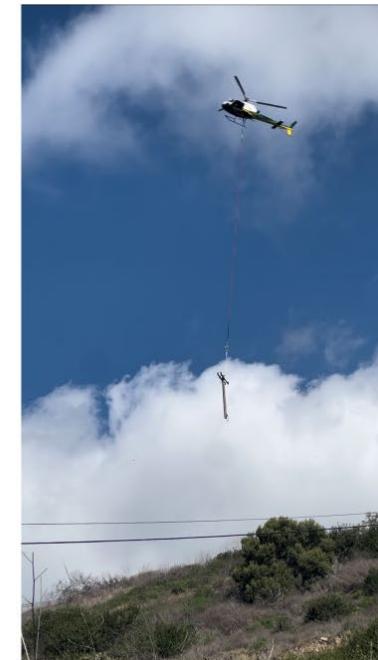
SCE Aerial Unit performing work in the Burma Trail.

The SCE Air Unit also regularly pro-actively inspects all poles, equipment and distribution lines in Rancho Palos Verdes, as part of their ongoing wildfire mitigation efforts.
