City of Rancho Palos Verdes
Rancho Palos Verdes ADA Assessment
Facility Report with Photos

Facility ID: # 11 - Point Vicente Fishing Access

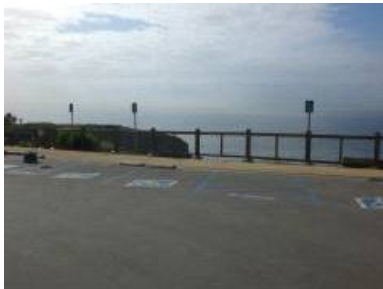
Location: Parking
Photo # 2

Field Condition	
01.09 - Stall Dimensions - Accessible parking spaces, including van spaces, are not at least 9' wide and 18' long with a demarcated access aisle. (Two spaces may share a common aisle; parking space width is measured from the center line of the stripe on one side to the center line of the stripe on the other.)	1991 ADAAG 4.6.3
Existing Condition: 17'-7" long.	2004 ADAAG 502.2
	2007 CBC 1129B.3 items 1 & 2
	Other

Classification	
DOJ Location Type:	1
Use:	PV
Severity:	C
Level of Difficulty	Low to Moderate

Corrective Action
193B - Re-stripe for Compliant Dimensions - Re-stripe to provide parking spaces with compliant dimensions.
Additional Comments:

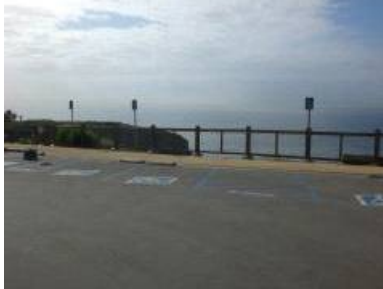
Keynote 3

Field Condition

01.10A - Van Access Aisle - Dimensions - Where the parking space is designated as "van accessible," the adjacent access aisle is not at least 8' wide by 18' long. (Aisle width is measured from the center line of the stripe on one side to the center line of the stripe on the other.)

Existing Condition: 17'-7" long by 8'-6" wide.

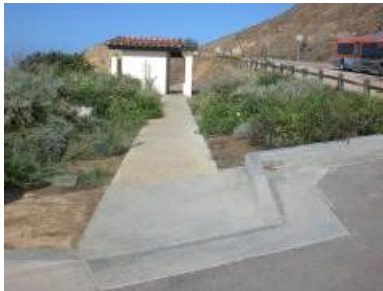
Keynote 49

Field Condition

16.04 - Accessible Path of Travel - Toilet room is not located on an accessible route of travel.

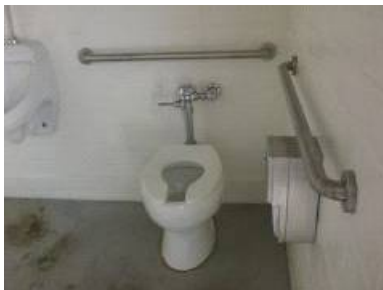
Keynote 60

Field Condition

16.55B - Back Grab Bar Height - Non-Tank-Type WC - At non-tank-type WC, back grab bar is not centered at 33" AFF. (ADA Standards require back grab bars to be centered from 33" to 36" AFF; CBC Standards require back grab bars to be centered at 33" AFF.)

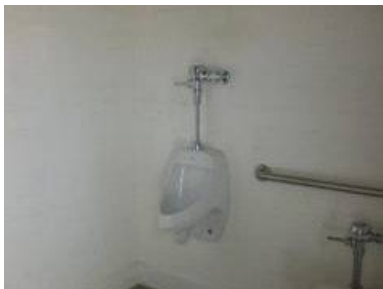
Keynote 62

Field Condition	
16.65D - Urinal Flush Controls - Height - Height of urinal flush controls exceeds 44" AFF. Existing Condition: 51" high.	1991 ADAAG 4.18.4 2004 ADAAG 605.4; 604.6; Advisory 604.6 2007 CBC 1115B.4.2(2) Other -

Classification	
DOJ Location Type:	3
Use:	PV
Severity:	C
Level of Difficulty	Moderate

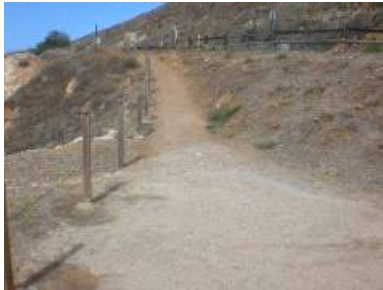
Keynote 71

Field Condition

30.10A - Trail Segment - Running Slope - Running slope of trail segment in the direction of travel does not comply with the following: a. 5% or less for any distance. b. From 5.1% to 8.33% for 200' maximum. c. From 8.34% to 10% for 30' maximum. d. From 10% to 12% for 10' maximum.

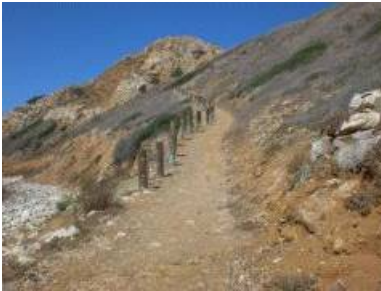
Keynote 76

Field Condition

30.10A - Trail Segment - Running Slope - Running slope of trail segment in the direction of travel does not comply with the following: a. 5% or less for any distance. b. From 5.1% to 8.33% for 200' maximum. c. From 8.34% to 10% for 30' maximum. d. From 10% to 12% for 10' maximum.

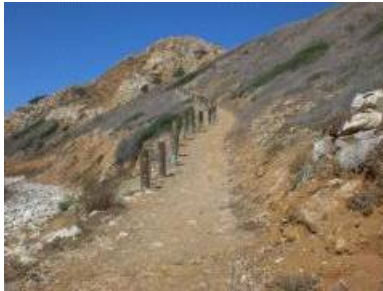
Keynote 77

Field Condition

30.10B - Trail Resting Space - Resting space does not comply with 1999 ADAAG Section 16.2.8 (Resting intervals shall be 60" min. in length, shall have a width at least as wide as the trail and have a slope of 5% or less in any direction. The installation of resting spaces is required as follows: Percent slope, maximum length, Rest interval: 0% to 5.0%, No restriction, No restriction; 5.1% to 8.33%, 200', Every 200'; 8.34% to 10%, 30', Every 30'; 10.1% to 12%, 10', Every 10'.)
