*City of Rancho Palos Verdes*  
**Rancho Palos Verdes ADA Assessment**  
**Facility Report with Photos**

**Facility ID: # 06 - Founders Park**

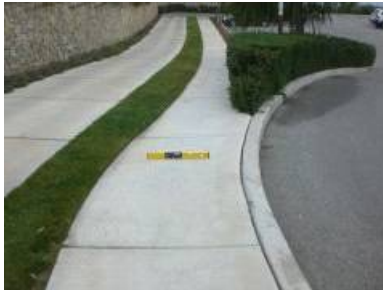
Location: Park Area Photo # 8

Field Condition	
03B.11 - Ramps - This portion of an accessible route with a slope greater than 5% does not comply with the requirements for compliant ramps.	1991 ADAAG 4.8.1
Existing Condition: 6.7% to 11.5% RS.	2004 ADAAG 405
	2007 CBC 1133B.5
	Other -

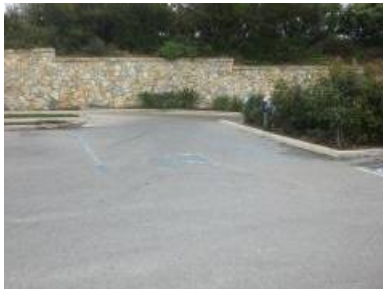
Field Condition	
01.13 - Level Surface - The accessible parking spaces and access aisles are not level (slope is greater than 2%).	1991 ADAAG 4.6.3
Existing Condition: 3.1%.	2004 ADAAG 502.4; advisory 502.4
	2007 CBC 1129B.3 items 3 & 4
	Other

Corrective Action	
194 - Asphalt Paved Parking Stall and Access Aisle - Remove non-compliant pavement and replace with new asphalt paving. The parking space and access aisle slope shall not exceed 2% in any direction.	
Additional Comments:

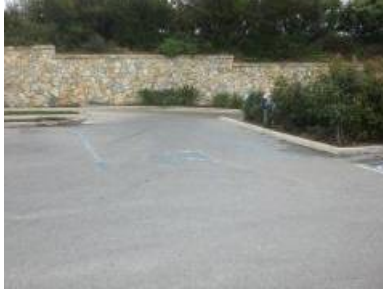
<b>Field Condition</b>	
01.19A - Lettering - The words "NO PARKING" is not provided in each access aisle, painted in white, 12" high letters.	1991 ADAAG -
Existing Condition:	2004 ADAAG -
	2007 CBC 1129B.3 items 1 & 2
	Other

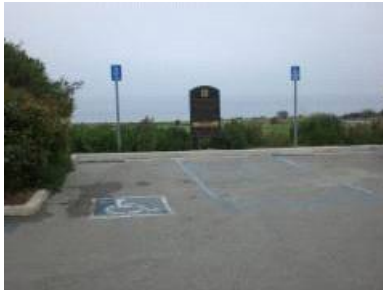
Location: Parking Photo # 18

<b>Field Condition</b>	
01.15C - Minimum Fine Sign - Accessible parking space has no sign stating "Minimum Fine \$250" below the ISA.	1991 ADAAG -
Existing Condition:	2004 ADAAG -
	2007 CBC 1129B.4
	Other

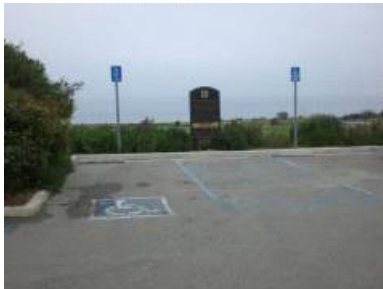
Location: Parking Photo # 18

<b>Field Condition</b>	
01.18 - Pavement Sign - A 36" square ISA is not painted on the pavement at the rear of the stall.	1991 ADAAG -
Existing Condition: 48" x 49".	2004 ADAAG 502.6
	2007 CBC 1129B.4
	Other

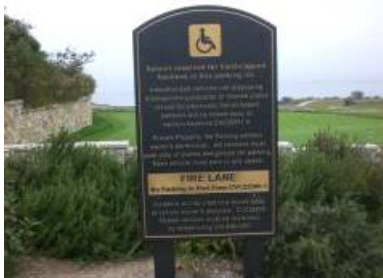
<b>Field Condition</b>	
01.23 - Other - Parking - See Additional Comments	1991 ADAAG -
Existing Condition: Term 'handicapped' used on sign.	2004 ADAAG -
	2007 CBC -
	Other

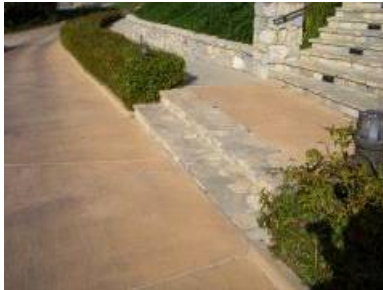
**Location:** Stairs  
**Photo #** 47

<b>Field Condition</b>	
08.07B - Intermediate Handrail - At stair required to be more than 88" wide, there is not at least one intermediate handrail for each 88" of required width.	1991 ADAAG -
Existing Condition:	2004 ADAAG -
	2007 CBC 1133B.4.1.1
	Other -

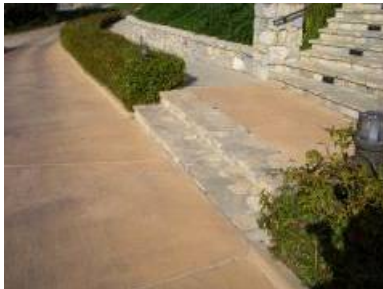
**Location:** Stairs  
**Photo #** 47

<b>Field Condition</b>	
08.03E - Drainage - Design of outside stairs and their approaches allows water to accumulate on walking surfaces.	1991 ADAAG 4.9.6
Existing Condition: 5.8% to 6.4% slope at landing.	2004 ADAAG 504.7
	2007 CBC 1133B.4.5.1
	Other -

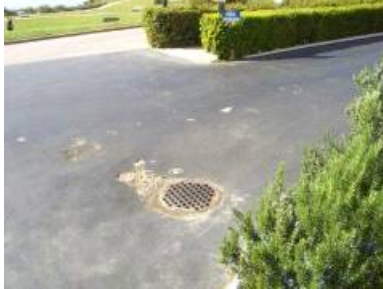
03B.21 - Hazardous Vehicular Areas - Detectable Warnings - Where a walk crosses or adjoins the vehicular way and the walking surface is not separated by curbs, railings, or other elements between the pedestrian areas and vehicular areas, the boundary between the areas is not defined by a continuous detectable warning at least 36" wide complying with CBC 1121B.3.1 item 8(a). (i.e., the warning surface shall contrast visually with adjoining surfaces, either light on dark or dark on light, and shall differ from adjoining walking surfaces in resiliency or sound on cane contact. Color: yellow conforming to Federal Color No. 33538, Table IV/ Standard No. 595B. Where the color value contrast between the yellow warning and the main walking surface is less than 70 percent, a 1" wide black strip shall separate the yellow warning from the main walking surface.)

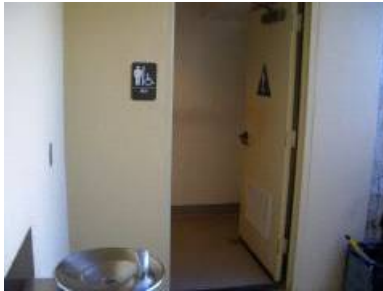
**Location:** Men's Restroom  
**Photo #** 58

<b>Field Condition</b>									
16.10 - Single-Action Hardware - Handles, locks, and latches or other operative devices are not operable with one hand. OR They are not operable without tight grasping, pinching, or twisting of the wrist. (U-shaped handles, levers, and push/pull type mechanisms are acceptable designs.)

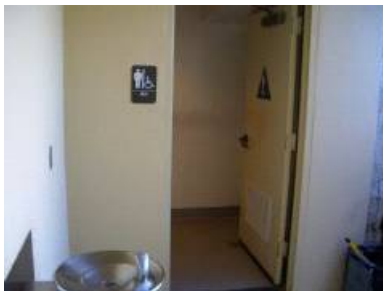
**Location:** Men's Restroom  
**Photo #** 58

<b>Field Condition</b>									
16.11A - Door Operating Effort - The force required to operate door exceeds 5 lbs. (Fire doors may have up to 15 lbs to achieve positive latching).

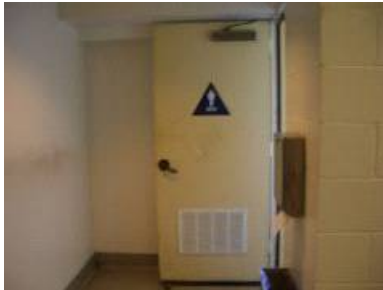
16.09A - Door Maneuvering Space - Door that is not automatic or power-assisted does not have compliant maneuvering space relative to the direction of approach as shown in CBC Fig. 11B-26. (Approach // Side // Width // Depth) (Front // Pull // D + 24" \* // 60") (Front // Push // D + 0" \*\* // 48") (Latch // Pull // D + 24" // 60") (Latch // Push // D + 24" // 44" \*\*\*) (Hinge // Pull // D + 36" // 60") (Hinge // Push // 54" \*\*\*\* // 44" \*\*\*\*\*) (\* D + 18" at interior doors.) (\*\* D + 12" if door has both a latch and a closer.) (\*\*\*) 48" if door has closer.) (\*\*\*\* Measured from latch toward hinge.) (\*\*\*\*\* 48" if door has both a latch and a closer.)

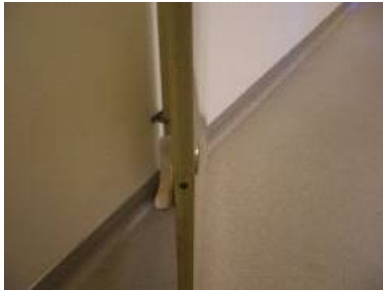
**Location:** Men's Restroom  
**Photo #** 62

<b>Field Condition</b>	
16.32A - U-Pulls at Stall Door - The stall door does not have U-pulls on both sides.	<b>1991 ADAAG</b> 4.13.9; 4.17.5
Existing Condition:	<b>2004 ADAAG</b> 309.4; 404.27; 604.8.1.2
	<b>2007 CBC</b> 1115B.3.1(4.4)
	<b>Other</b> -

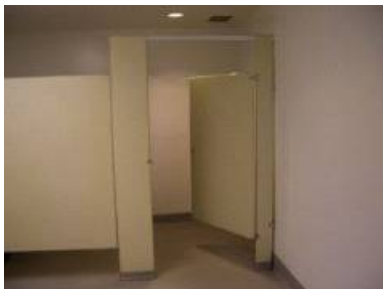
<b>Field Condition</b>	
16.33 - Self-Closing Stall Door - The stall door is not self-closing.	<b>1991 ADAAG</b> 4.13.10
Existing Condition:	<b>2004 ADAAG</b> 604.8.1.2
	<b>2007 CBC</b> 1115B.3.1(4.4)
	<b>Other</b> -

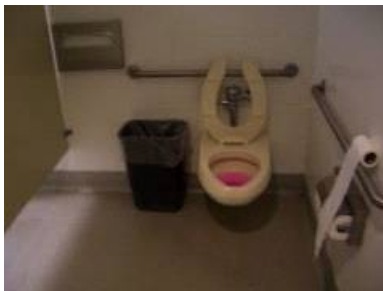
16.59 - Side Grab Bar - At WC providing front transfer, the side grab bar location is not compliant. (CBC Standards require the side grab bar to extend at least 54" min.. beyond the back wall while the other end is 12" max.. from the back wall. CBC also requires the grab bar's front end to be positioned 24" min.. in front of the WC.)

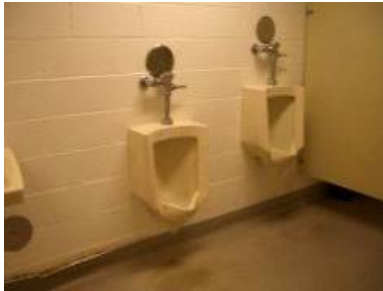
**Location:** Men's Restroom  
**Photo #** 68

16.65A - Wall-Hung Urinal - Rim Projection from Wall - The wall-hung urinal's elongated rim does not project 14" min.. to 17" max.. from the wall.

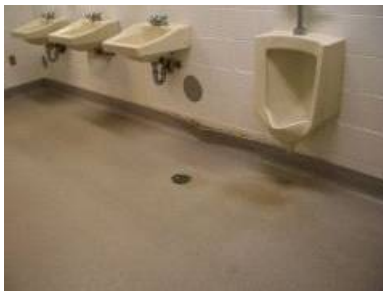
14.25 - > 1/4" Changes in Level - At level changes, the vertical difference between them exceeds 1/4 inch. OR Changes in level between 1/4 inch and 1/2 inch are not beveled with a slope no greater than 1:2.

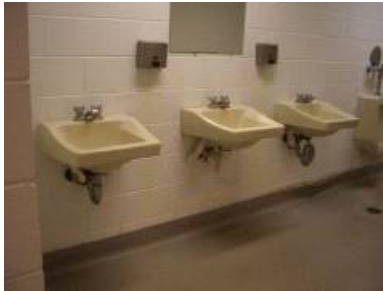
**Location:** Men's Restroom  
**Photo #** 70

16.73 - Lavatory Knee Clearance - Lavatory does not provide accessible knee clearance (i.e. at least 27" clearance from the floor to the underside of the lavatory, extending 8" min.. measured from the front edge underneath the lavatory back towards the wall).

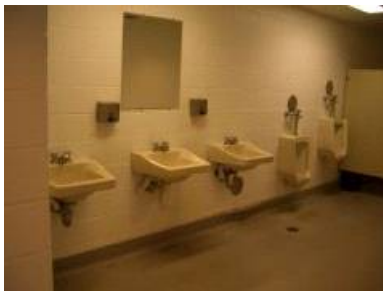
16.82A - Mirror Height - Max. 40" AFF Standard - Mirror above accessible lavatory or countertop is mounted so the bottom edge of the reflective surface is not 40" max.. AFF. (ADA Standards require at least one mirror to be accessible; CBC Standards prior to August 1, 2009 required all mirrors to be accessible. Effective August 1, 2009, amended CBC Standards require all mirrors above accessible lavatories or countertops to be accessible.)

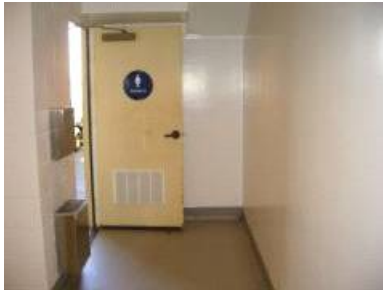
16.09A - Door Maneuvering Space - Door that is not automatic or power-assisted does not have compliant maneuvering space relative to the direction of approach as shown in CBC Fig. 11B-26. (Approach // Side // Width // Depth) (Front // Pull // D + 24" \* // 60") (Front // Push // D + 0" \*\* // 48") (Latch // Pull // D + 24" // 60") (Latch // Push // D + 24" // 44" \*\*\*) (Hinge // Pull // D + 36" // 60") (Hinge // Push // 54" \*\*\*\* // 44" \*\*\*\*\*) (\* D + 18" at interior doors.) (\*\* D + 12" if door has both a latch and a closer.) (\*\*\*) 48" if door has closer.) (\*\*\*\* Measured from latch toward hinge.) (\*\*\*\*\* 48" if door has both a latch and a closer.)

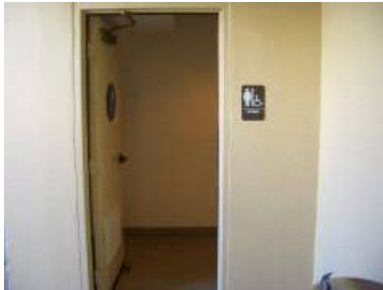
**Location:** Women's Restroom  
**Photo #** 74

<b>Field Condition</b>	
16.11A - Door Operating Effort - The force required to operate door exceeds 5 lbs. (Fire doors may have up to 15 lbs to achieve positive latching).	<b>1991 ADAAG</b> 4.13.11
Existing Condition: 17 LBF.	<b>2004 ADAAG</b> 404.2.9
	<b>2007 CBC</b> 1133B.2.5
	<b>Other</b> -

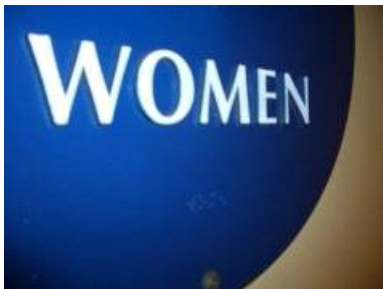
<b>Field Condition</b>	
16.21A - Raised Characters and Braille (Visual/Tactile Signs) - The raised characters on this sign are not accompanied by California Grade 2 Braille (i.e., the dots within each cell are domed and spaced 1/10" o.c.)	<b>1991 ADAAG</b> 4.30.4
Existing Condition:	<b>2004 ADAAG</b> 703.2; 703.3
	<b>2007 CBC</b> 1117B.5.5 item 1, 1117B.5.6
	<b>Other</b> -

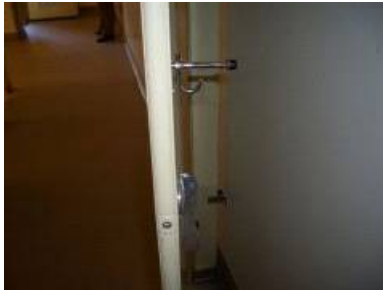
Location: Women's Restroom Photo # 76

<b>Field Condition</b>	
16.32A - U-Pulls at Stall Door - The stall door does not have U-pulls on both sides.	1991 ADAAG 4.13.9; 4.17.5
Existing Condition:	2004 ADAAG 309.4; 404.27; 604.8.1.2
	2007 CBC 1115B.3.1(4.4)
	Other -

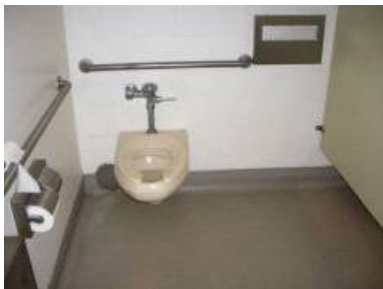
<b>Field Condition</b>	
16.47A - WC Location from Sidewall - The centerline of the WC is not 18" absolute from a wall or partition.	1991 ADAAG 4.22.4
Existing Condition: 18 3/8".	2004 ADAAG -
	2007 CBC 1115B.4.1(1)
	Other -

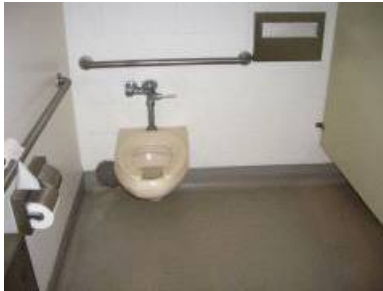
**Location:** Women's Restroom  
**Photo #** 77

<b>Field Condition</b>	
16.55A - Side Grab Bar Height - Side grab bar is not centered at 33" AFF. (ADA Standards require side grab bars to be centered from 33" to 36" AFF; CBC Standards require side grab bars to be centered at 33" AFF.)	<b>1991 ADAAG</b> 4.17.6; Figs. 29 & 30  <b>2004 ADAAG</b> 604.5; Advisory 604.5; 604.5.2; Fig. 604.5.2; 609.4  <b>2007 CBC</b> 1115B.4.1(3.1); Fig. 11B-1A  <b>Other</b> -
Existing Condition: 32 3/4" high.

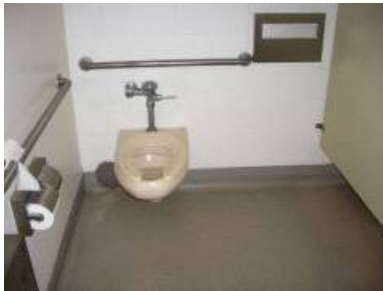
**Location:** Women's Restroom  
**Photo #** 77

<b>Field Condition</b>	
16.55C - Back Grab Bar Height - Tank-Type WC - At tank-type WC, back grab bar is not centered between 33" and 36" AFF or does not maintain 1-1/2" min.. space between the grab bar and the top of the tank.	<b>1991 ADAAG</b> 4.17.6; Figs. 29 & 30  <b>2004 ADAAG</b> 604.5; Advisory 604.5; 609.4  <b>2007 CBC</b> 1115B.4.1(3.2); Fig. 11B-1A  <b>Other</b> -
Existing Condition: 33 7/8" high.

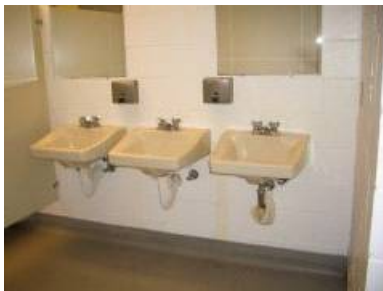
**Location:** Women's Restroom  
**Photo #** 81

**Field Condition**  
 16.73 - Lavatory Knee Clearance - Lavatory does not provide accessible knee clearance (i.e. at least 27" clearance from the floor to the underside of the lavatory, extending 8" min.. measured from the front edge underneath the lavatory back towards the wall).  
 Existing Condition: 26" high.

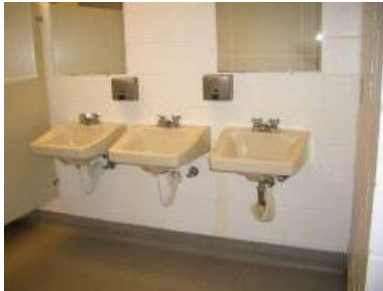
16.82A - Mirror Height - Max. 40" AFF Standard - Mirror above accessible lavatory or countertop is mounted so the bottom edge of the reflective surface is not 40" max.. AFF. (ADA Standards require at least one mirror to be accessible; CBC Standards prior to August 1, 2009 required all mirrors to be accessible. Effective August 1, 2009, amended CBC Standards require all mirrors above accessible lavatories or countertops to be accessible.)

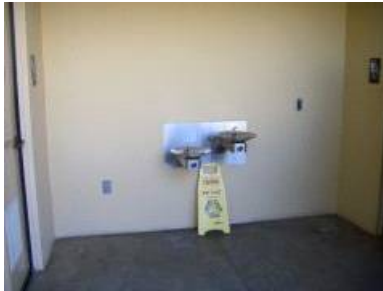
**Location:** Drinking Fountain  
**Photo #** 84

Field Condition	
05.05A - Knee Space Height - Drinking fountain provides less than 27" high accessible knee clearance between the bottom of the apron and the floor.	1991 ADAAG 4.15.5(1); Figs. 27(a) and (b)
Existing Condition: 26 1/2" high.	2004 ADAAG 306.3; Fig. 306.3
	2007 CBC 1115B.4.6 item 2
	Other -

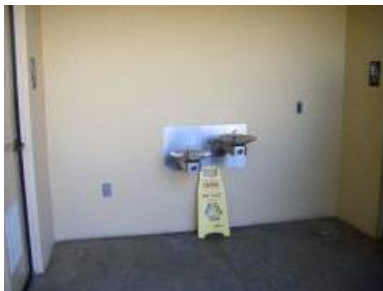
**Location:** Drinking Fountain  
**Photo #** 84

Field Condition	
05.13 - Operation - The controls are not compliant.(Accessible controls shall be operable with one hand, and without tight grasping, pinching, or twisting of the wrist, and the force to operate the controls shall be no greater than 5 lbs.)	1991 ADAAG 4.27.4
Existing Condition: 7 LBF.	2004 ADAAG 602.3; 309.4
	2007 CBC 1115B.4.6 item 4
	Other -

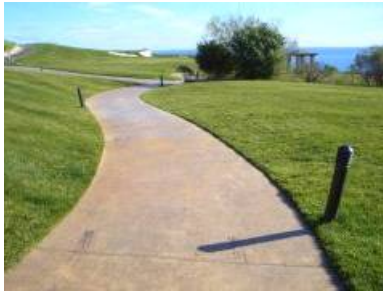
**Keynote 86**

<b>Field Condition</b>									
03B.09 - Cross Slope - Cross slope of the accessible route of travel exceeds 1:50. Existing Condition: 2.3% to 4.7% CS.

<table><tr> <td><b>1991 ADAAG</b></td> <td>4.3.7</td> </tr></table>

<b>Corrective Action</b>
006 - Concrete Walk - Remove non-compliant pavement and replace with new concrete (area as shown on the drawings). The walkway slope shall not exceed 5% along the POT and cross slope shall not exceed 2%.  Additional Comments:

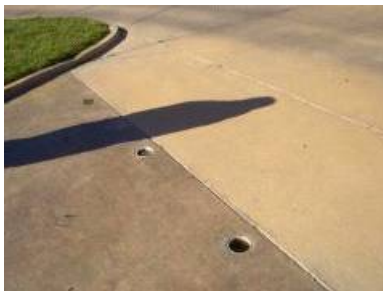
**Keynote 87**

<b>Field Condition</b>									
03B.13 - > 1/2" Changes in Level - Curb ramps, ramps, or elevators are not used for changes in level greater than 1/2 inch. (Lifts may only be used in certain limited situations.) Existing Condition: 4" in diameter, 7 1/2" deep bollard holes.

<table><tr> <td><b>1991 ADAAG</b></td> <td>4.5.2</td> </tr></table>

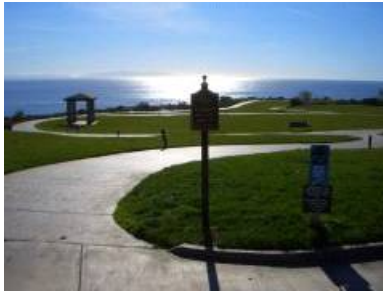
**Keynote 88**

Field Condition									
03B.10 - Running Slope - Slope of the accessible route of travel exceeds 1:20.  Existing Condition: 9.3% to 11.1% RS.

<table><tr> <td>1991 ADAAG</td> <td>4.3.7</td> </tr></table>

Corrective Action	
006 - Concrete Walk - Remove non-compliant pavement and replace with new concrete (area as shown on the drawings). The walkway slope shall not exceed 5% along the POT and cross slope shall not exceed 2%.	
Additional Comments:

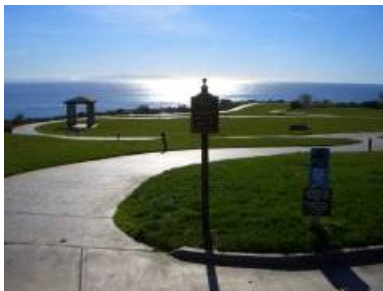
**Keynote 89**

Field Condition									
03B.09 - Cross Slope - Cross slope of the accessible route of travel exceeds 1:50.  Existing Condition: 2.9% CS.

<table><tr> <td>1991 ADAAG</td> <td>4.3.7</td> </tr></table>

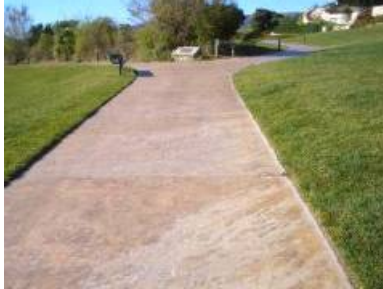
**Keynote 90**

Field Condition									
03B.10 - Running Slope - Slope of the accessible route of travel exceeds 1:20.  Existing Condition: 5.3% to 6.5% RS.

<table><tr> <td><b>1991 ADAAG</b></td> <td>4.3.7</td> </tr></table>

Corrective Action
006 - Concrete Walk - Remove non-compliant pavement and replace with new concrete (area as shown on the drawings). The walkway slope shall not exceed 5% along the POT and cross slope shall not exceed 2%.  Additional Comments:

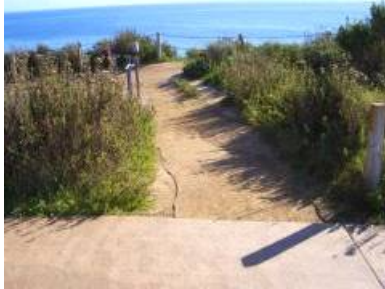
**Keynote 93**

Field Condition	
30.10A - Trail Segment - Running Slope - Running slope of trail segment in the direction of travel does not comply with the following: a. 5% or less for any distance. b. From 5.1% to 8.33% for 200' maximum. c. From 8.34% to 10% for 30' maximum. d. From 10% to 12% for 10' maximum.	1991 ADAAG -
Existing Condition: 11.6%.	2004 ADAAG -
	2007 CBC -
	Other 1999 ADAAG-16.2.7.2.1; 16.2.7.2.2; 16.2.7.2.3; 16.2.7.2.4

Classification	
DOJ Location Type:	1
Use:	PV
Severity:	C
Level of Difficulty	Moderate to High

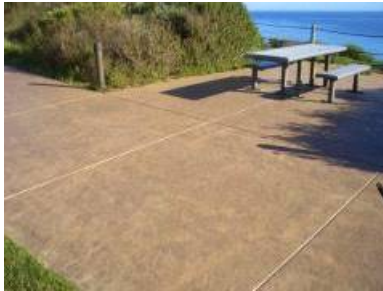
**Keynote 94**

<b>Field Condition</b>	
30.28 - Picnic Site - Surface Slope - The accessible picnic site is located on a surface area with slope greater than 2% in some or all directions.(1999 ADAAG: 3% slope is allowed when necessary for drainage).	1991 ADAAG 4.3.7
Existing Condition: 4.5% at picnic table.	2004 ADAAG 403.3
	2007 CBC -
	Other 1999 ADAAG-16.5.7

<b>Classification</b>	
DOJ Location Type:	1
Use:	PV
Severity:	C
Level of Difficulty	High

<b>Corrective Action</b>	
006 - Concrete Walk - Remove non-compliant pavement and replace with new concrete (area as shown on the drawings). The walkway slope shall not exceed 5% along the POT and cross slope shall not exceed 2%.	
Additional Comments:

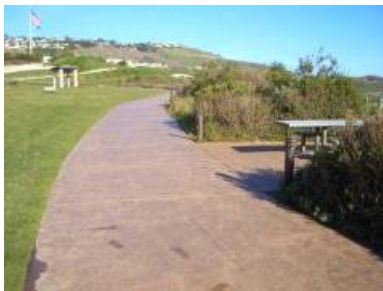
**Keynote 95**

<b>Field Condition</b>	
30.28 - Picnic Site - Surface Slope - The accessible picnic site is located on a surface area with slope greater than 2% in some or all directions.(1999 ADAAG: 3% slope is allowed when necessary for drainage).	1991 ADAAG 4.3.7
Existing Condition: 2.9%.	2004 ADAAG 403.3
	2007 CBC -
	Other 1999 ADAAG-16.5.7

<b>Classification</b>	
DOJ Location Type:	1
Use:	PV
Severity:	C
Level of Difficulty	High

<b>Corrective Action</b>	
006 - Concrete Walk - Remove non-compliant pavement and replace with new concrete (area as shown on the drawings). The walkway slope shall not exceed 5% along the POT and cross slope shall not exceed 2%.	
Additional Comments:

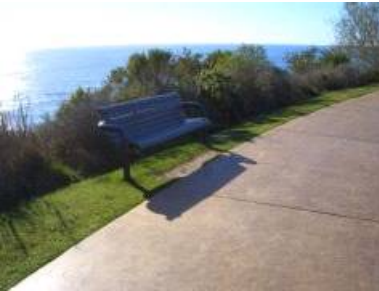
**Keynote 96**

Field Condition	
30.12 - Fixed Bench - Fixed bench is not accessible for users with various types of disabilities.	1991 ADAAG -
Existing Condition:	2004 ADAAG 903.1
	2007 CBC -
	Other 1999 ADAAG-16.12.2.1

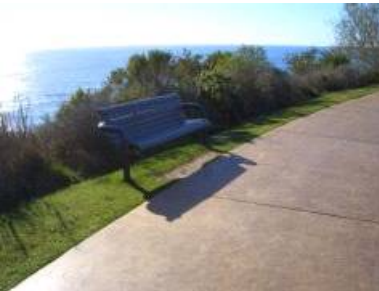
**Keynote 97**

Field Condition	
30.16 - Fixed Bench / Wheelchair Seating Space - Shoulder Alignment - A clear space at least 30" x 48" in size has not been provided at one end of the fixed bench so that a wheelchair user may be seated shoulder-to-shoulder with an individual seated on the bench.	1991 ADAAG -
Existing Condition:	2004 ADAAG -
	2007 CBC -
	Other 1999 ADAAG-16.12.4

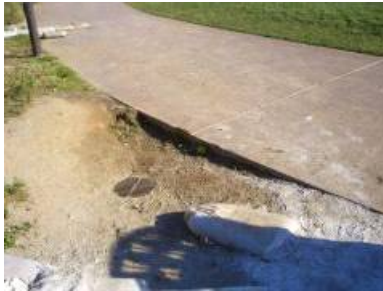
**Keynote 98**

<b>Field Condition</b>	
03B.13 - > 1/2" Changes in Level - Curb ramps, ramps, or elevators are not used for changes in level greater than 1/2 inch. (Lifts may only be used in certain limited situations.)	1991 ADAAG 4.5.2
Existing Condition: 3 1/2" change in level.	2004 ADAAG 303.4
	2007 CBC 1124B.2
	Other -

<b>Classification</b>	
DOJ Location Type:	1
Use:	PV
Severity:	A
Level of Difficulty	Moderate

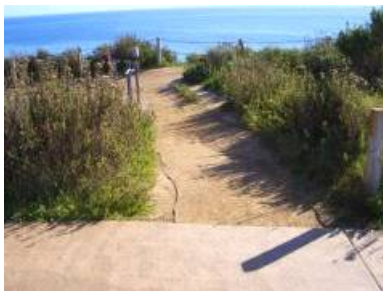
**Keynote 99**

<b>Field Condition</b>	
30.10C - Trail Segment - Cross Slope - Cross slope of the trail segment exceeds 1:20.	1991 ADAAG -
Existing Condition: 10.4% CS.	2004 ADAAG -
	2007 CBC -
	Other 1999 ADAAG-16.2.7.1

<b>Classification</b>	
DOJ Location Type:	1
Use:	PV
Severity:	C
Level of Difficulty	Moderate

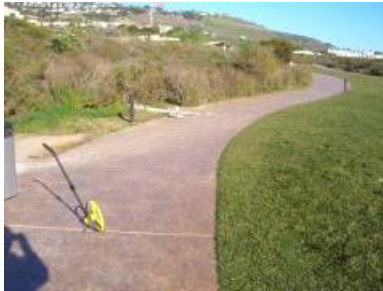
**Keynote 100**

Field Condition									
03B.10 - Running Slope - Slope of the accessible route of travel exceeds 1:20. Existing Condition: 5.4% to 6.8% RS.

<table><tr> <td>1991 ADAAG</td> <td>4.3.7</td> </tr></table>

Corrective Action
090B - Ramp with Handrails - Remove non-compliant pavement and replace with new ramp with handrails. The ramp slope shall not exceed 8.33% along the POT and cross slope shall not exceed 2%. Additional Comments: Provide new handrails at ramp condition.

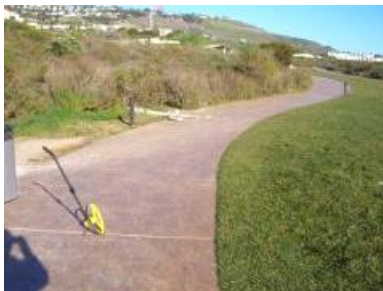
**Keynote 101**

Field Condition									
03B.09 - Cross Slope - Cross slope of the accessible route of travel exceeds 1:50. Existing Condition: 2.1% to 2.3% CS.

<table><tr> <td>1991 ADAAG</td> <td>4.3.7</td> </tr></table>

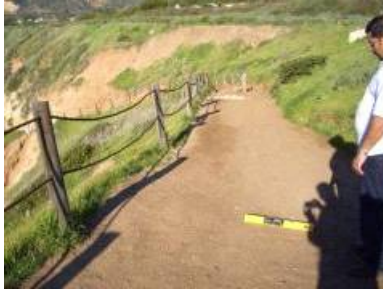
**Keynote 102**

<b>Field Condition</b>	
30.10A - Trail Segment - Running Slope - Running slope of trail segment in the direction of travel does not comply with the following: a. 5% or less for any distance. b. From 5.1% to 8.33% for 200' maximum. c. From 8.34% to 10% for 30' maximum. d. From 10% to 12% for 10' maximum.	<b>1991 ADAAG</b> -
Existing Condition: 6.3% to 24.2% RS.	<b>2004 ADAAG</b> -
	<b>2007 CBC</b> -
	<b>Other</b> 1999 ADAAG-16.2.7.2.1; 16.2.7.2.2; 16.2.7.2.3; 16.2.7.2.4

<b>Classification</b>	
<b>DOJ Location Type:</b>	1
<b>Use:</b>	PV
<b>Severity:</b>	A
<b>Level of Difficulty</b>	Low to Moderate

<b>Corrective Action</b>
429 - Signs - Miscellaneous - See Additional Comments
Additional Comments: Provide Sign stating trail condition, distance, point of departure, and directional route if other compliant trail is provided.

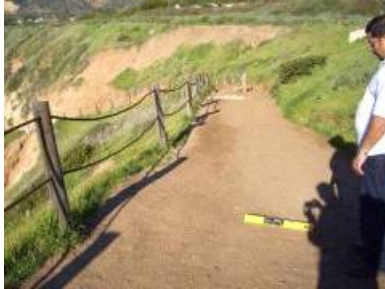
**Keynote 103**

Field Condition	
30.10C - Trail Segment - Cross Slope - Cross slope of the trail segment exceeds 1:20.	1991 ADAAG -
Existing Condition: 4.9% to 10% CS.	2004 ADAAG -
	2007 CBC -
	Other 1999 ADAAG-16.2.7.1

Classification	
DOJ Location Type:	1
Use:	PV
Severity:	C
Level of Difficulty	Moderate

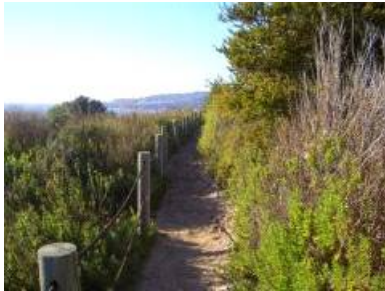
**Keynote 104**

**Field Condition**

Existing Condition: 5.0% to 19.2% RS.

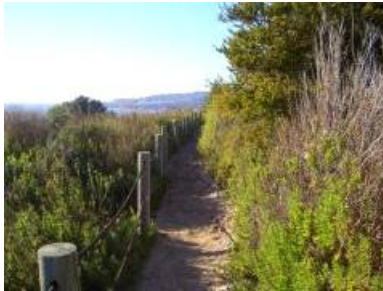
**Keynote 105**

<b>Field Condition</b>	
30.10C - Trail Segment - Cross Slope - Cross slope of the trail segment exceeds 1:20.  Existing Condition: 2.3% to 16.6% CS.	<b>1991 ADAAG</b> -  <b>2004 ADAAG</b> -  <b>2007 CBC</b> -  <b>Other</b> 1999 ADAAG-16.2.7.1

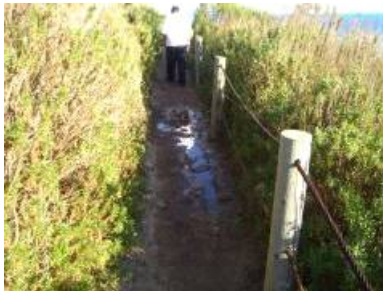
**Keynote 106**

<b>Field Condition</b>	
30.10E - Trail Surface - The surface of the trail is not firm or stable.  Existing Condition: Pond and erosion.	<b>1991 ADAAG</b> -  <b>2004 ADAAG</b> -  <b>2007 CBC</b> -  <b>Other</b> 1999 ADAAG-16.2.1

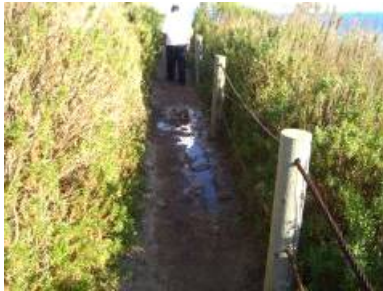
**Keynote 107**

Field Condition	
30.05 - Accessible Route - Width - Accessible route of travel is less than 48" wide (note: 48" wide requirement does not apply to doorways or gates).	1991 ADAAG 4.3.3
Existing Condition:	2004 ADAAG 403.5.1
	2007 CBC 1133B.7.1
	Other -

Classification	
DOJ Location Type:	1
Use:	PV
Severity:	C
Level of Difficulty	Moderate

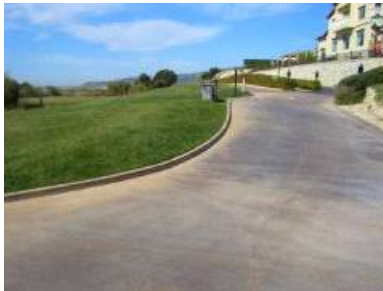
**Keynote 108**

Field Condition	
03B.10 - Running Slope - Slope of the accessible route of travel exceeds 1:20.	1991 ADAAG 4.3.7
Existing Condition: 6.1% to 7.8% RS.	2004 ADAAG 403.3
	2007 CBC 1133B.7.3
	Other -

Classification	
DOJ Location Type:	1
Use:	PV
Severity:	C
Level of Difficulty	Moderate to High

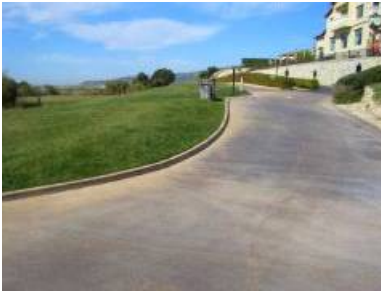
**Keynote 109**

Field Condition									
03B.09 - Cross Slope - Cross slope of the accessible route of travel exceeds 1:50. Existing Condition: 3.1%

<table><tr> <td><b>1991 ADAAG</b></td> <td>4.3.7</td> </tr></table>

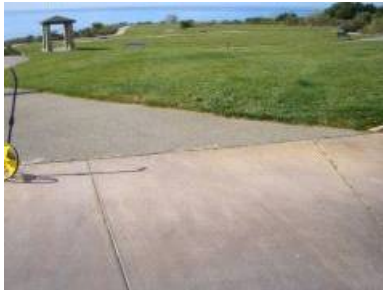
**Keynote 110**

**Field Condition**

03B.21 - Hazardous Vehicular Areas - Detectable Warnings - Where a walk crosses or adjoins the vehicular way and the walking surface is not separated by curbs, railings, or other elements between the pedestrian areas and vehicular areas, the boundary between the areas is not defined by a continuous detectable warning at least 36" wide complying with CBC 1121B.3.1 item 8(a). (i.e., the warning surface shall contrast visually with adjoining surfaces, either light on dark or dark on light, and shall differ from adjoining walking surfaces in resiliency or sound on cane contact. Color: yellow conforming to Federal Color No. 33538, Table IV/ Standard No. 595B. Where the color value contrast between the yellow warning and the main walking surface is less than 70 percent, a 1" wide black strip shall separate the yellow warning from the main walking surface.)

Existing Condition:

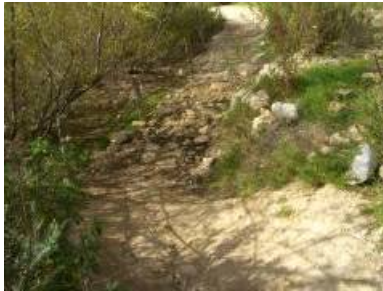
**Keynote 111**

Field Condition	
30.10E - Trail Surface - The surface of the trail is not firm or stable.	1991 ADAAG -
Existing Condition: Loose gravel & erosion.	2004 ADAAG -
	2007 CBC -
	Other 1999 ADAAG-16.2.1

Classification	
DOJ Location Type:	1
Use:	PV
Severity:	A
Level of Difficulty	Moderate to High

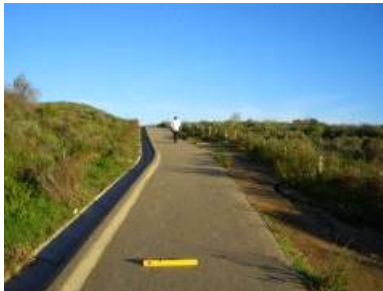
**Keynote 112**

Field Condition	
03B.09 - Cross Slope - Cross slope of the accessible route of travel exceeds 1:50.	1991 ADAAG 4.3.7
Existing Condition: 5.5%	2004 ADAAG 403.3
	2007 CBC 1133B.7.1.3
	Other -

Classification	
DOJ Location Type:	1
Use:	PV
Severity:	C
Level of Difficulty	Moderate

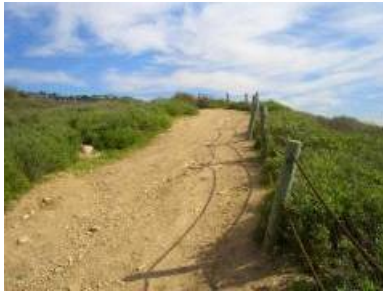
**Keynote 114**

**Field Condition**

30.10A - Trail Segment - Running Slope - Running slope of trail segment in the direction of travel does not comply with the following: a. 5% or less for any distance. b. From 5.1% to 8.33% for 200' maximum. c. From 8.34% to 10% for 30' maximum. d. From 10% to 12% for 10' maximum.

Existing Condition: 8.2% to 21.2% RS.

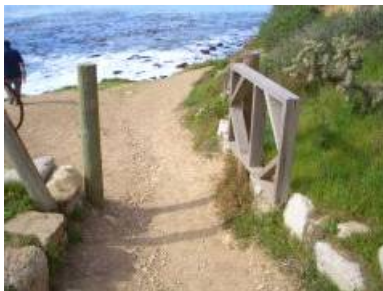
**Keynote 116**

<b>Field Condition</b>	
30.68 - Other - Parks - See Additional Comments	1991 ADAAG -
Existing Condition: 22 1/2" bottom gap at door.	2004 ADAAG -
	2007 CBC -
	Other -

<b>Classification</b>	
DOJ Location Type:	1
Use:	PV
Severity:	C
Level of Difficulty	Low to Moderate

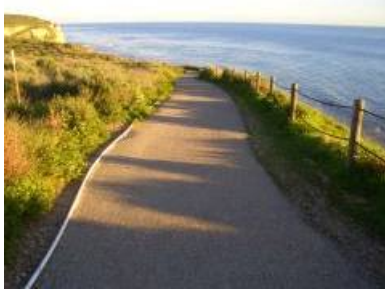
**Keynote 117**

Field Condition									
03B.10 - Running Slope - Slope of the accessible route of travel exceeds 1:20.  Existing Condition: 5.7% to 8.4% RS.

Corrective Action
004A - Asphalt Paving - Remove non-compliant pavement and replace with new asphalt paving (area as shown on the drawings). The walkway slope shall not exceed 5% along the POT and cross slope shall not exceed 2%.  Additional Comments:

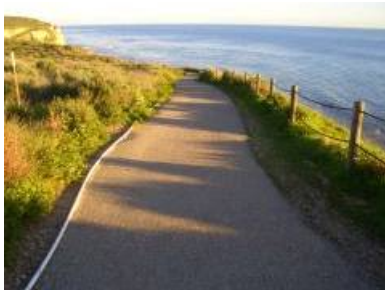
**Keynote 118**

Field Condition									
03B.09 - Cross Slope - Cross slope of the accessible route of travel exceeds 1:50.  Existing Condition: 2.6% to 5.5% CS.

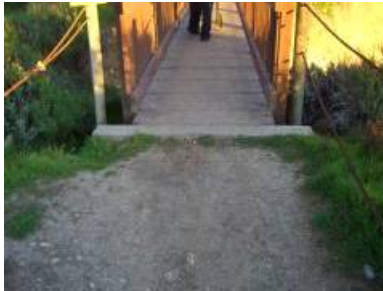
**Keynote 119**

**Field Condition**

30.07A - Openings in Outdoor Recreation Access Routes (ORAR) - Openings in the surface are greater than 1/2" wide. OR Elongated openings are not placed so that the long dimension is perpendicular or diagonal to the dominant direction of travel. Exception: Openings are permitted to run parallel to the direction of travel so long as the opening is no wider than 1/4".

Existing Condition: 1 1/2" level change from trail to bridge.

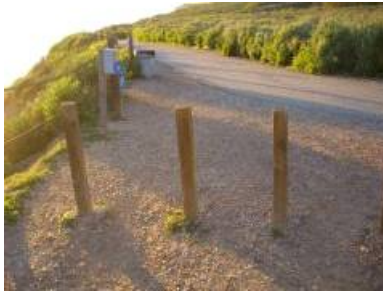
**Keynote 120**

**Field Condition**

30.10A - Trail Segment - Running Slope - Running slope of trail segment in the direction of travel does not comply with the following: a. 5% or less for any distance. b. From 5.1% to 8.33% for 200' maximum. c. From 8.34% to 10% for 30' maximum. d. From 10% to 12% for 10' maximum.

Existing Condition: 5.2% to 13.6% RS.

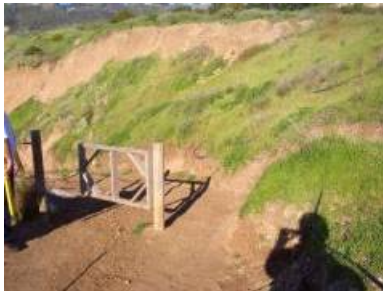
**Keynote 122**

<b>Field Condition</b>	
30.68 - Other - Parks - See Additional Comments	1991 ADAAG -
Existing Condition: Bottom of gate is greater than 3" above finished grade.	2004 ADAAG -
	2007 CBC -
	Other -

<b>Classification</b>	
DOJ Location Type:	2
Use:	PV
Severity:	C
Level of Difficulty	Low to Moderate

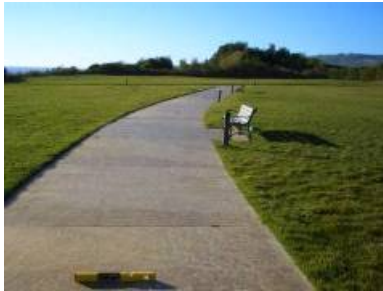
**Keynote 123**

Field Condition									
03B.09 - Cross Slope - Cross slope of the accessible route of travel exceeds 1:50. Existing Condition: 3.6% to 4.8% CS.

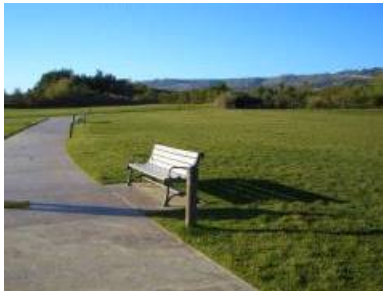
**Keynote 124**

Field Condition									
30.12 - Fixed Bench - Fixed bench is not accessible for users with various types of disabilities. Existing Condition: Provide wheelchair space next to fixed bench.

Corrective Action
008 - Concrete Landing - Remove non-compliant pavement and replace with new concrete. The landing slope shall not exceed 2% in any direction.  Additional Comments:
