City of Rancho Palos Verdes
Rancho Palos Verdes ADA Assessment
Facility Report with Photos

Facility ID: # Area 1 Pedestrian Signals

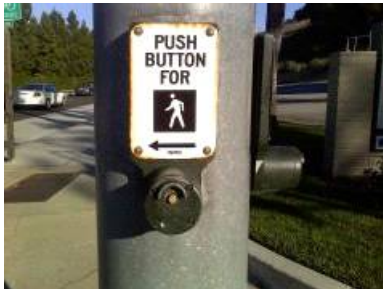
Field Condition	
04.32C - Push Button Size - The pedestrian signal push button is not a min.. 2" across in one dimension.	1991 ADAAG - 2004 ADAAG - 2007 CBC - Other 2005 PROWAG-R306.3.3
Existing Condition: 1/2" diameter.

Classification	
DOJ Location Type:	1
Use:	PV
Severity:	C
Level of Difficulty	Moderate

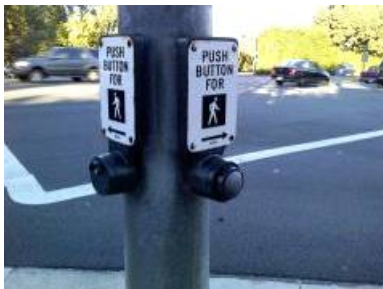
Location: Hawthorne Blvd. & Grayslake Rd.
Photo # 21

Field Condition	
04.24B - Vibrotactile Signal Device - A crosswalk with pedestrian signal indication does not have a vibrotactile signal device integrated into the signal device to indicate the WALK interval.	1991 ADAAG -
Existing Condition:	2004 ADAAG -
	2007 CBC -
	Other 2005 PROWAG-R306.2

Corrective Action
039 - Operable Parts - Miscellaneous - See Additional Comments
Additional Comments: Replace with vibrotactile signal device. Mount devices on separate poles a minimum of 10' apart.

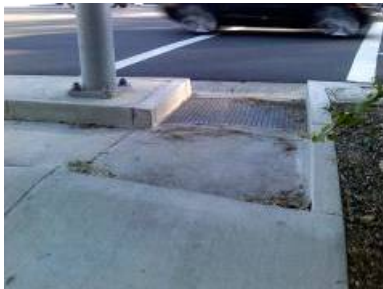
Field Condition	
04.25 - Pedestrian Signal Device - Clear Floor Space - Location of pedestrian signal device does not accommodate a level 30" x 48" min.. clear space, centered and parallel to the pedestrian signal push button. (Accessible pedestrian signals shall be located so that the vibrotactile feature can be contacted from the level landing serving a curb ramp, if provided, or from a clear floor or ground space that is in line with the crosswalk line adjacent to the vehicle stop line.)	1991 ADAAG 4.2.4
Existing Condition: 2.7% CS.	2004 ADAAG 305.3; Fig. 305.3
	2007 CBC 1118B.4 item 1
	Other 2005 PROWAG-R306.2.1

Classification	
DOJ Location Type:	1
Use:	PV
Severity:	C
Level of Difficulty	High

Corrective Action	
008 - Concrete Landing - Remove non-compliant pavement and replace with new concrete. The landing slope shall not exceed 2% in any direction.	
Additional Comments:

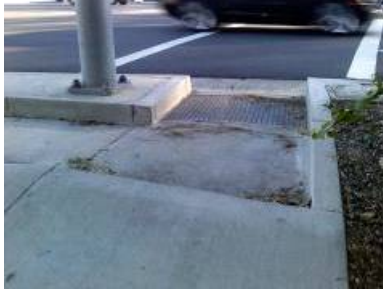
Field Condition	
04.40 - Other - Curb Ramps and Pedestrian Crossings - See Additional Comments	1991 ADAAG -
Existing Condition: 6" change in level at signal.	2004 ADAAG -
	2007 CBC -
	Other -

Classification	
DOJ Location Type:	1
Use:	PV
Severity:	C
Level of Difficulty	Moderate

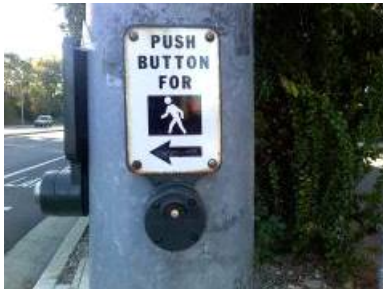
Field Condition	
04.32A - Push Button Operating Effort - The force required to activate operable part(s) of pedestrian signal device exceeds 5 lbs.	1991 ADAAG 4.27.4
Existing Condition: 6 LBF.	2004 ADAAG 309.4
	2007 CBC 1117B.6 item 4
	Other 2005 PROWAG-R306.3.1; R405.4

Classification	
DOJ Location Type:	1
Use:	PV
Severity:	C
Level of Difficulty	Moderate

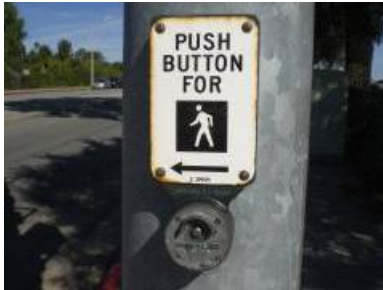
Field Condition	04.33C - Street Name - Pedestrian signal device does not include street name information consisting of California Grade 2 Braille and aligned parallel to the crosswalk direction. OR Pedestrian signal device does not provide street name information in audible format. (Street name information in one format or the other is required to be compliant.)	1991 ADAAG -
		2004 ADAAG -
Existing Condition:		2007 CBC -
		Other 2005 PROWAG-R306.4.2

Classification	
DOJ Location Type:	1
Use:	PV
Severity:	C
Level of Difficulty	Moderate

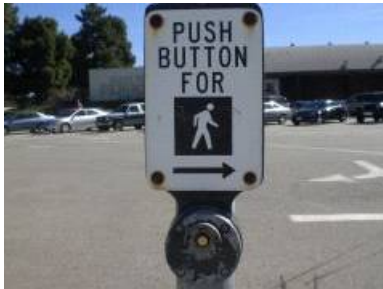
Field Condition	
04.24A - Audible Signal Device - A crosswalk with pedestrian signal indication does not have an audible signal device to indicate the WALK interval.	1991 ADAAG -
Existing Condition:	2004 ADAAG -
	2007 CBC -
	Other 2005 PROWAG-R306.2

Classification	
DOJ Location Type:	1
Use:	PV
Severity:	A
Level of Difficulty	Moderate

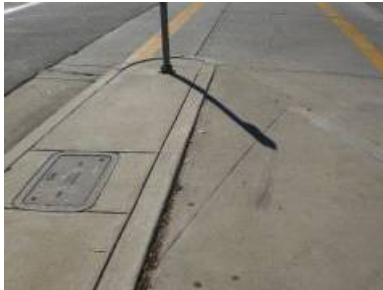
Field Condition	
04.40 - Other - Curb Ramps and Pedestrian Crossings - See Additional Comments	1991 ADAAG -
Existing Condition: Accessible path of travel to signal device is not provided.	2004 ADAAG -
	2007 CBC -
	Other -

Classification	
DOJ Location Type:	1
Use:	PV
Severity:	C
Level of Difficulty	Moderate

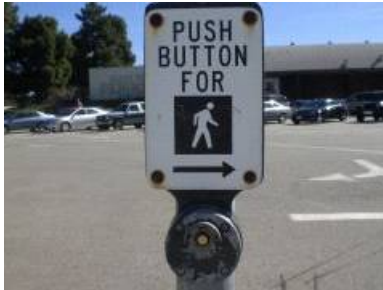
Field Condition	04.33B - Arrow - Pedestrian signal device does not include a tactile arrow that contrasts with the background and is aligned parallel to the crosswalk direction.	1991 ADAAG -
Existing Condition:		2004 ADAAG -
		2007 CBC -
		Other 2005 PROWAG-R306.4.1

Classification	
DOJ Location Type:	1
Use:	PV
Severity:	C
Level of Difficulty	Moderate

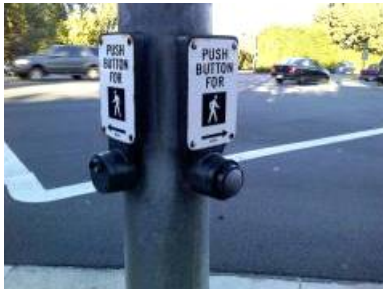
Field Condition	04.26C - Pedestrian Signal Device - Spacing - Pedestrian signal devices at a crossing are spaced less than 10' apart.	1991 ADAAG -
Existing Condition: Pedestrian signal devices are mounted on same pole.		2004 ADAAG -
		2007 CBC -
		Other 2005 PROWAG-R306.2.1.1

Classification	
DOJ Location Type:	1
Use:	PV
Severity:	C
Level of Difficulty	Moderate

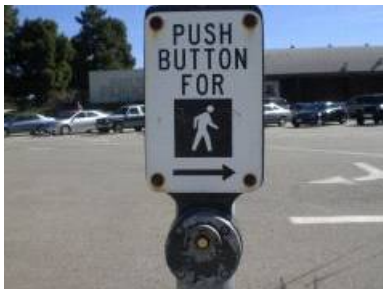
Field Condition	
04.33C - Street Name - Pedestrian signal device does not includes street name information consisting of California Grade 2 Braille and aligned parallel to the crosswalk direction. OR Pedestrian signal device does not provide street name information in audible format. (Street name information in one format or the other is required to be compliant.)	1991 ADAAG -
Existing Condition:	2004 ADAAG -
	2007 CBC -
	Other 2005 PROWAG-R306.4.2

Classification	
DOJ Location Type:	1
Use:	PV
Severity:	C
Level of Difficulty	Moderate

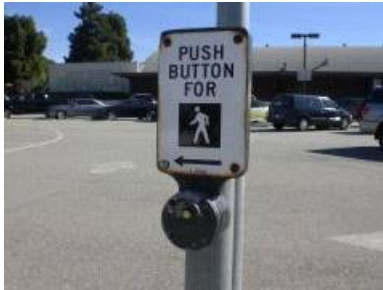
Field Condition	
04.32C - Push Button Size - The pedestrian signal push button is not a min.. 2" across in one dimension.	1991 ADAAG -
Existing Condition: 1/2" diameter.	2004 ADAAG -
	2007 CBC -
	Other 2005 PROWAG-R306.3.3

Classification	
DOJ Location Type:	1
Use:	PV
Severity:	C
Level of Difficulty	Moderate

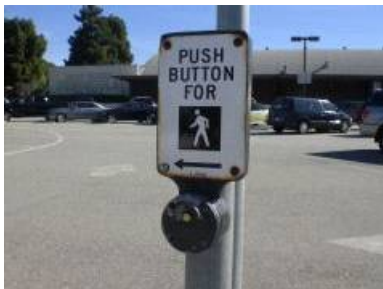
Field Condition	
04.33C - Street Name - Pedestrian signal device does not includes street name information consisting of California Grade 2 Braille and aligned parallel to the crosswalk direction. OR Pedestrian signal device does not provide street name information in audible format. (Street name information in one format or the other is required to be compliant.)	1991 ADAAG -
Existing Condition:	2004 ADAAG -
	2007 CBC -
	Other 2005 PROWAG-R306.4.2

Classification	
DOJ Location Type:	1
Use:	PV
Severity:	C
Level of Difficulty	Moderate

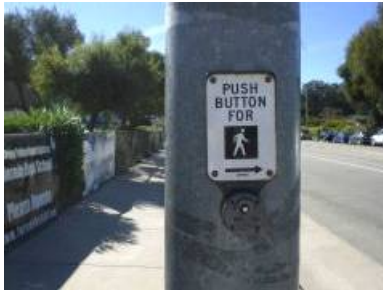
04.24B - Vibrotactile Signal Device - A crosswalk with pedestrian signal indication does not have a vibrotactile signal device integrated into the signal device to indicate the WALK interval.

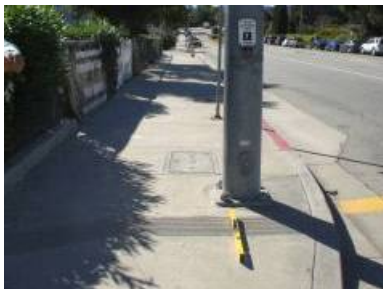
04.25 - Pedestrian Signal Device - Clear Floor Space - Location of pedestrian signal device does not accommodate a level 30" x 48" min.. clear space, centered and parallel to the pedestrian signal push button. (Accessible pedestrian signals shall be located so that the vibrotactile feature can be contacted from the level landing serving a curb ramp, if provided, or from a clear floor or ground space that is in line with the crosswalk line adjacent to the vehicle stop line.)

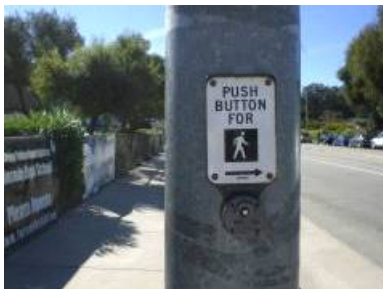
Field Condition	
04.33A - Directional Information and Signs - Pedestrian signal device does not provides compliant tactile or visual signs on the face of the device or its housing or mounting to indicate crosswalk direction and the name of the street containing the crosswalk served by the pedestrian signal.	1991 ADAAG 4.30.4
Existing Condition:	2004 ADAAG 703.1
	2007 CBC 1117B.5.1 item 2; 1117B.5.6
	Other 2005 PROWAG-R306.4

Classification	
DOJ Location Type:	1
Use:	PV
Severity:	C
Level of Difficulty	Moderate

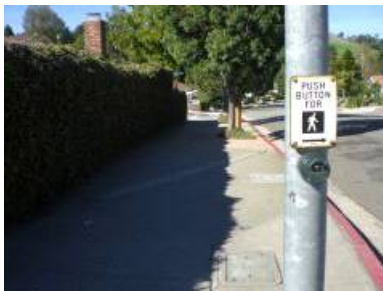
Location: Silver Spur Rd. & Basswood Ave.
Photo # 91

Field Condition	
04.24A - Audible Signal Device - A crosswalk with pedestrian signal indication does not have an audible signal device to indicate the WALK interval.	1991 ADAAG -
Existing Condition:	2004 ADAAG -
	2007 CBC -
	Other 2005 PROWAG-R306.2

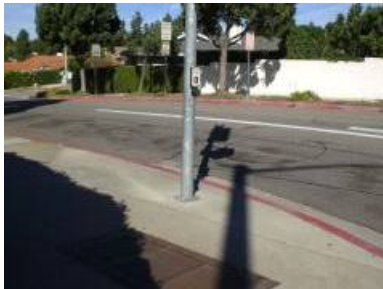
Field Condition	04.25 - Pedestrian Signal Device - Clear Floor Space - Location of pedestrian signal device does not accommodate a level 30" x 48" min.. clear space, centered and parallel to the pedestrian signal push button. (Accessible pedestrian signals shall be located so that the vibrotactile feature can be contacted from the level landing serving a curb ramp, if provided, or from a clear floor or ground space that is in line with the crosswalk line adjacent to the vehicle stop line.)	1991 ADAAG 4.2.4
	Existing Condition: 2.8% CS & 3.1% RS.	2004 ADAAG 305.3; Fig. 305.3
		2007 CBC 1118B.4 item 1
		Other 2005 PROWAG-R306.2.1

Classification	
DOJ Location Type:	1
Use:	PV
Severity:	C
Level of Difficulty	High

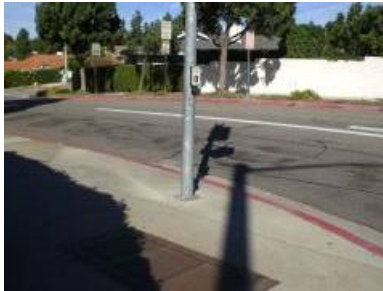
Field Condition	
04.26A - Pedestrian Signal Device - Location versus Crosswalk Line - Location of pedestrian signal device is not within 5' of crosswalk line.	1991 ADAAG -
Existing Condition:	2004 ADAAG -
	2007 CBC -
	Other 2006 Cal MUTCD-Sec. 4E-09, Fig. 4E-2

Classification	
DOJ Location Type:	1
Use:	PV
Severity:	C
Level of Difficulty	Moderate

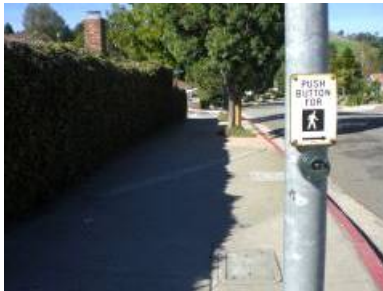
Field Condition	
04.32C - Push Button Size - The pedestrian signal push button is not a min.. 2" across in one dimension.	1991 ADAAG -
Existing Condition: 1/2" diameter.	2004 ADAAG -
	2007 CBC -
	Other 2005 PROWAG-R306.3.3

Classification	
DOJ Location Type:	1
Use:	PV
Severity:	C
Level of Difficulty	Moderate

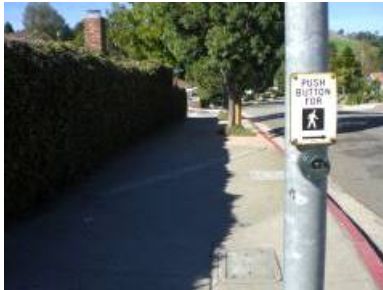
Field Condition	
04.33A - Directional Information and Signs - Pedestrian signal device does not provides compliant tactile or visual signs on the face of the device or its housing or mounting to indicate crosswalk direction and the name of the street containing the crosswalk served by the pedestrian signal.	1991 ADAAG 4.30.4
Existing Condition:	2004 ADAAG 703.1
	2007 CBC 1117B.5.1 item 2; 1117B.5.6
	Other 2005 PROWAG-R306.4

Classification	
DOJ Location Type:	1
Use:	PV
Severity:	C
Level of Difficulty	Moderate

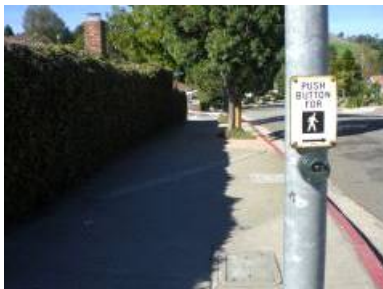
Field Condition	
04.33B - Arrow - Pedestrian signal device does not includes a tactile arrow that contrasts with the background and is aligned parallel to the crosswalk direction.	1991 ADAAG -
Existing Condition:	2004 ADAAG -
	2007 CBC -
	Other 2005 PROWAG-R306.4.1

Classification	
DOJ Location Type:	1
Use:	PV
Severity:	C
Level of Difficulty	Moderate

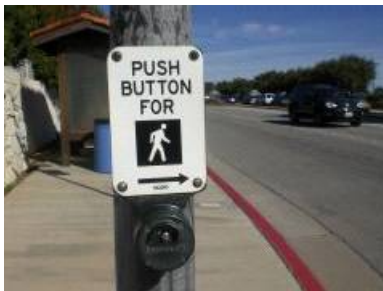
Field Condition	
04.33B - Arrow - Pedestrian signal device does not includes a tactile arrow that contrasts with the background and is aligned parallel to the crosswalk direction.	1991 ADAAG -
Existing Condition:	2004 ADAAG -
	2007 CBC -
	Other 2005 PROWAG-R306.4.1

Classification	
DOJ Location Type:	1
Use:	PV
Severity:	C
Level of Difficulty	Moderate

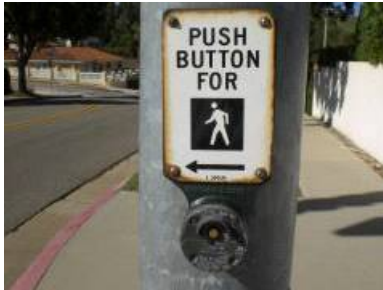
Field Condition	
04.24A - Audible Signal Device - A crosswalk with pedestrian signal indication does not have an audible signal device to indicate the WALK interval.	1991 ADAAG -
Existing Condition:	2004 ADAAG -
	2007 CBC -
	Other 2005 PROWAG-R306.2

Classification	
DOJ Location Type:	1
Use:	PV
Severity:	A
Level of Difficulty	Moderate

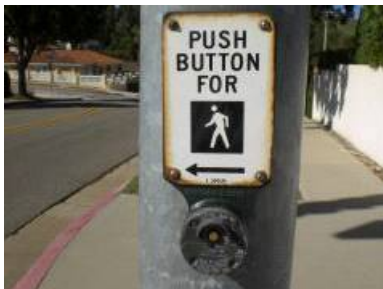
Field Condition	
04.24A - Audible Signal Device - A crosswalk with pedestrian signal indication does not have an audible signal device to indicate the WALK interval.	1991 ADAAG -
Existing Condition:	2004 ADAAG -
	2007 CBC -
	Other 2005 PROWAG-R306.2

Classification	
DOJ Location Type:	1
Use:	PV
Severity:	C
Level of Difficulty	Moderate

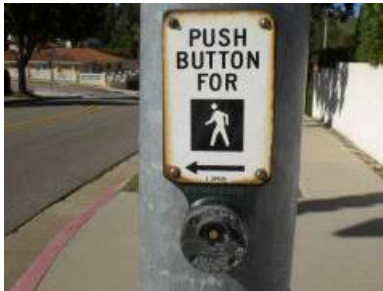
Field Condition	
04.33B - Arrow - Pedestrian signal device does not includes a tactile arrow that contrasts with the background and is aligned parallel to the crosswalk direction.	1991 ADAAG -
Existing Condition:	2004 ADAAG -
	2007 CBC -
	Other 2005 PROWAG-R306.4.1

Classification	
DOJ Location Type:	1
Use:	PV
Severity:	C
Level of Difficulty	Moderate

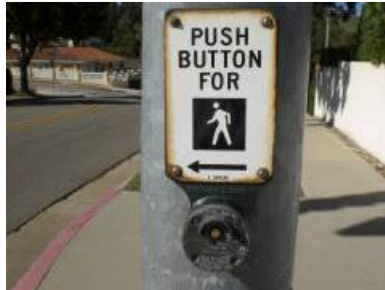
04.33C - Street Name - Pedestrian signal device does not include street name information consisting of California Grade 2 Braille and aligned parallel to the crosswalk direction. OR Pedestrian signal device does not provide street name information in audible format. (Street name information in one format or the other is required to be compliant.)
