City of Rancho Palos Verdes
Rancho Palos Verdes ADA Assessment
Facility Report with Photos

Facility ID: # Curb Ramps

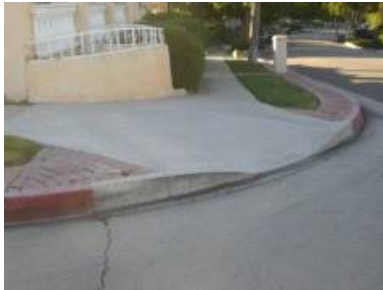
Keynote 11

Field Condition	
04.04 - Counter Slope - The running slopes of the road, gutter or accessible route adjoining the ramp exceed 5%.	1991 ADAAG 4.7.2
Existing Condition: 10.6% CS.	2004 ADAAG 406.2
	2007 CBC 1127B.5 item 3
	Other 2005 PROWAG-R303.3.5

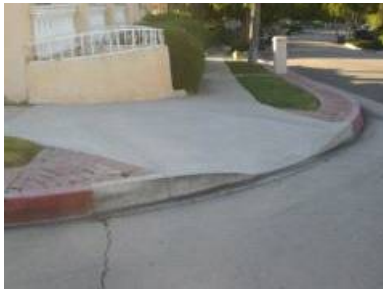
Keynote 12

Field Condition	
04.05 - Width - The width of the curb ramp, not including the flared sides, is less than 48".	1991 ADAAG 4.7.3
Existing Condition: 38" wide.	2004 ADAAG 406.1; 405.5
	2007 CBC 1127B.5 item 2
	Other 2005 PROWAG-R303.3.1

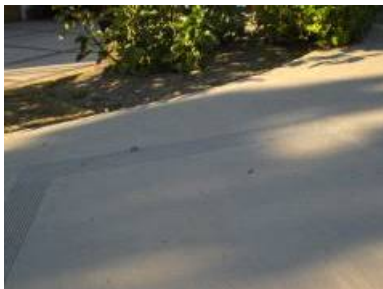
Keynote 28

Field Condition	
03A.02A - Width - Accessible route of travel is less than 48" wide (note: 48" wide requirement does not apply to doorways or gates).	1991 ADAAG 4.3.3
Existing Condition: 35" wide.	2004 ADAAG 403.5.1
	2007 CBC 1133B.7.1
	Other 2005 PROWAG-R301.3.1

Corrective Action
008 - Concrete Landing - Remove non-compliant pavement and replace with new concrete. The landing slope shall not exceed 2% in any direction.
Additional Comments:

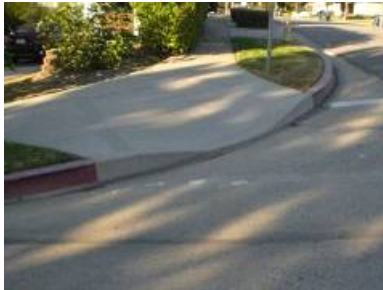
Keynote 31

Field Condition	
04.10 - Detectable Warning Requirement - Regardless of slope, the curb ramp does not have a detectable warning.	1991 ADAAG 4.7.7; 4.29.2
Existing Condition: Not provided.	2004 ADAAG 705.1; Fig. 705.1
	2007 CBC 1127B.5 item 7
	Other 2005 PROWAG-R303.3.2

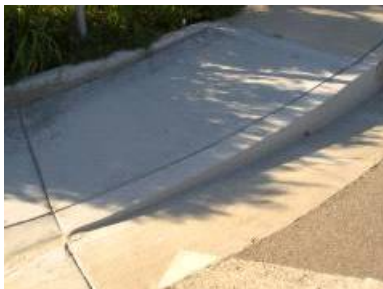
Keynote 32

Field Condition	
04.02 - Slope - Slope of the curb ramp exceeds 8.33% (or the least possible compliant slope).	1991 ADAAG 4.7.2; 4.8.2
Existing Condition: 11.8% RS.	2004 ADAAG 405.2; Advisory 405.2
	2007 CBC 1127B.5 item 3
	Other 2005 PROWAG-R303.2.1.1; R303.2.2.1

Corrective Action
120D - Replace Curb Ramp - Remove existing curb ramp, provide new.
Additional Comments:

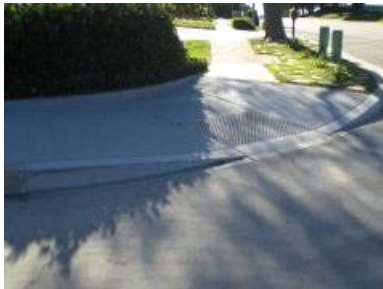
Keynote 42

Field Condition	
04.07B - Side Flare Slope (8.33% Max. Requirement) - Where the landing at the top of the ramp is less than 48" deep and wheelchair users must use the side flares for access, the flared sides have a slope greater than 8.33% (measured along the curb).	1991 ADAAG Fig. 12(a)
Existing Condition: 15% RS.	2004 ADAAG 406.3; Fig. 406.3
	2007 CBC 1127B.5 item 4
	Other -

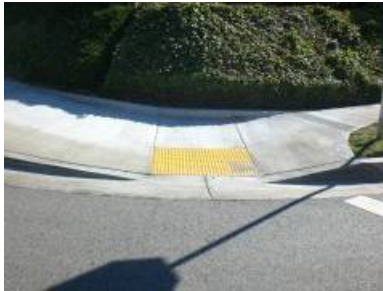
Keynote 77

Field Condition	
04.02 - Slope - Slope of the curb ramp exceeds 8.33% (or the least possible compliant slope).	1991 ADAAG 4.7.2; 4.8.2
Existing Condition: 10.4% and 13.6% RS.	2004 ADAAG 405.2; Advisory 405.2
	2007 CBC 1127B.5 item 3
	Other 2005 PROWAG-R303.2.1.1; R303.2.2.1

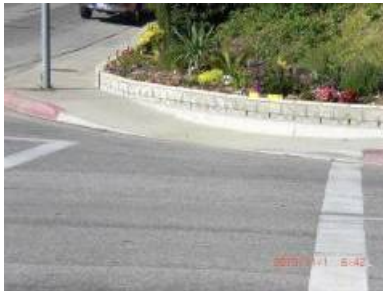
Keynote 78

Field Condition	
04.02 - Slope - Slope of the curb ramp exceeds 8.33% (or the least possible compliant slope).	1991 ADAAG 4.7.2; 4.8.2
Existing Condition: 11.7% RS.	2004 ADAAG 405.2; Advisory 405.2
	2007 CBC 1127B.5 item 3
	Other 2005 PROWAG-R303.2.1.1; R303.2.2.1

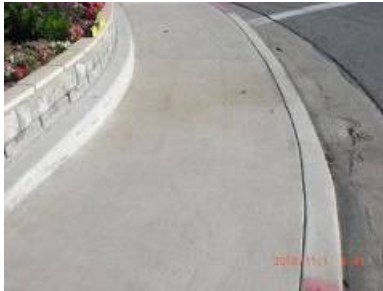
Keynote 79

Field Condition	
04.03 - Transition - The transition from the curb ramp to the road or gutter is not flush or free of abrupt changes.	1991 ADAAG 4.7.2
Existing Condition: 1/2" transition.	2004 ADAAG 406.2; Fig. 406.2
	2007 CBC 1127B.5 item 3
	Other 2005 PROWAG-R301.5.1

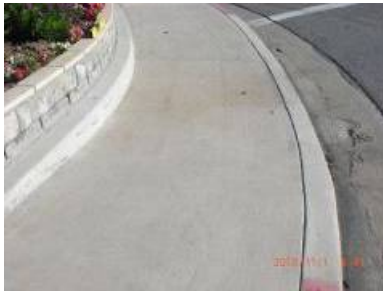
Keynote 82

Field Condition	
04.40 - Other - Curb Ramps and Pedestrian Crossings - See Additional Comments	1991 ADAAG -
Existing Condition: 2.7% CS.	2004 ADAAG -
	2007 CBC -
	Other -

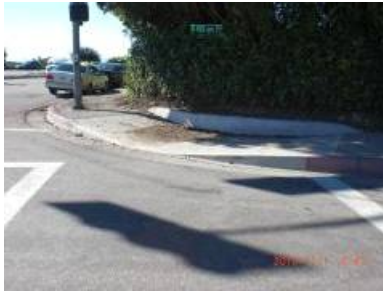
Keynote 83

Field Condition	
04.02 - Slope - Slope of the curb ramp exceeds 8.33% (or the least possible compliant slope).	1991 ADAAG 4.7.2; 4.8.2
Existing Condition: 12.6% RS.	2004 ADAAG 405.2; Advisory 405.2
	2007 CBC 1127B.5 item 3
	Other 2005 PROWAG-R303.2.1.1; R303.2.2.1

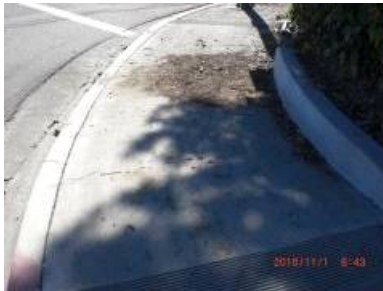
Keynote 84

Field Condition	
04.03 - Transition - The transition from the curb ramp to the road or gutter is not flush or free of abrupt changes.	1991 ADAAG 4.7.2
Existing Condition: 3/4" transition.	2004 ADAAG 406.2; Fig. 406.2
	2007 CBC 1127B.5 item 3
	Other 2005 PROWAG-R301.5.1

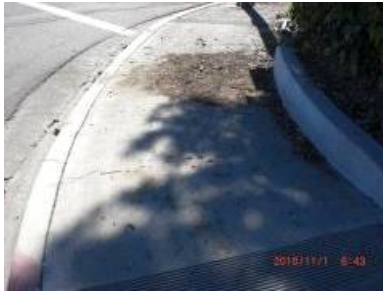
Keynote 85

Field Condition	
04.09B - Grooved Border - Location - A 12" wide grooved border has not been provided on the level surface of the walkway.	1991 ADAAG -
Existing Condition: Grooves are on sloping area of curb ramp.	2004 ADAAG -
	2007 CBC 1127B.5 item 6
	Other -

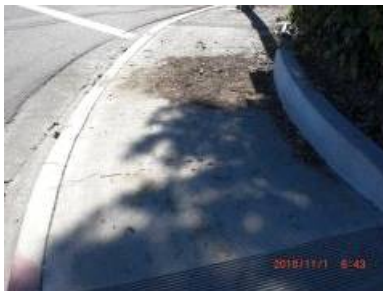
Keynote 86

Field Condition	
04.10 - Detectable Warning Requirement - Regardless of slope, the curb ramp does not have a detectable warning.	1991 ADAAG 4.7.7; 4.29.2
Existing Condition: Not provided.	2004 ADAAG 705.1; Fig. 705.1
	2007 CBC 1127B.5 item 7
	Other 2005 PROWAG-R303.3.2

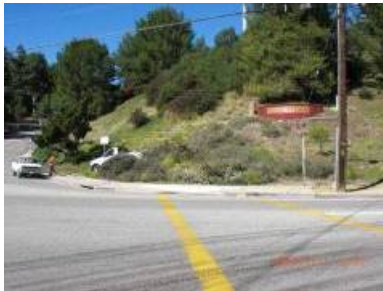
Keynote 88

Field Condition	
04.02 - Slope - Slope of the curb ramp exceeds 8.33% (or the least possible compliant slope).	1991 ADAAG 4.7.2; 4.8.2
Existing Condition: 9.1% RS.	2004 ADAAG 405.2; Advisory 405.2
	2007 CBC 1127B.5 item 3
	Other 2005 PROWAG-R303.2.1.1; R303.2.2.1

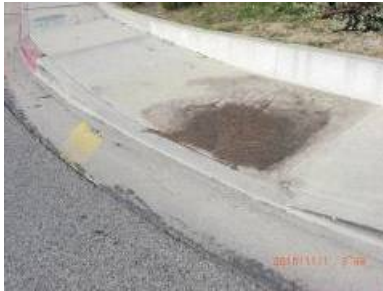
Keynote 89

Field Condition	
04.03 - Transition - The transition from the curb ramp to the road or gutter is not flush or free of abrupt changes.	1991 ADAAG 4.7.2
Existing Condition: 3/4" transition.	2004 ADAAG 406.2; Fig. 406.2
	2007 CBC 1127B.5 item 3
	Other 2005 PROWAG-R301.5.1

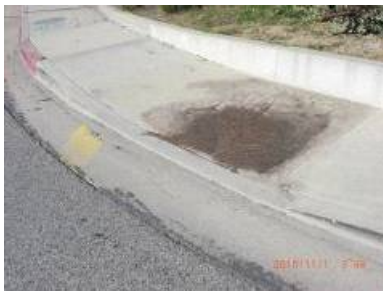
Keynote 90

Field Condition	
04.04 - Counter Slope - The running slopes of the road, gutter or accessible route adjoining the ramp exceed 5%.	1991 ADAAG 4.7.2
Existing Condition: 8.5% counter slope.	2004 ADAAG 406.2
	2007 CBC 1127B.5 item 3
	Other 2005 PROWAG-R303.3.5

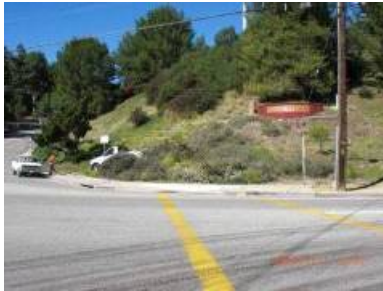
Keynote 91

Field Condition	
04.40 - Other - Curb Ramps and Pedestrian Crossings - See Additional Comments	1991 ADAAG -
Existing Condition: 48" bottom landing.	2004 ADAAG -
	2007 CBC -
	Other -

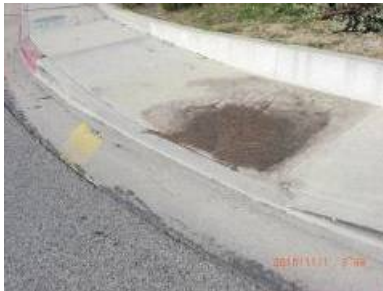
Keynote 92

Field Condition	
04.40 - Other - Curb Ramps and Pedestrian Crossings - See Additional Comments	1991 ADAAG -
Existing Condition: Pond.	2004 ADAAG -
	2007 CBC -
	Other -

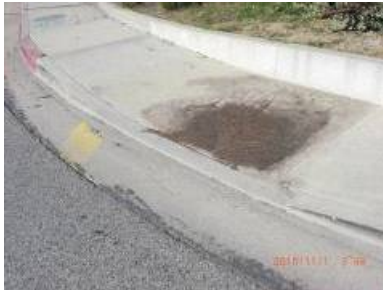
Keynote 93

Field Condition	
04.10 - Detectable Warning Requirement - Regardless of slope, the curb ramp does not have a detectable warning.	1991 ADAAG 4.7.7; 4.29.2
Existing Condition: Not provided.	2004 ADAAG 705.1; Fig. 705.1
	2007 CBC 1127B.5 item 7
	Other 2005 PROWAG-R303.3.2

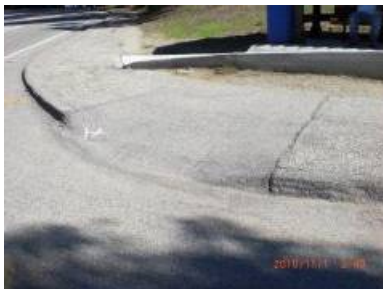
Keynote 94

Field Condition	
04.02 - Slope - Slope of the curb ramp exceeds 8.33% (or the least possible compliant slope).	1991 ADAAG 4.7.2; 4.8.2
Existing Condition: 14.3% RS.	2004 ADAAG 405.2; Advisory 405.2
	2007 CBC 1127B.5 item 3
	Other 2005 PROWAG-R303.2.1.1; R303.2.2.1

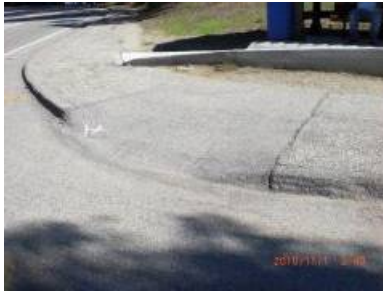
Keynote 95

Field Condition									
04.06 - Surface - The surface of the curb ramp is not stable, firm and slip-resistant. Existing Condition: Loose asphalt.

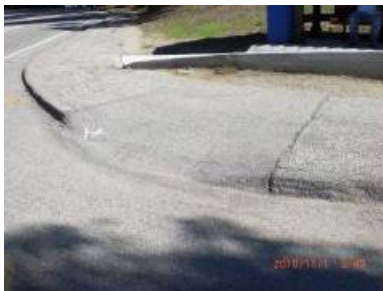
Keynote 96

Field Condition									
04.07B - Side Flare Slope (8.33% Max. Requirement) - Where the landing at the top of the ramp is less than 48" deep and wheelchair users must use the side flares for access, the flared sides have a slope greater than 8.33% (measured along the curb). Existing Condition: 13.6% and 21.6%.

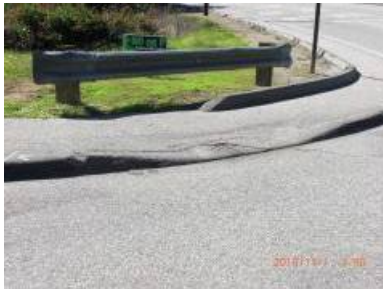
Keynote 100

Field Condition	
04.03 - Transition - The transition from the curb ramp to the road or gutter is not flush or free of abrupt changes.	1991 ADAAG 4.7.2
Existing Condition: 1" transition.	2004 ADAAG 406.2; Fig. 406.2
	2007 CBC 1127B.5 item 3
	Other 2005 PROWAG-R301.5.1

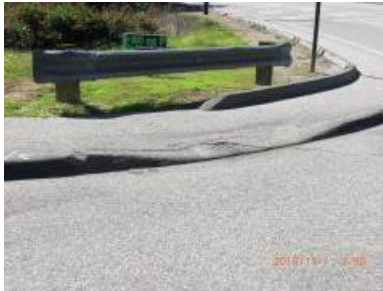
Keynote 101

Field Condition	
04.04 - Counter Slope - The running slopes of the road, gutter or accessible route adjoining the ramp exceed 5%.	1991 ADAAG 4.7.2
Existing Condition: 7.4% counter slope.	2004 ADAAG 406.2
	2007 CBC 1127B.5 item 3
	Other 2005 PROWAG-R303.3.5

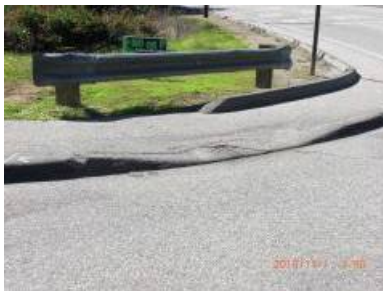
Keynote 102

Field Condition	
04.06 - Surface - The surface of the curb ramp is not stable, firm and slip-resistant.	1991 ADAAG 4.5.1
Existing Condition: Curb ramp has deteriorated.	2004 ADAAG 302.1; Advisory 302.1
	2007 CBC 1127B.5 item 5
	Other 2005 PROWAG-R301.5

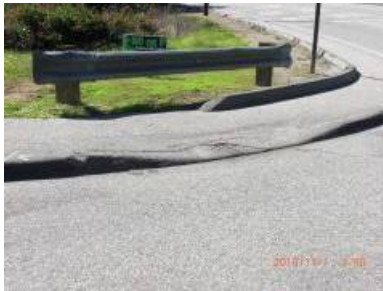
Keynote 104

Field Condition	
04.09A - Grooved Border Requirement - Curb ramp does not have a 12" wide grooved border around upper edges of curb ramp and flares to indicate transition from sidewalk to curb ramp. Existing Condition: Not provided.	1991 ADAAG - 2004 ADAAG - 2007 CBC 1127B.5 item 6 Other -
