THE CITY OF  
**RANCHO PALOS VERDES**

## Infrastructure Report Card

Revised May 14, 2014

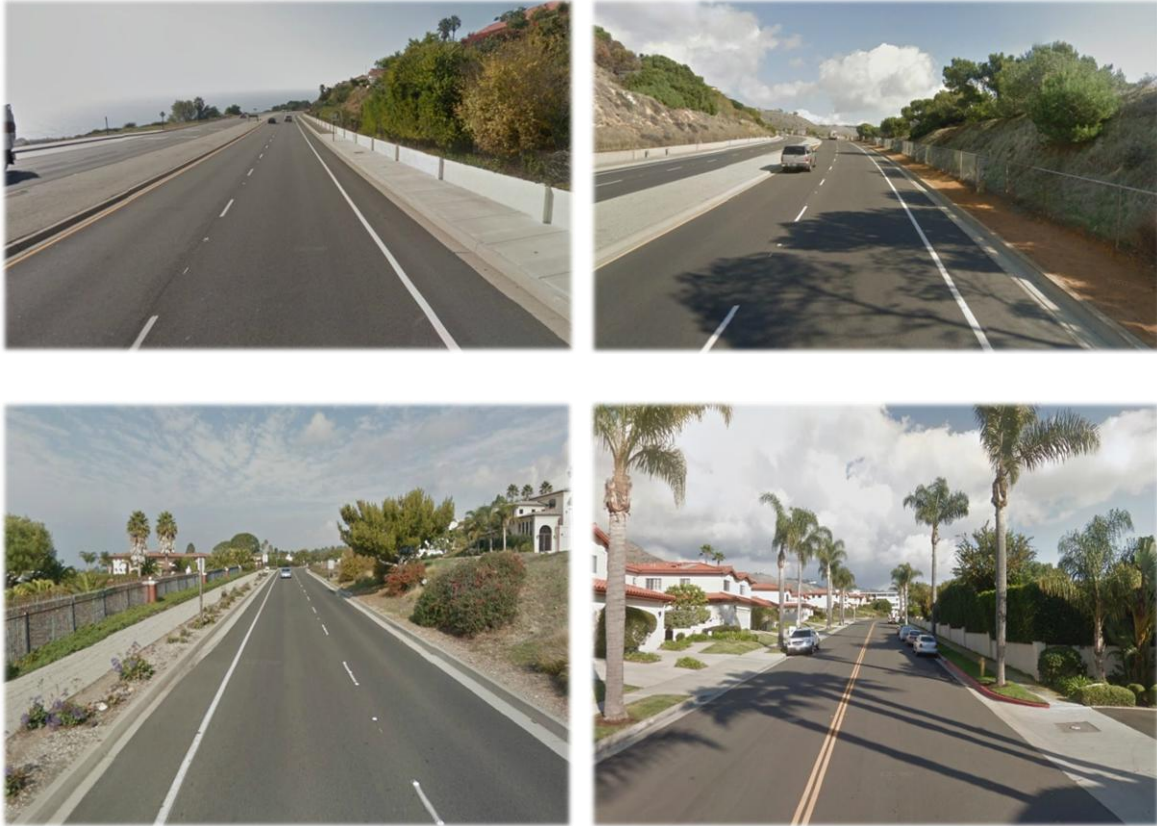
### Various Streets

| Evaluation of Right of Way and Traffic Devices | | | |
|---|---|---|---|
| 3 | Severity of structural/condition problems | 8 | Mostly general cracking/deterioration |
| 4 | Safety concerns of structural/maintenance problems | 9 | No major potholes/safety hazards |

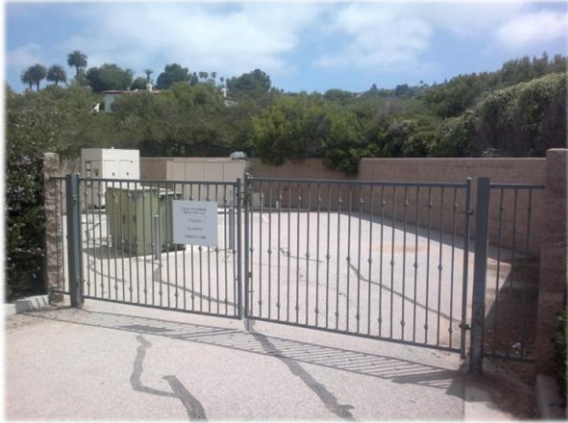
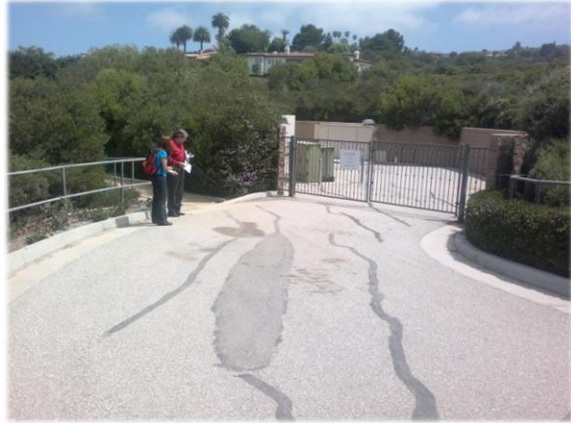
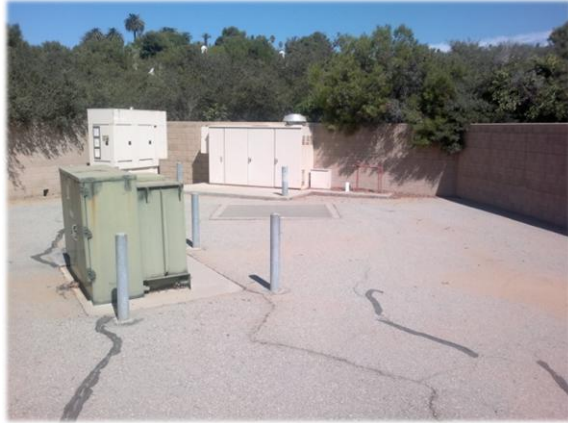
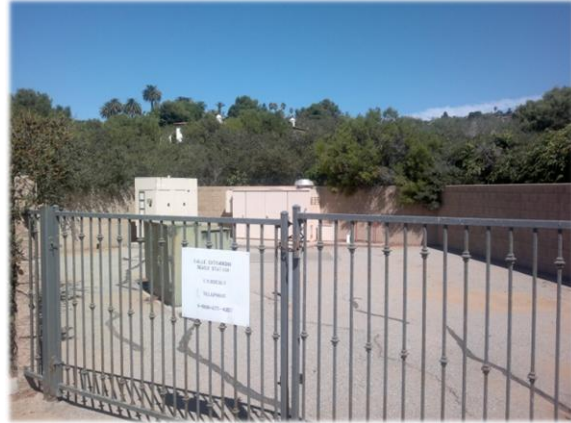
### Calle Entradero Sewer Station

| <u>No.</u> | <u>Subcriteria</u> | <u>Score</u> | <u>Comments</u> |
|---|---|---|---|
| 1 | Overall structural condition of sewer facilities | 7 | Some maintenance/structural deficiencies |
| 3 | Severity of maintenance/structural problems | 6 | No gasketed joints/root intrusion & cracking |

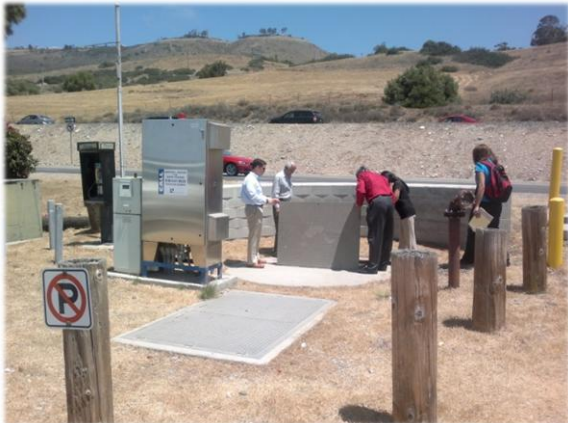
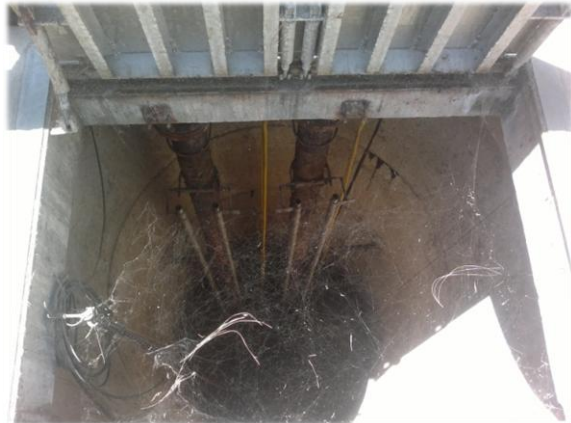
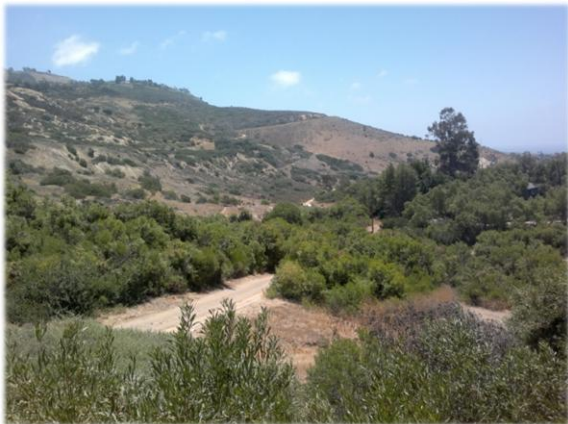
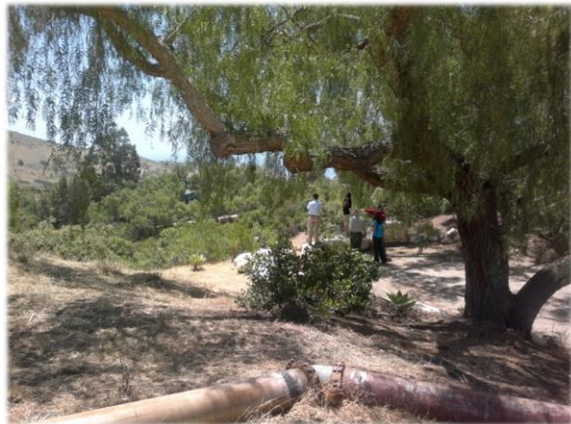
### Abalone Cove District Facilities

| No. | Subcriteria | Score | Comments |
|---|---|---|---|
| 1 | Overall structural condition of sewer facilities | 7 | Some maintenance/structural deficiencies |
| 3 | Severity of maintenance/structural problems | 8 | No gasketed joints/root intrusion & cracking |

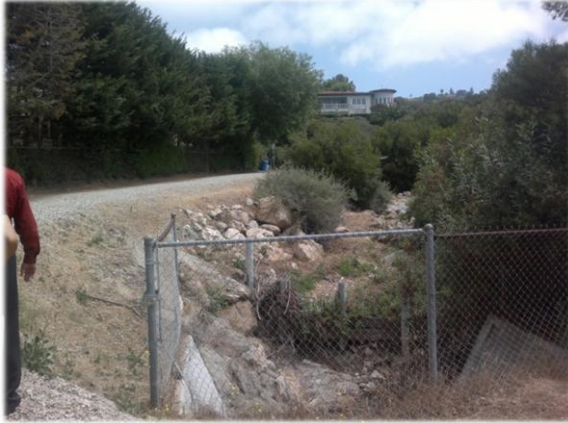
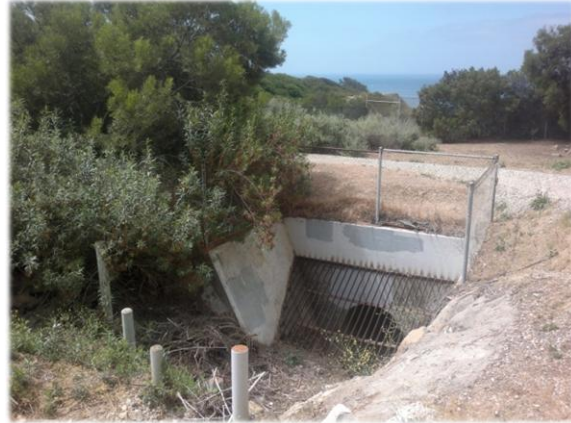
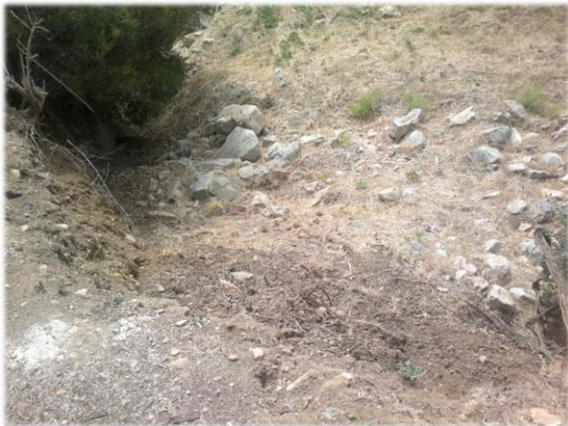
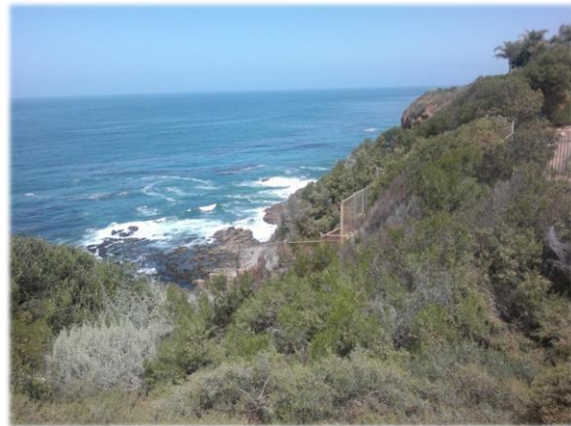
### Drainage Facilities Near Pacifica Del Mar

| No. | Subcriteria | Score | Comments |
|---|---|---|---|
| 1 | Overall structural condition of drainage facilities | 8 | Overall decent condition of facilities |
